HERTFORD CONSERVATION AREA APPRAISAL AND MANAGEMENT PLAN

DRAFT FOR CONSULTATION 2016

East Herts. District Council

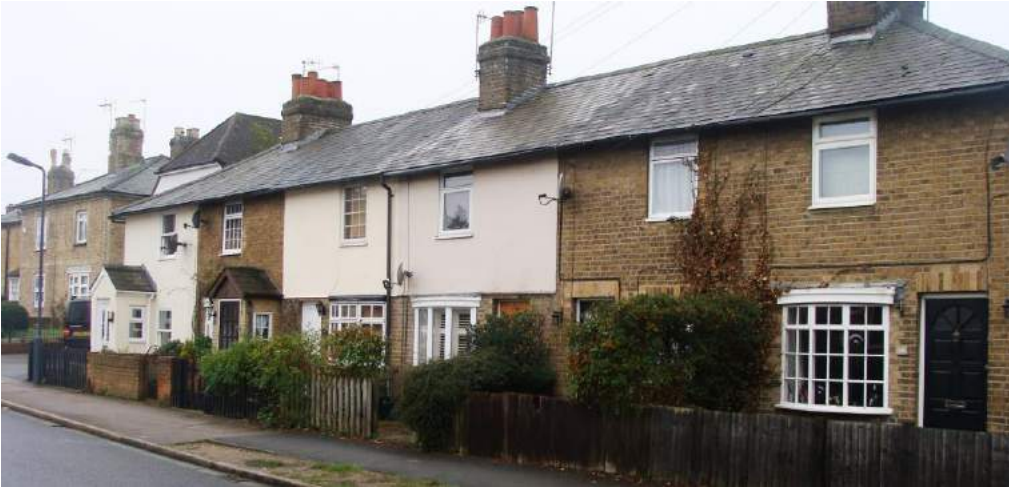
Picture 43. A terrace within the town where various window and porch types together with painting of brick work have altered the original visual harmony and historical integrity of the group.

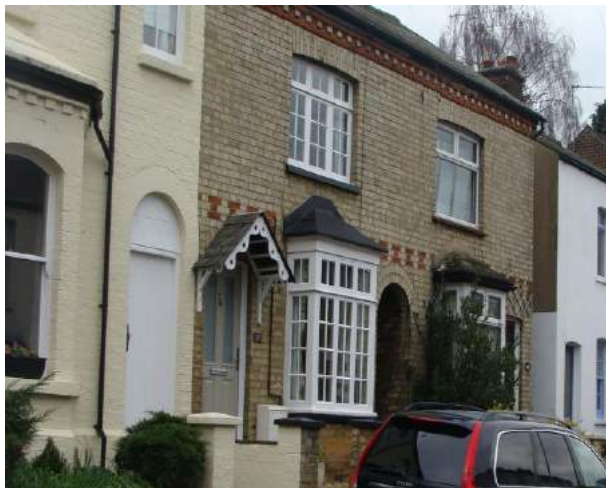
Picture 54. Another similar example, various replacement window types.

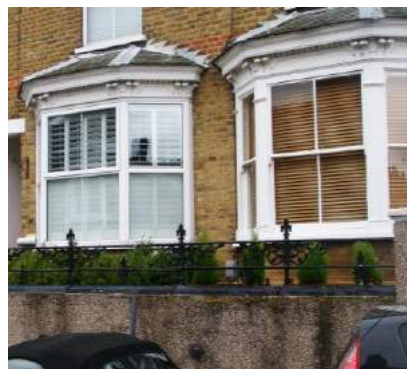
Picture 65. Window on the right is of traditional design; the replacement on the left is heavier and in comparison rather crude, in the fieldworker's opinion.

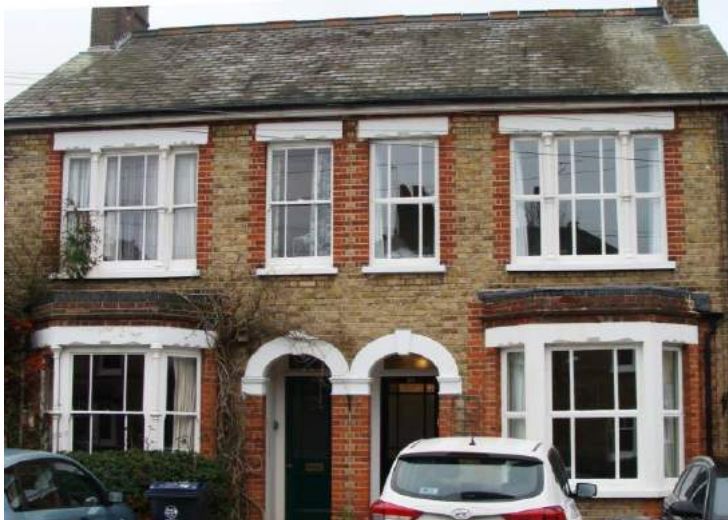
Picture 76. A better solution but one that could have been improved upon. The window surround detailing has been retained and this is important. It is particularly important that the recessed entrances have not been altered. The property on the left has early/ original windows whilst those on the right are heavier but nevertheless retain similar profiles to the originals. This is not an uncommon occurrence in the town.

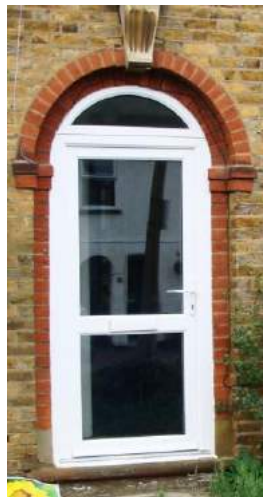
Picture 87. An example of where a recessed entrance has been enclosed. Compare the visual impact with those remaining open in the picture above.

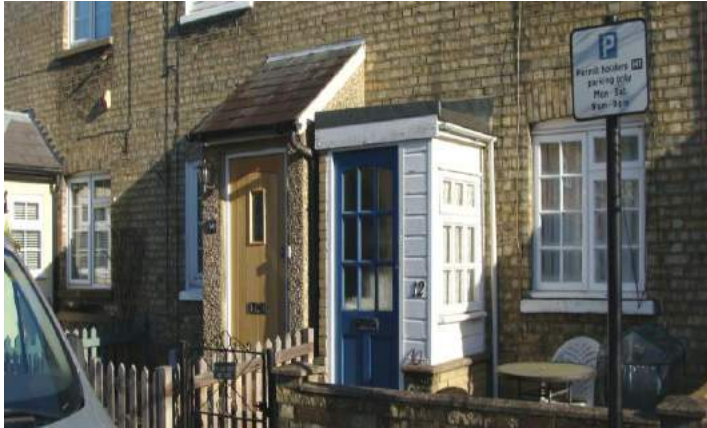
Picture 98. Inappropriate porch detailing.

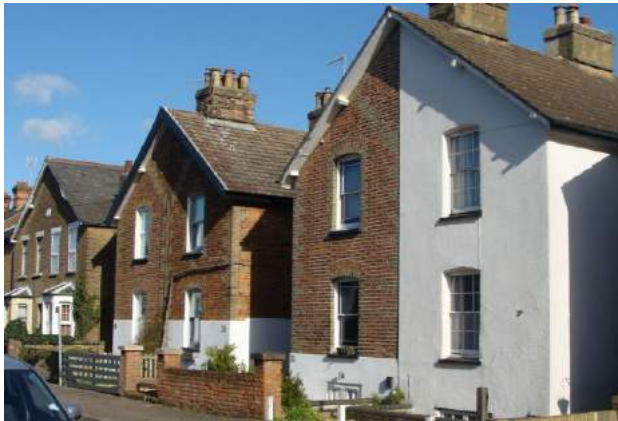
Picture 499. A mixture of render and brick, assumed to demark property ownership is visually disruptive.

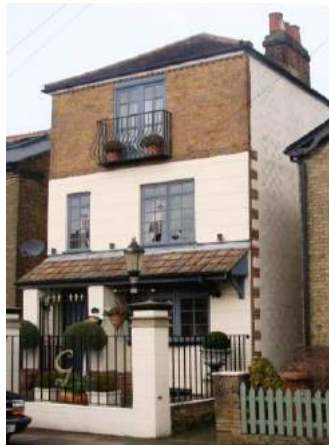
Picture 140. A highly personalised treatment of a three storey building in a 19th century street scene.

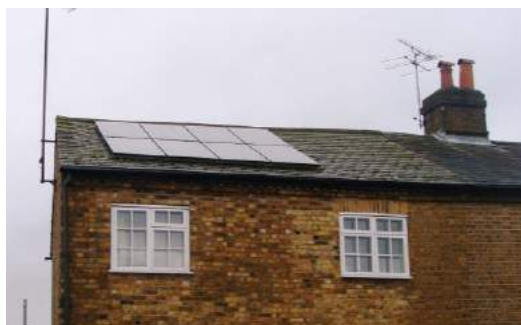
Picture 121. Thus far the visual impact of solar panels on historic houses is limited in Hertford but will this remain the case and if it does not what is the reader's views of introducing additional controls to restrict what is often 'Permitted Development'?

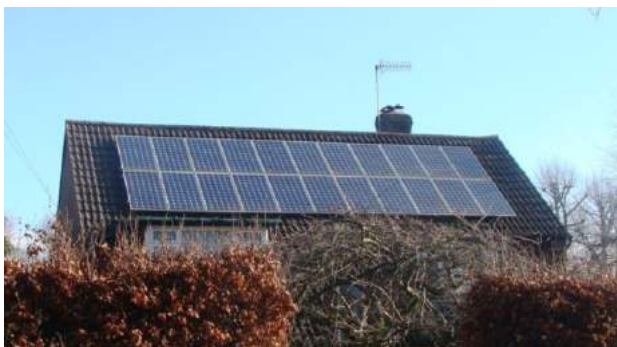
Picture 132. Another example of solar panel on a modern building in the conservation area.

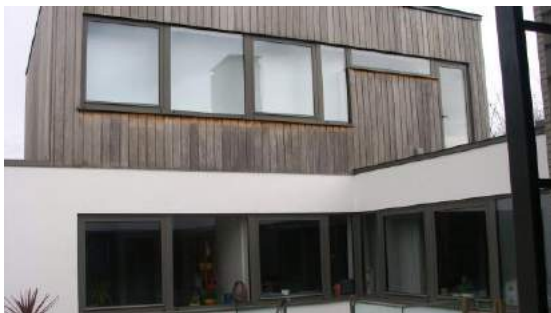
Picture 143. Hide House Railway Place. Hide House 2B Railway Place. A modern 'eco' solution. The owner advises this house is super insulated with some green roof space. Solar panels, air source heat pump system, heat recovery system and controlled lighting. John Pratley, Building Futures Awards Judge, said: "Hide House is an interesting attempt to construct a low energy home at a reasonable cost. The owners have created a house which makes excellent use of daylight and provides very good use of the available land on a very constrained site. The owners should be congratulated for designing and building a very attractive home on a very difficult to exploit site."

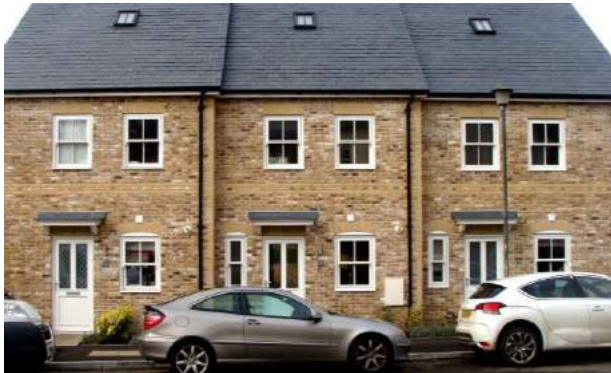
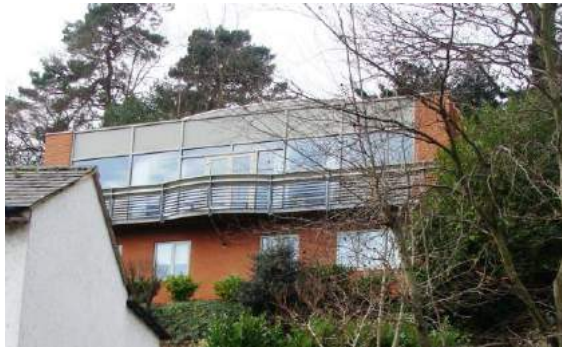
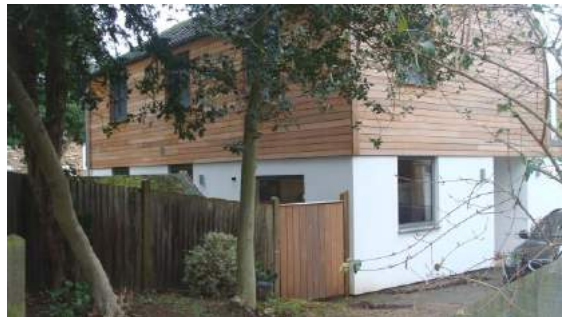
Picture 154-176. Modern housing design solutions in Hertford. First picture solution in traditional mode, next a more adventurous and contemporary solution; lower a contemporary/ traditional solution with simple and effective design detailing. In the fieldworker's opinion Hertford could accommodate more contemporary solutions.

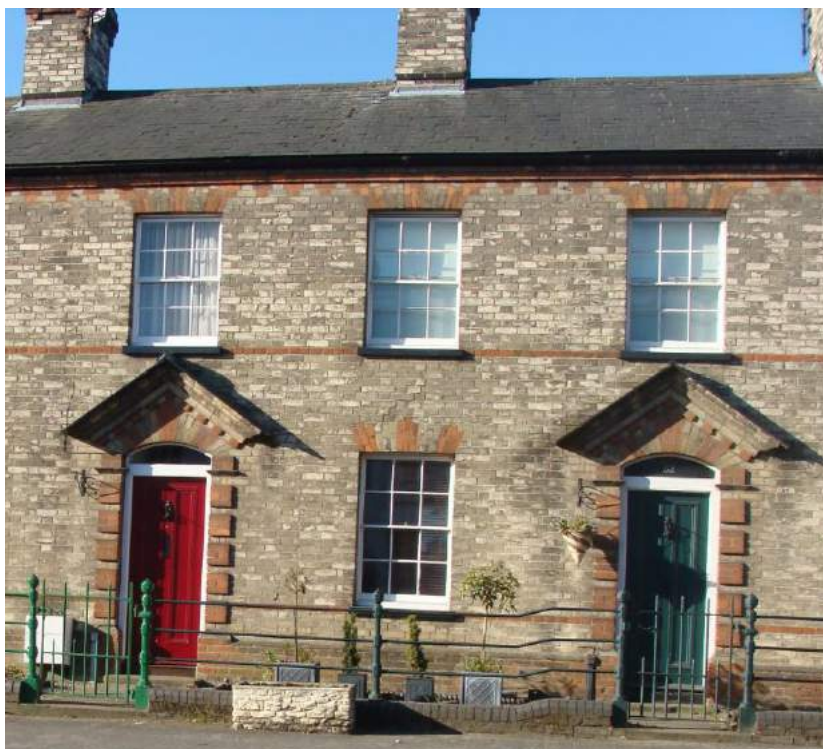
Picture 187. A listed terrace not local to East Hertfordshire. The purpose of this picture is to illustrate the importance of design detail in relation to traditional late19th/early20th century terraces. There are large numbers of similar unlisted terraces in Hertford identified by this appraisal as being important. Retaining the character of such terraces in part depends on keeping simple original repetitive detailing, including doors. Compare this simple solution with some of the previous illustrations which do not provide any sense of architectural 'rhythm' and are disruptive. Expression of ownership can be provided by painting doors different colours.

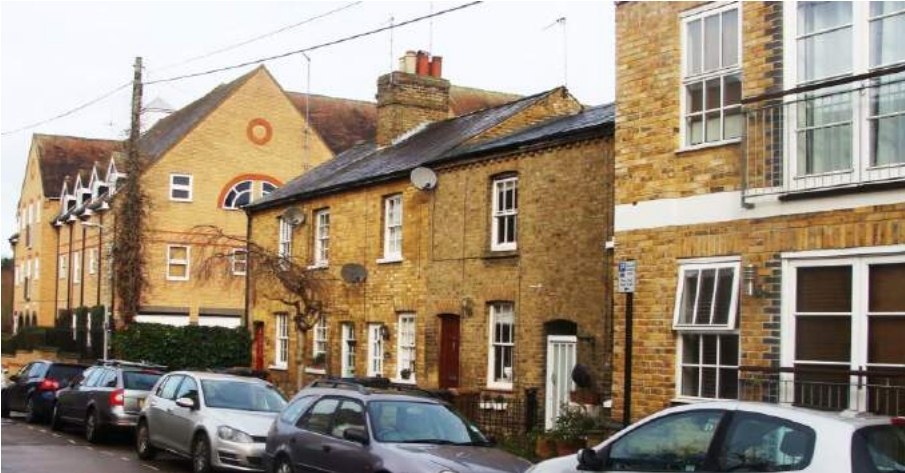
Picture 198. Priory Street an area of considerable redevelopment where the retention of this historic terrace is considered to be most important.

5.5. In some locations in Hertford larger scale redevelopment is taking place. Sometimes within these areas there are historic terraces or corner buildings still remaining. Often it will be important for such features to remain.

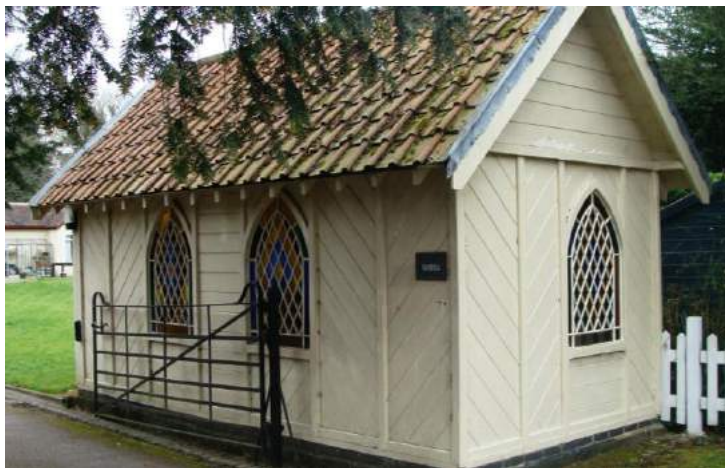
5.16. Gazebo in grounds of Rockall, North Road. Grade II. Gazebo. Circa 1830-40, restored early 1990s. Timber-framed, with timber cladding, and a pantiled roof. Gothick style. The building was originally sited in the garden of No.2 North Road.

Picture 2019. Charming Gazebo in Gothick style, listed Grade II but no longer in original location.

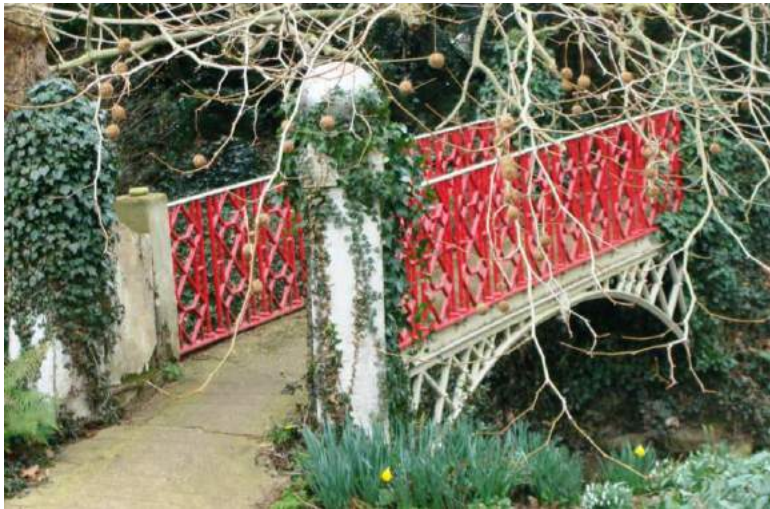
5.17. Footbridge over mill stream, in grounds 40m north of North Road House - grade II. 1848 (date on arch). Architect Thomas Smith. Cast-iron with gault brick and stucco abutments. Segmentally arched girders with trellis-pattern spandrels, with bamboo-form lattice pattern handrails.

Picture 240. Charming 19th century listed footbridge over mill stream.

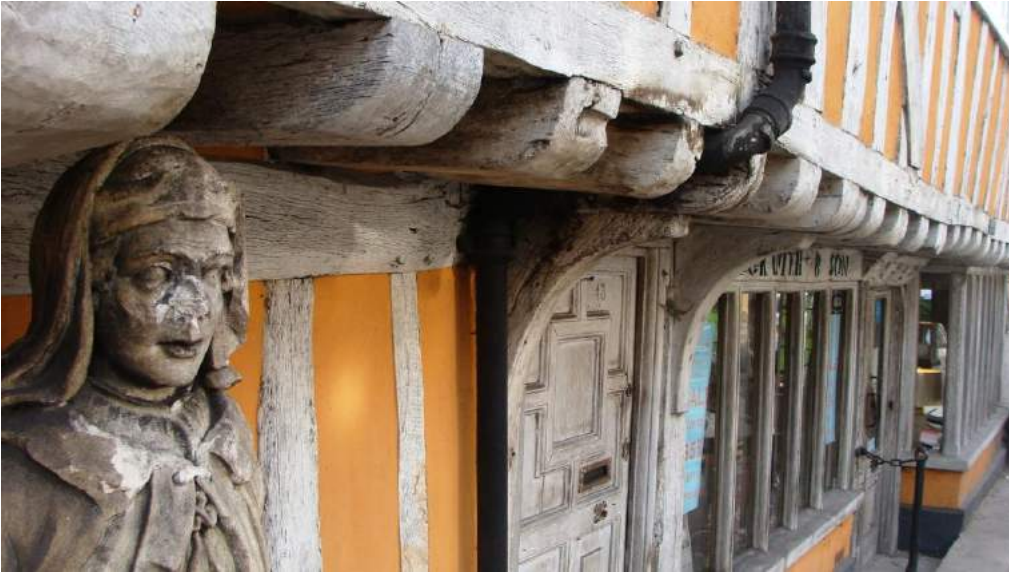
5.19. No.43 St. Andrew Street including St Nicholas Hall - Grade II*. Now antique shop, incorporating former church hall at rear. 15th century, altered and extended early 17th century, rear range of 15th century cottage demolished 1892 and rebuilt as St Nicholas Hall. Timber-framed and plastered front with exposed studwork. St Nicholas Hall commemorates a former parish of Hertford, unified with St Andrew's about 1707 ~~Earlier~~earlier church was demolished in 1675 and was sited near the river on the present Maidenhead Yard, where it is shown on John Speed's map published 1610.

Picture 221. No. 43 St Andrew Street, a fine grade II* listed building dating from the 15th century.

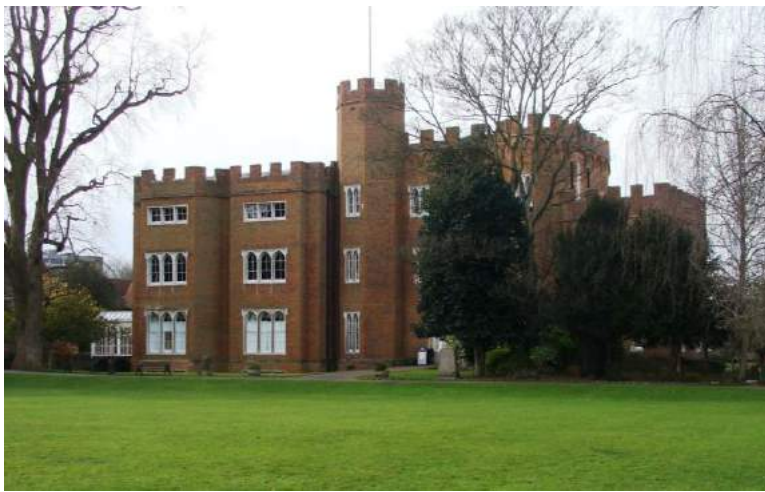
5.20. Gatehouse to Hertford Castle 10/02/50 (Hertford Castle demolished) - Grade I. Castle gatehouse, subsequently residence, Local Authority offices since 1912. Altered and extended. Red brick (~~locally manufactured~~locally manufactured by Cornelius Gyles). Stone dressings, Welsh slated roofs. Hertford Castle reputedly originated as a Saxon fort built by order of King Alfred against the Danes encamped at Ware. The castle was built (or reconstructed) by William I shortly after 1066 as a motte and bailey. In 1304 the castle became a royal palace and a prison where David II and James I of Scotland and King John of France were held. From 1805-18, the castle was used by the East India Company College, from 1822-32 the Dispensary which preceded the General Infirmary (County Hospital) was held there, and it was also used as a judges' lodging. In 1911 Hertford Corporation approached Lord Salisbury to purchase the castle, and a lease of 75 years at a peppercorn rent of 2s 6d per annum was granted. The grounds were laid out as public gardens, and the entrance gates leading from The Wash were donated by Osmond Henry McMullen in 1912 which are separately listed grade II.

Picture 232. Hertford Castle listed Grade 1.

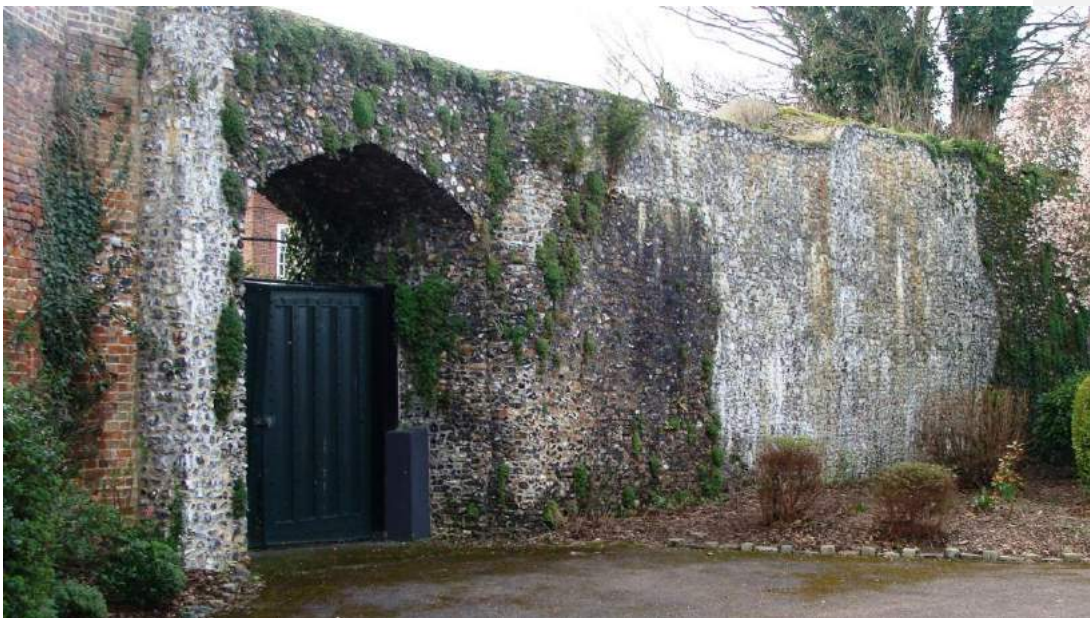
5.21. Hertford Castle Bailey Walls - Grade II*. Curtain wall along north-east side of Castle Bailey. Late 12th century with later repairs and alterations. Flint rubble with clunch blocks, and extensive repairs and rebuilding in red brick laid to English bond. At south-east corner is a screen totally rebuilt in red brick. The wall attains its greatest height of 15 -18 ft, without later crenellations. Also south-east range along south-east side of Castle Bailey of similar date.

Picture 243. Impressive walls dating from the late 12th century with later additions/alterations, listed Grade II*.

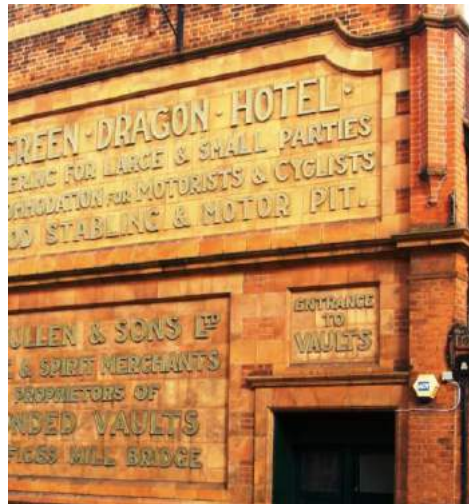
5.22. Former stables to former Green Dragon Hotel - Grade II. Circa 1903-4, with late 20th century alterations. Architect James Farley. Bronze brick with terracotta dressings and ornament, clay tiled roof. Ground floor has brick plinth, with blank arches, terracotta band, and large terracotta panel with raised lettering.

Picture 254. Early 20th century raised lettering on frontage to Green Dragon stabling, unusual.

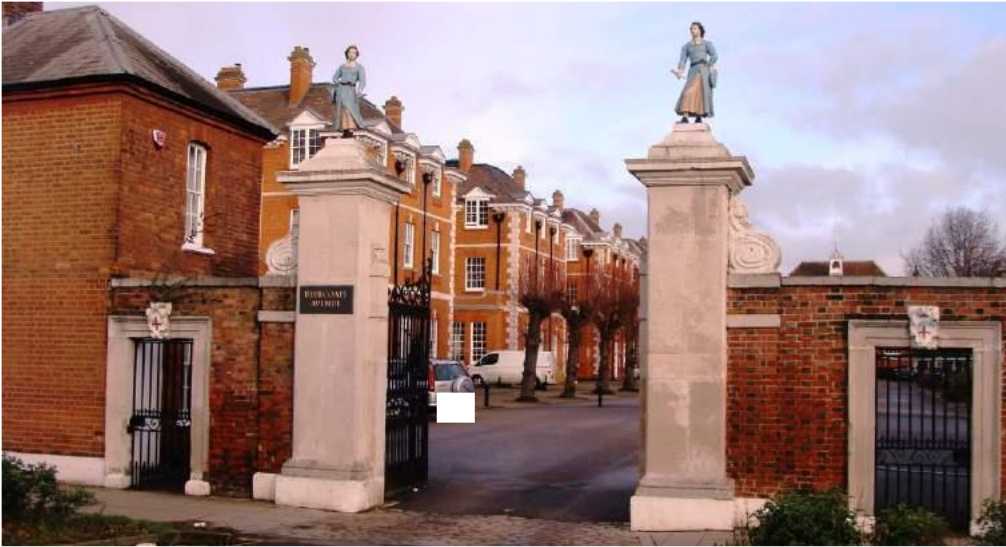
5. 24. Listed buildings including wall and gate piers to front of Bluecoats - Grade II. Gateway with piers, gates, footgates and attached walls, including continuation of wall eastwards along Fore Street frontage. Surmounted by a statue of a Bluecoat Boy in uniform fibre-glass replicas of the original cast-lead statues which were removed in 1986. The gateway is the axial entrance into the Christ's Hospital site, acquired in 1683. It is recorded that the statues were set up in 1689. The courtyard beyond was originally flanked by dormitory terraces at either side with the School Hall placed on the axial termination at the far end. The original dormitories were demolished circa 1900 and replaced by 8 dormitory houses in 1904-6.

Picture 265. A fine grouping of listed buildings, walls and other structures at Bluecoats.

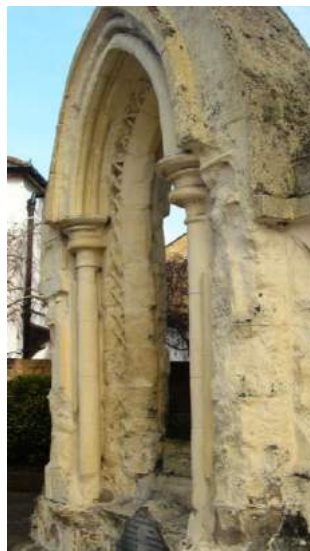
5. 25. Fragments of the church of St Mary the Less, Old Cross. Drinking fountain. 1890, reconstructed from fragments of the former Hertford Church of St Mary the Less which were found on the site during the construction of the Library in 1880. The church was built before 1210 and destroyed before 1552. The structure is clunch stone, consisting of a base, with a small pointed arch with crude roll mouldings above a drainage recess. A tablet set in the base of the lancet opening records the history of the structure which was erected by public subscription.

Picture 276. Fragments of St Mary the Less discovered and subsequently erected in 1890.

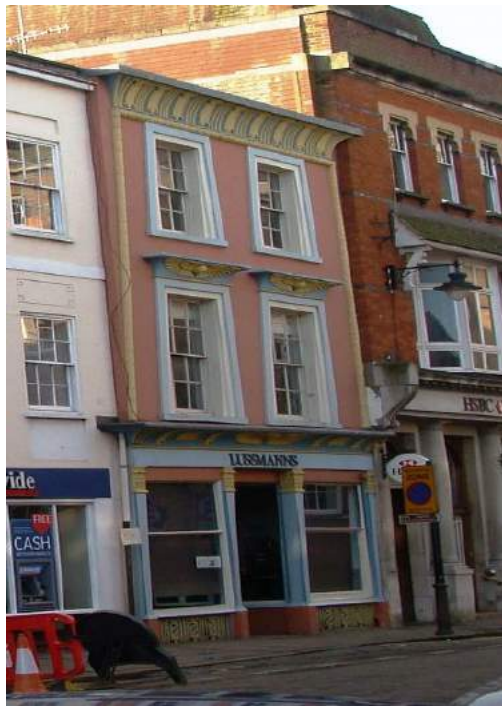
5.26. No. 42 Fore Street - Grade II*. Circa 1825, with late 19th/20th century alterations. Stuccoed front, yellow-grey stock brick rear, with plastered second floor. 3 storeys late Georgian urban facade overlaid with modelled stucco decorative motifs, with a ground floor timber shop front of the same style. Tapered roll mouldings outline a full-height pylon across the elevation, with a bold cavetto cornice enriched with modelled scarabs. First and second floors have recessed 12-pane sash windows. Ground floor has original Egyptian style shop front, substantially unaltered save for the late 19th century substitution of large plate-glass sashes for the original small-paned display windows. The Egyptian Revival became fashionable at the time of the Egyptian campaigns in the Napoleonic Wars. The opening of William Bullock's Egyptian Hall in Piccadilly in 1812 sparked a series of Egyptian style buildings. Most of the urban buildings in the Egyptian style built over the next two decades, including this Hertford building, can be traced to The Egyptian Hall. A polychromatic colour scheme was installed during the 1980s following the example of The Egyptian House in Penzance (circa 1835).

Picture 287. No. 42 Fore Street, a building in the Egyptian Revival style fashionable at the time of the Egyptian campaigns in the Napoleonic Wars.

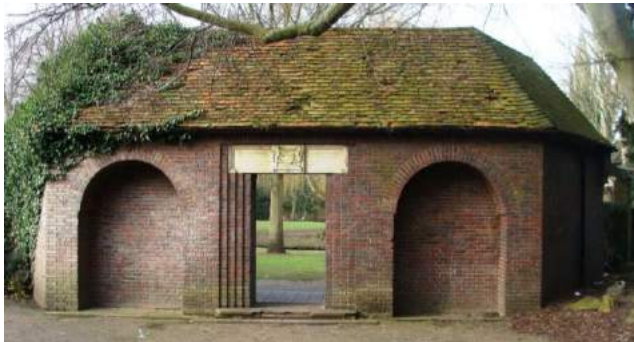
structure on which to grow. The building is in a deteriorating condition and is in need of renovation. It is understood there are conflicting views concerning its future, with some favouring its removal whilst others consider its repair to be most appropriate. Whichever of these views may prevail it is unacceptable that the building remains in its current dilapidated condition. It has a certain charm and historical association and a case exists for its retention.

Picture 298. The commemorative pavilion in the grounds of Hertford Castle. It is unacceptable the building remain in its current condition in the public realm. A decision is needed now.

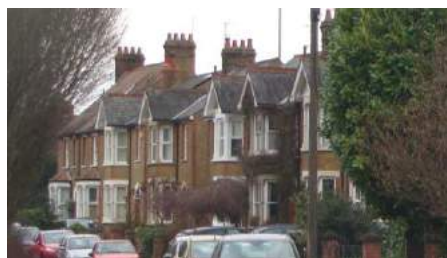
5.33. Nos. 52-90 Hertingfordbury Road. Date from the early 20th century. Various of red brick yellow brick construction, generally with bay windows to both floors, principally slate roofs (Nos. 88-90 bay windows to ground floor only and tiled roof). Elsewhere later replacement tiled roof. Good quality features include prominent chimneys with pots, decorative ridge tiles and finial detailing, decorative wooden detailing and recessed entrances. An Article 4 Direction to provide protection for selected features may be appropriate subject to further consideration and notification.

Picture 3029. Early 20th century houses on Hertingfordbury Road.

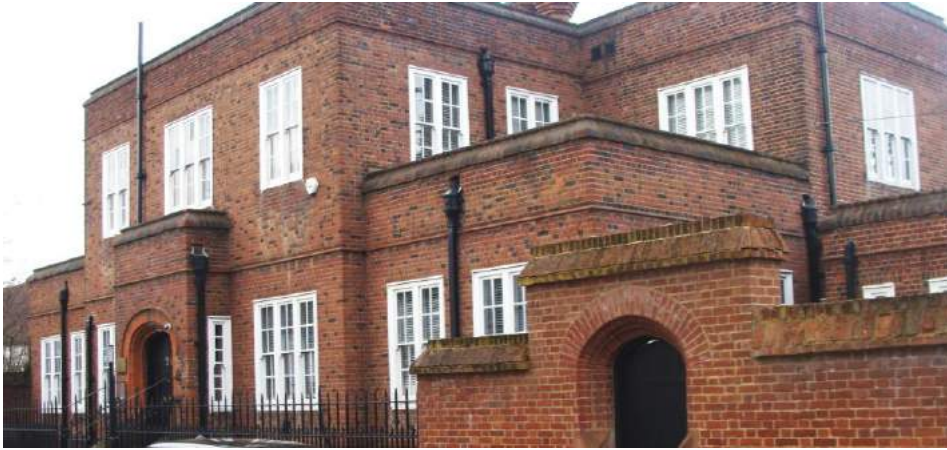
5.40. No. 28 Castle Street. Interesting building group dating from the early 20th century. Two storeys above ground level and basement. Of red brick construction with flat roof, rubbed brick detailing to central entrance. Some original rainwater goods with decorative hopper detailing. Good quality

railings on dwarf wall to front. Early vertical sliding sash windows. In commercial use; alterations administered by normal development control.

Picture 340. Interesting flat roof building of early 20th century date, unusual and most worthy of retention. Does any reader have more information concerning its original use? A public building?

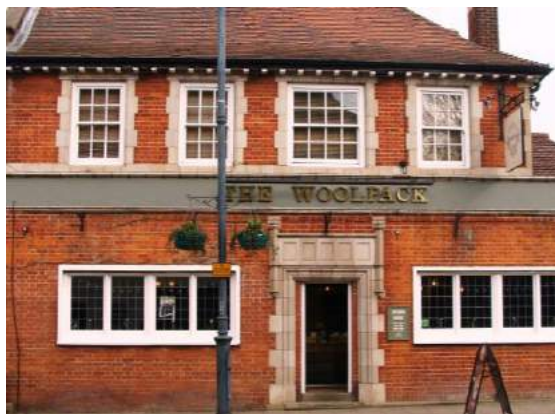
5.42. The Woolpack PH, Mill Bridge. Two storey red brick building with tiled roof and chimneys. Some good quality windows with stone surround detailing. Normal development control administers alterations.

Picture 321. The Woolpack PH nicely proportioned and detailed commercial building.

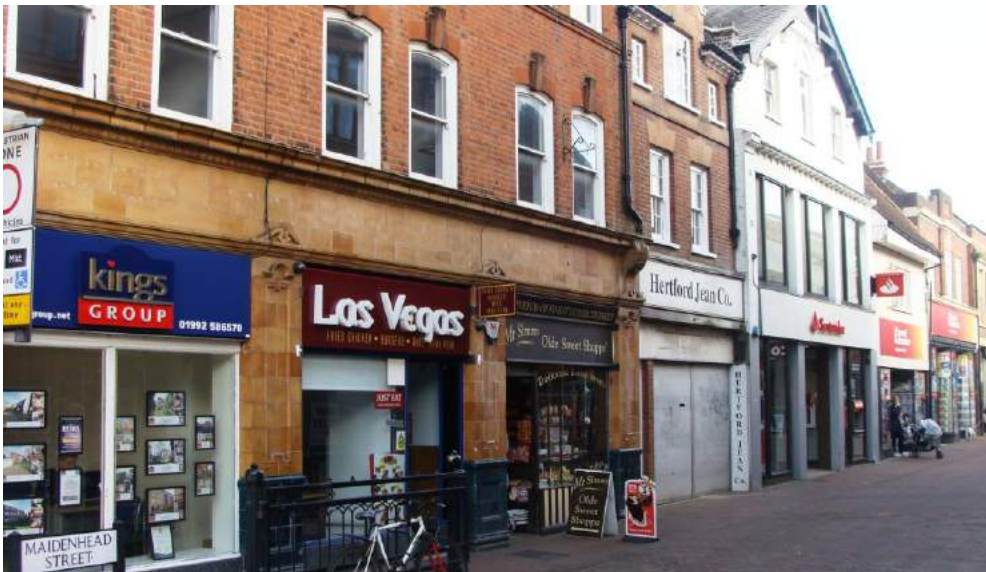
5.45. It is noted that several shops are currently unoccupied. The pedestrianised surface of Maidenhead Street is beginning to deteriorate in places and its colour and material used are unremarkable. The presence of several vacant shops and discordant signage, results in a street scene that is less than satisfactory. It is considered Maidenhead Street has the potential for significant improvement that may be of interest to the local traders and other interested organisations.

Picture 332. Maidenhead Street. This pedestrianised street in the centre of the town has the potential for improvement. Strident and discordant signage could be much improved when shops change occupation and new fascia advertisements are needed. Repaving as advocated by the Urban Design Strategy would be most beneficial.

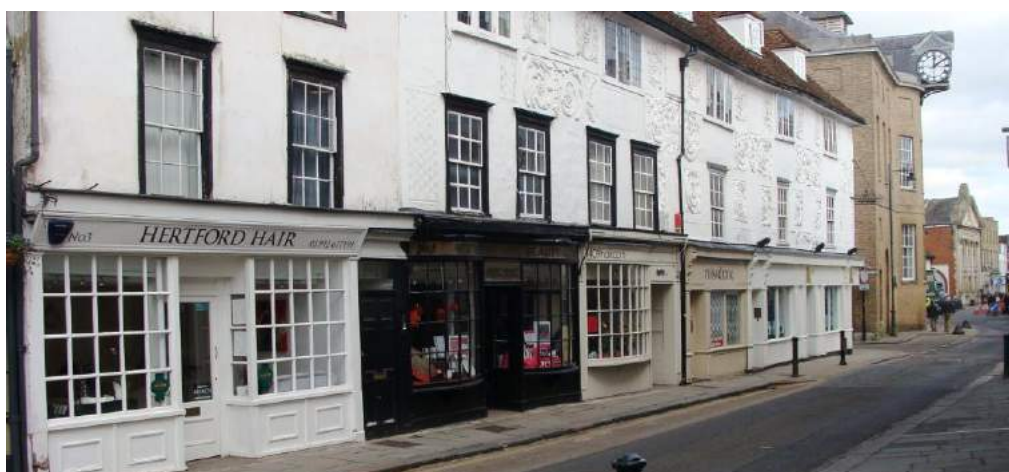
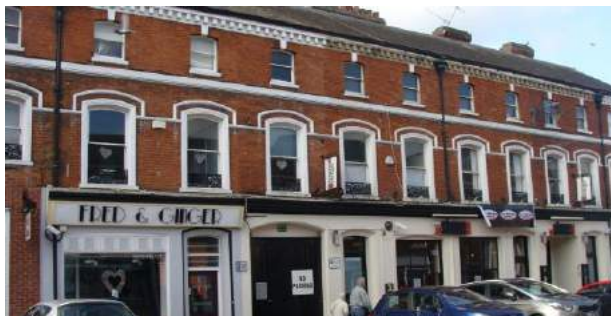
5.46. Elsewhere in the town centre there are other examples of poor sign and fascia design that detract. There are District Plan policies relating to shop fronts and advertisements. Whilst the views of the shopkeeper and the planner may

Picture 49. Attaining external professional advice to reduce the visual impact of Gascoyne Way car park is recommended.

Pictures 343-354. Compare the quality of fascia design in these two pictures.

5.47. Bull Plain. Prominent group of commercial properties, south west corner of Bull Plain. Late 19th/ early 20th century in appearance. Three storeys in

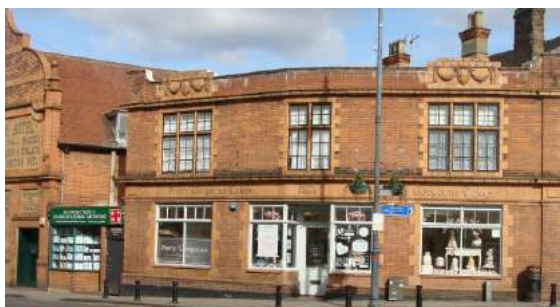
Picture 365. Prominent and largely unspoilt group of commercial properties Bull Plain.

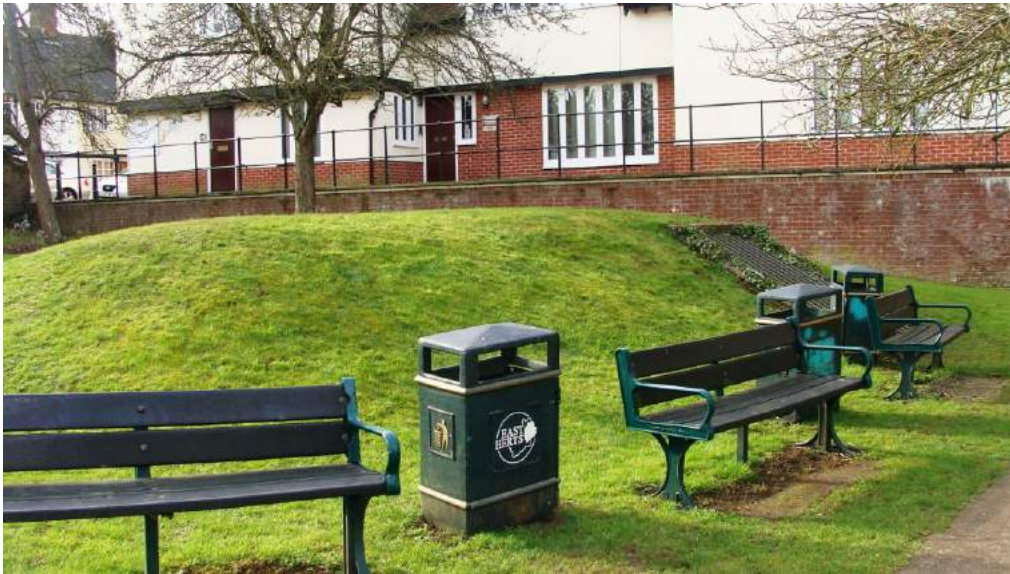
5.69. The Moat Garden. This small open space is located to the south of the main Castle garden area to which it provided access from Castle Street. The space essentially consists of four grass quadrants and a fine sensory garden against the Castle wall. There are other elements which are less satisfactory. These include a modern brick wall (graffiti prone) on the western boundary, a circular planted bed, large number of seats, six in total and four litter bins most of which are concentrated near to a late 18th century listed Ice House. Whilst the need for seating is appreciated the numbers are perhaps excessive. It is considered at minimal effort and expense simple rearrangements could achieve visual improvements. It is suggested landscape proposals be drawn up and implemented.

Picture 40. The Moat Garden, production of a simple landscape plan could secure real improvements to this small but important open space. The fieldworker has been advised this seating arrangement was part of an effort to restrict skateboarding on the mound but is there not a visually more satisfactory solution?

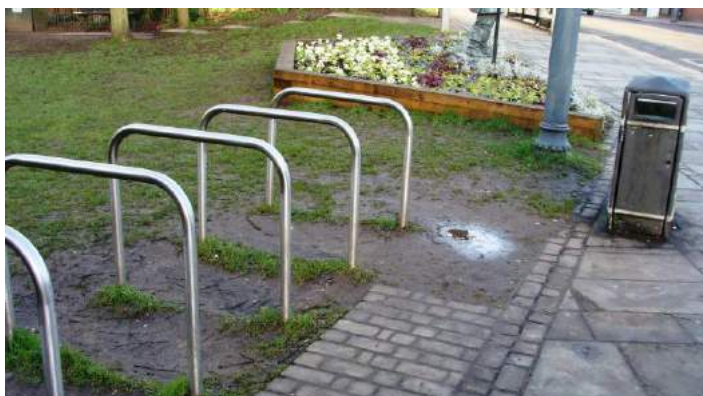
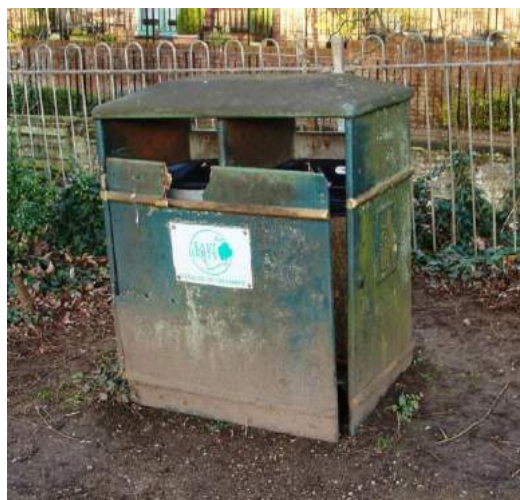
5.70. Small but important area of open space adjacent to theatre, Mill Bridge. The focal point is a good quality sculpture of Samuel Stone (17th century Puritan minister born in the town and associated with establishing Hartford Connecticut USA) fronting a grassed area with seats, litter box and various planted areas, including high maintenance planting around statue. The grass surface is rather worn. One double litter bin broken. The area adjoins the river and visible to pedestrians viewing the adjacent water features and accessing nearby car park. It is suggested detailed landscaping proposals be prepared to enhance this important and centrally located urban space. Its current condition is a poor advertisement for visitors to the town.

Pictures 41-42. Various detracting aspects of Millennium Sculpture area. Badly worn surfaces and shattered litter bin. This area is in real need of improvement, a view independently shared with the Hertford Urban Design Strategy.

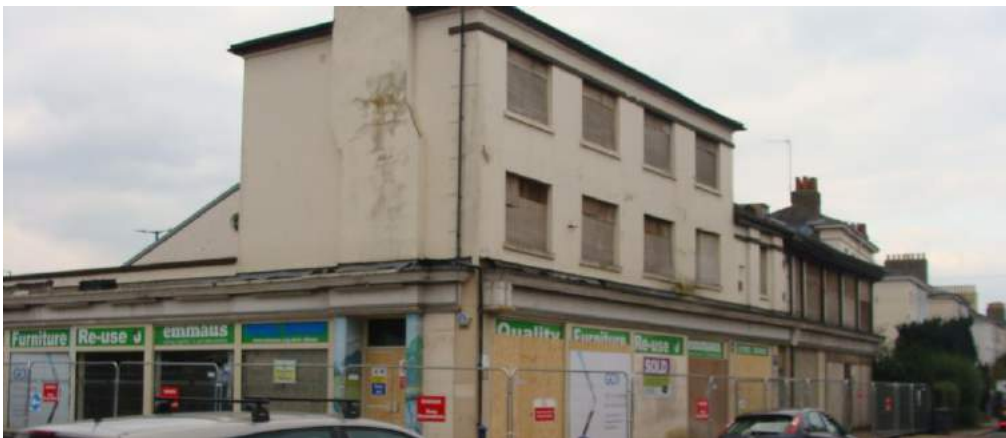
5.77. Important views. A selection as shown on accompanying plans.

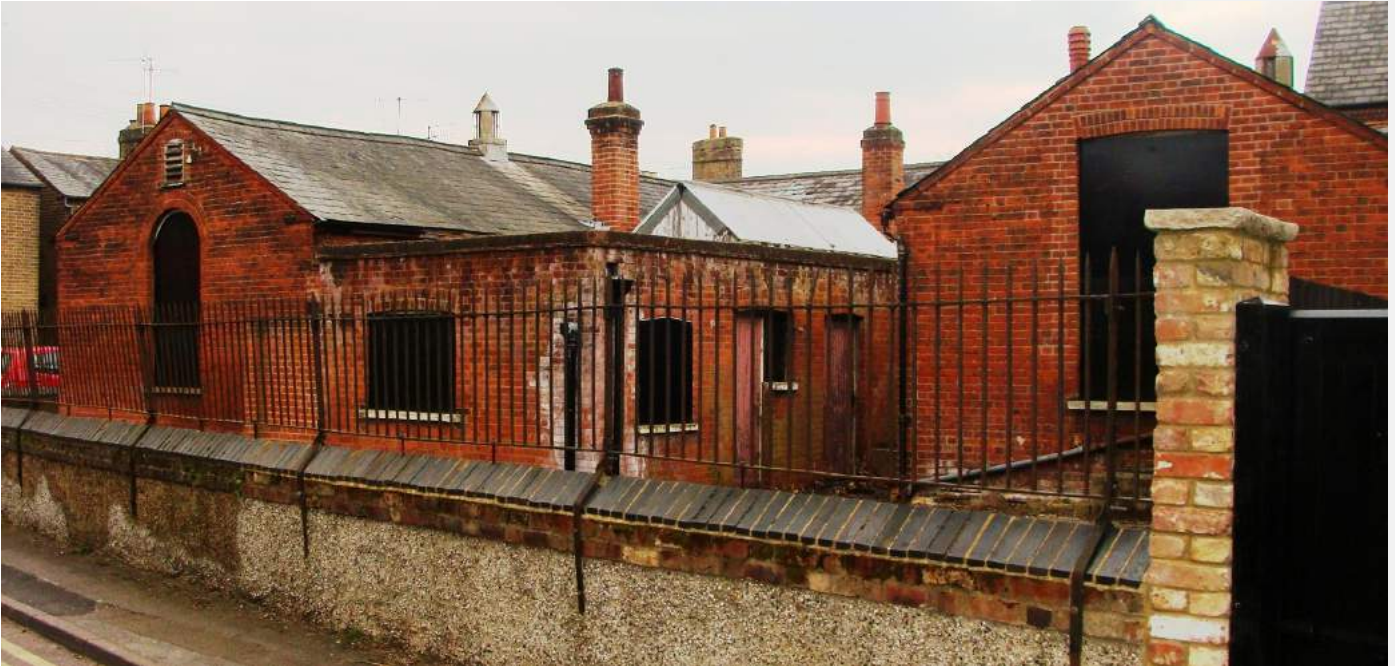
5.80. Untidy area of car parking and unused buildings, Dimsdale Street. The notice to the parking area advises this is HCC land. The car parking area is uneven with dilapidated metal fence and tree stumps and detracts. The unused buildings appear on late 19th century mapping as having once been a British School for Boys and Girls. The building group is identified as being at Risk on the Council's Heritage at Risk Register. The fieldworker was advised by a local resident that the buildings had been unoccupied for a number of years and that the buildings were insecure and 'supported by props' internally. The same resident also advised ownership of the site might be complex. Dimsdale Street itself is narrow and one way. On the one hand the former school buildings and surrounding metal fence on dwarf wall have architectural and historic interest that warrant retention but on the other hand appropriate partial redevelopment of the area that also provided benefits (traffic circulation and resident parking) would be beneficial. Further investigation particularly in respect of the condition of the buildings is needed before any conclusion can be reached.

Picture 44. Part of a larger site at Dimsdale Street that is cause of concern and in need of further investigation before concluding its future.

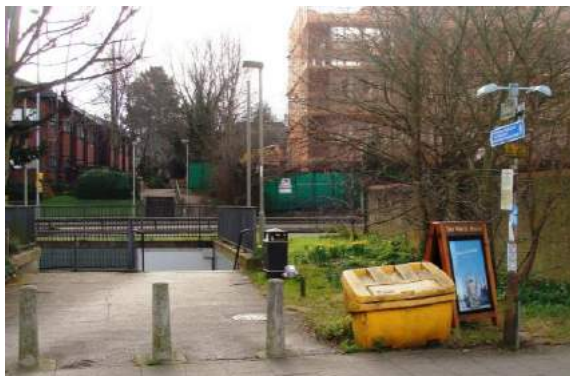
5.81. Small untidy area to south side of Castle Street (opposite the Moat Garden, providing subway access). A small untidy area with signage advertisement signs and salt bin. Looks unattractive and uncared for. Proposals for its improvement are needed.

Picture 45. Small untidy area to south of Castle Street that would benefit from improvements.

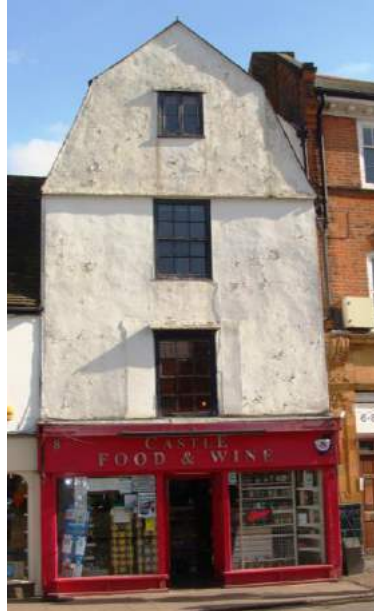
5.83. No. 8 The Wash a listed building in need of renovation/redecoration. The upper floors detract from this part of the conservation area.

Picture 46. Upper floors to No. 8 The Wash in need of refurbishment.

5.87. Opportunities to secure improvements. Improvements to various shop front facias in the main central commercial areas. Consider implementing minor repair works to frontage wall of random brick and clinker construction to front of hospital site. Significant improvements will materialise through the planning process for the former Emmaus superstore site and the Noble car parking site. Prepare landscape enhancement plan to improve the Moat Garden on Castle Street. Secure improvements to subway access approach south side of Castle Street. Improve environmental quality of area adjacent to William H Brown building. Improve open space adjacent to theatre containing the Hertford Millennium sculpture. Refurbishment of No. 8 The Wash, a listed

building in need of refurbishment. Seek to replace/ landscape poor quality fencing to Bluecoats complex Mill Road. Seek repairs to listed wrought iron gates end of Church Street. Obtain high quality advice in respect of reducing the visual impact of Gascoyne Way car park.

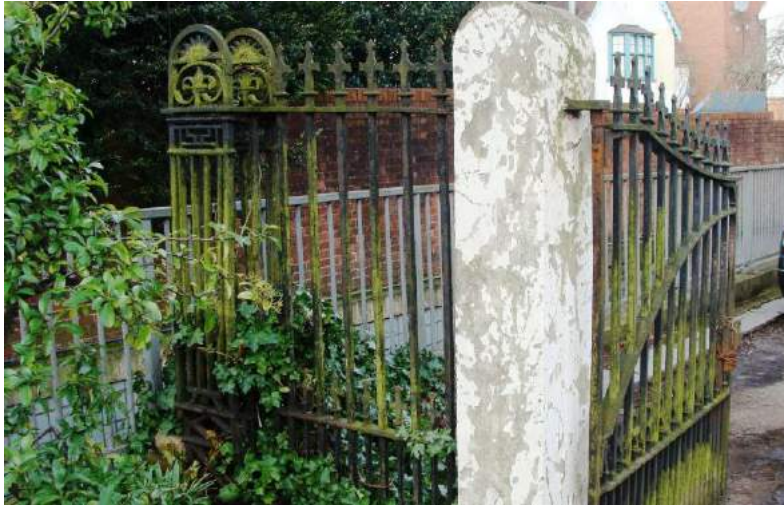
Picture 48. Listed gates etc end of Church Street in need of refurbishment.

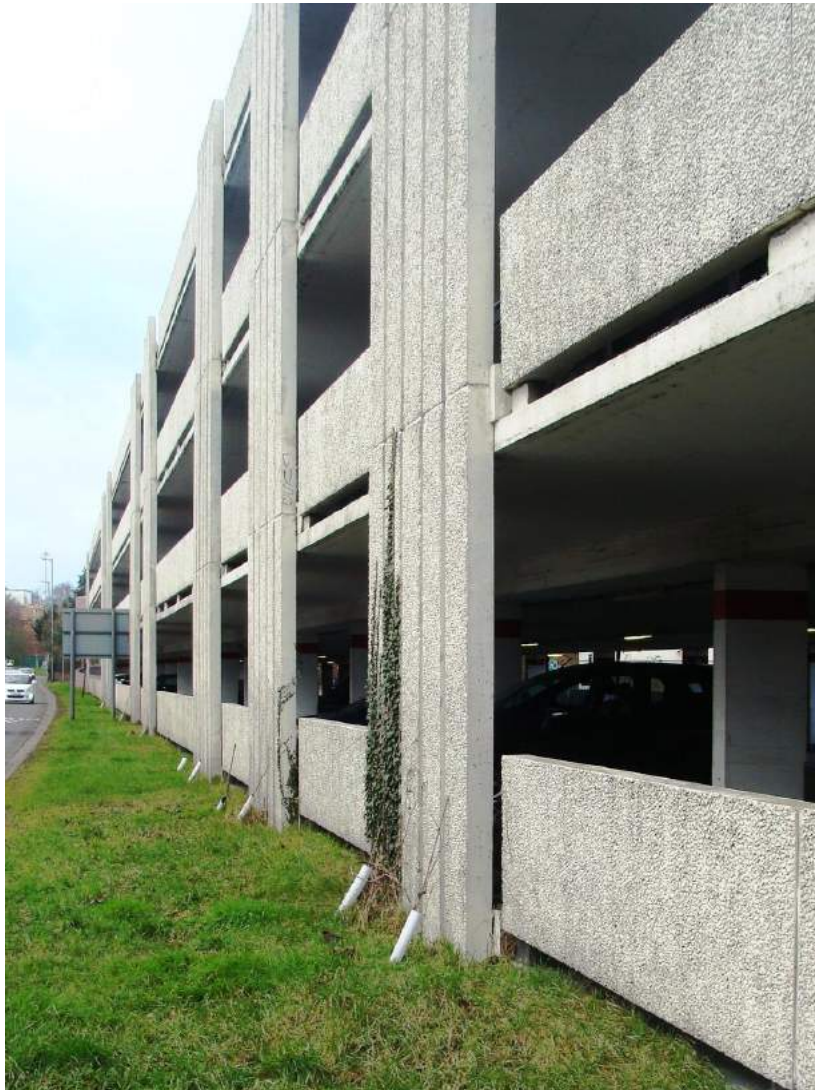
5.86. Gascoyne Way car park. This long linear car park is extremely striking in the street scene whose unattractive visual prominence will be noticed by residents and visitors to the town alike. However it is well used and provides an essential parking provision, with a life expectancy of at least 20 years, following an expensive refurbishment in 2010/2011. In the short to medium term, it is here to stay. Can its rather unattractive appearance be reduced? In this respect a key unattractive feature is its linear nature which if broken up might result in improvements. One solution might be planting 'green walls' on selected vertical elements of the structure; another might be repainting using different colours to provide some vertical emphasis. Substantial tracery tree planting in the narrow strip between the car park and carriageway is worthy of exploration but might well be impractical because of the existence of essential services. Resolving the problem will not be easy and it is considered high quality urban design advice will be necessary. Attaining the latter is proposed.

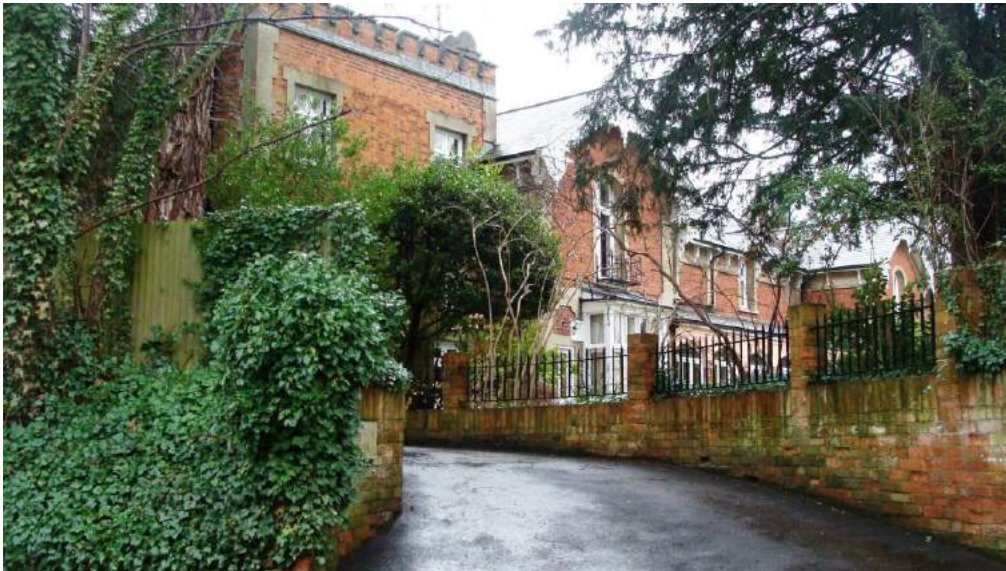
5.92. Individually Listed Buildings. A selection of Listed Buildings with abbreviated descriptions based on the National list is provided below.

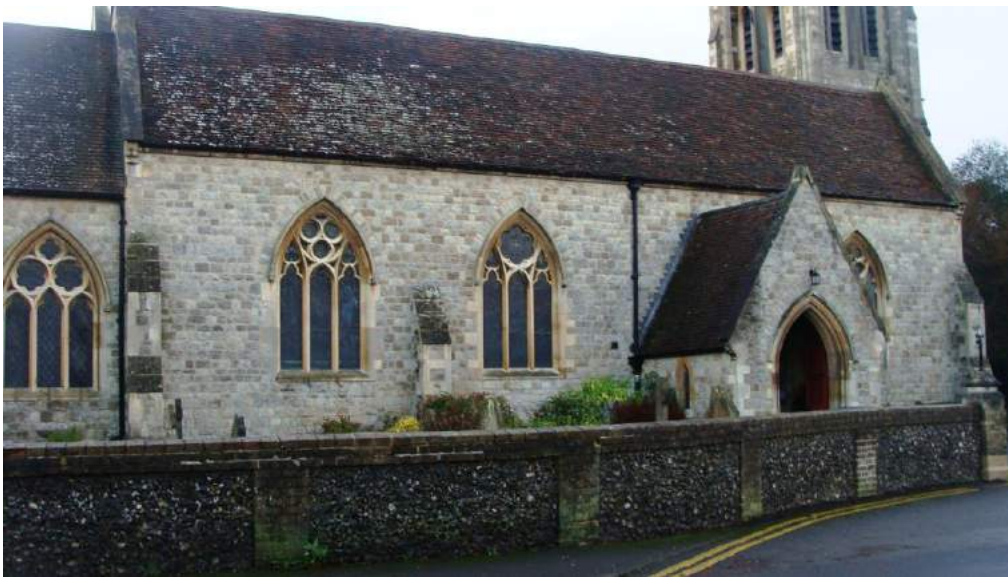
Picture 50. The important grade II* Listed Building, Warren Park.

5.94. Church of Holy Trinity, New Road, Bengeo, also Lych Gate separately listed - both Grade II. 1855, architect Benjamin Ferrey, chancel refurbished 1884, architect EB Ferrey. Kentish Ragstone, coursed squared rubble, with ashlar dressings, yellow sandstone windows, buttresses with flint panels, old tile roofs. In style of Early English Gothic Revival. In plan form: west tower, spire, nave, aisles and chancel. *Early pews*. Holy Trinity Church was built when Bengeo developed as a residential suburb of Hertford, and superseded St Leonard's as the Parish Church. The Architect Benjamin Ferrey (1810-80) was a pupil of Augustus Charles Pugin father of Augustus Welby Northmore Pugin) and designed a number of Gothic Revival churches.

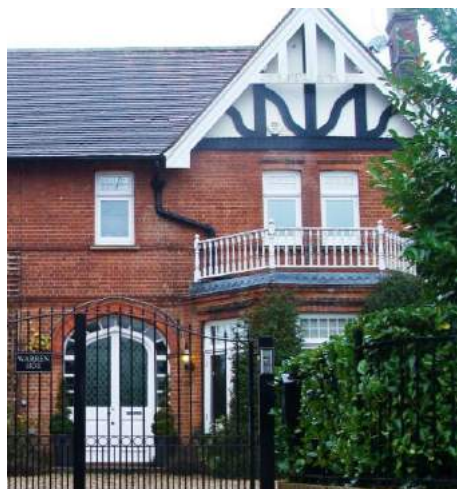
5.101. Garden House, Warren Park Road. Large detached residence dating from the early 20th century principally of brick construction with tiled roof. Good quality chimney stacks and decorative woodwork detailing. A fine property set in treed garden. An Article 4 Direction to provide protection for selected features may be appropriate subject to further consideration and notification.

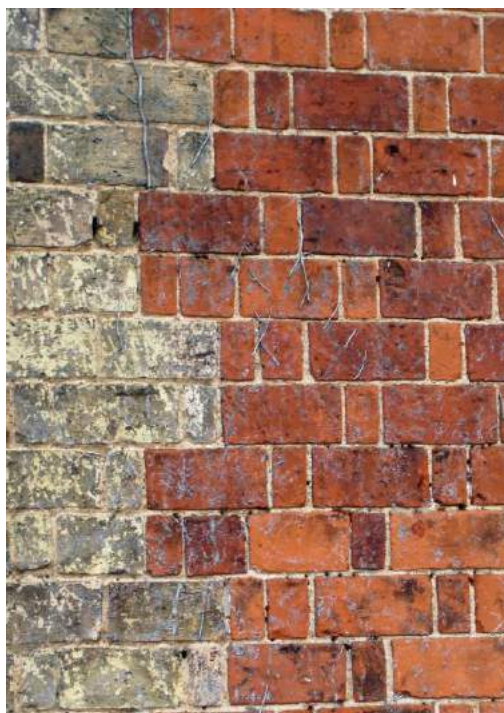
Picture 55. Rat trap brick bonding to Nos. 22-40 Bengo Street that is most unusual and which should not be rendered or painted over. This bonding of bricks laid on edge provided a stable and cheaper form of construction sometimes used in the 19th century.
