HERTFORD CONSERVATION AREA APPRAISAL AND MANAGEMENT PLAN

DRAFT FOR CONSULTATION 2016

East Herts. District Council

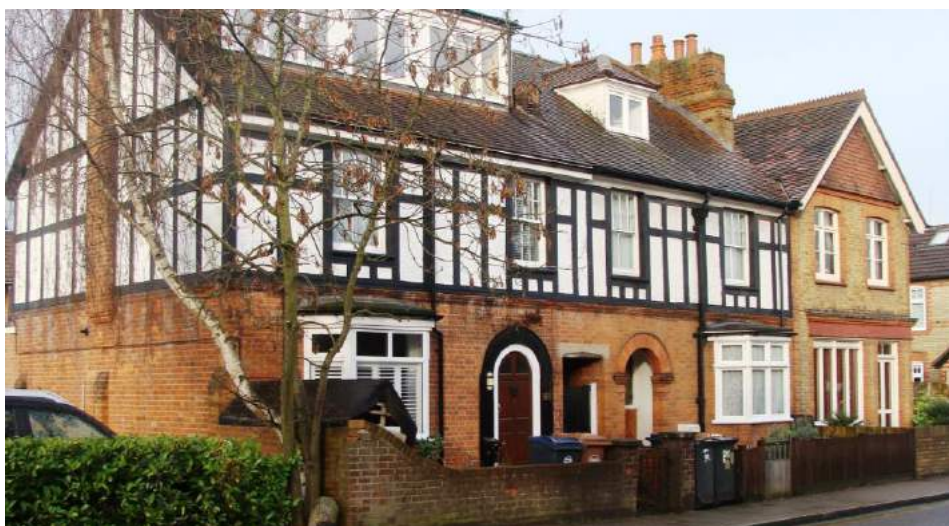
and window detailing which detract. On balance the contribution the mass of the block makes to the conservation area is considered to outweigh the impact of the later and less satisfactory alterations. An Article 4 Direction to provide protection for selected features may be appropriate subject to further consideration and notification.

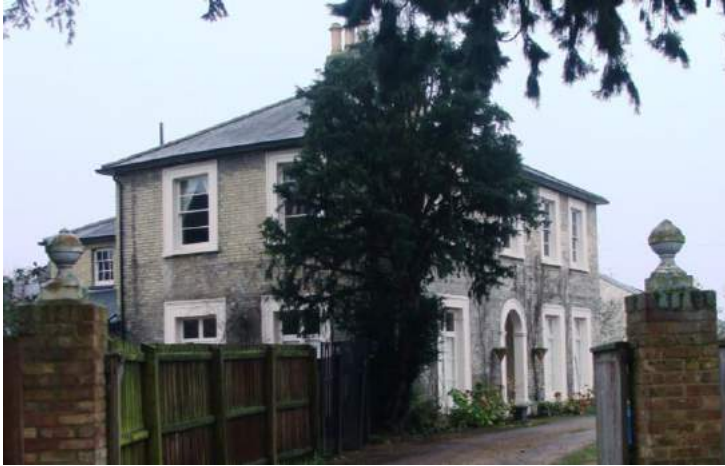
5.121. No. 121, The Yews, Bengo Street. Tall prominent detached yellow brick house probably of 19th century date, pyramidal slate roof with chimneys. Fine window detailing with central recessed entrance. An Article 4 Direction to

Picture 62. The Yews - a tall prominent property on Bengo Street.

provide protection for selected features may be appropriate subject to further consideration and notification. Fine tree of Wellingtonia species to front.

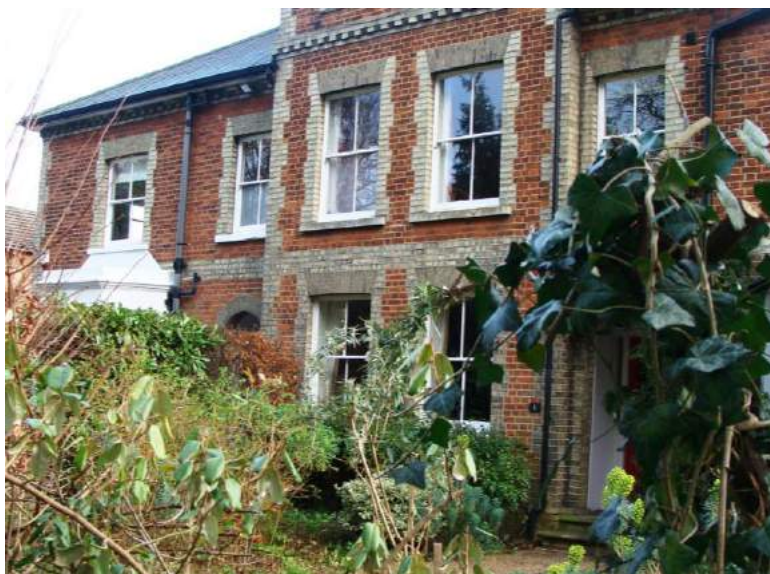
5.124. Nos. 1-3 Duncombe Road. Tall distinctive late 19th century pair of red brick with yellow brick detailing, and slate roof and tall chimney stacks. Rubbed brick lintels, recessed entrances, 2 No. bay windows to ground floor and early/original windows. An Article 4 Direction to provide protection for selected features may be appropriate subject to further consideration and notification.

Picture 63. Nos. 1-3 Duncombe Road an important and prominent 19th century building that retains many of its original features most worthy of retention and protection.

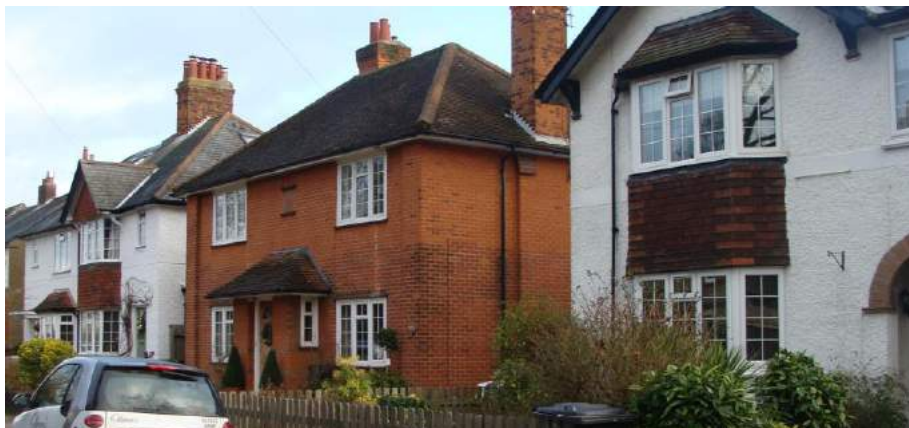
5.125. Nos. 5-11 Duncombe Road. Group of early 20th century dwellings; slate/tiled roofs with prominent chimneys with pots. Some brick some render. Generally modern window replacements. Some vertical tile detailing. One plaque inscribed with date 1927 noted. An Article 4 Direction to provide protection for selected features may be appropriate subject to further consideration and notification.

Picture 64. Despite modern window replacements these earlier 20th century properties make a positive contribution to the street scene.

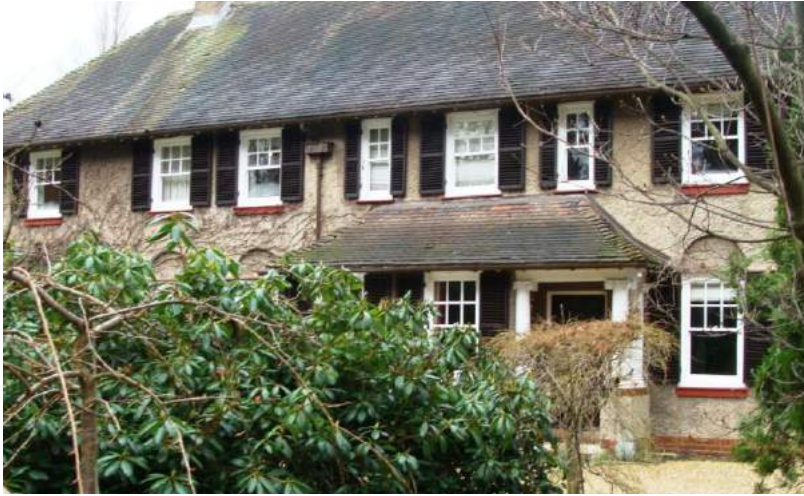
5.132. Wisteria Place, corner Duncombe Road Church Road. Large early 20th century detached pebble dashed residence with steeply sloping tiled roof and tall chimney stacks. Original/early/sympathetic windows. Distinctive and unusual. An Article 4 Direction to provide protection for selected features may be appropriate subject to further consideration and notification.

Picture 65. Wisteria Place, a large 20th century detached residence of quality and distinctive unusual design.

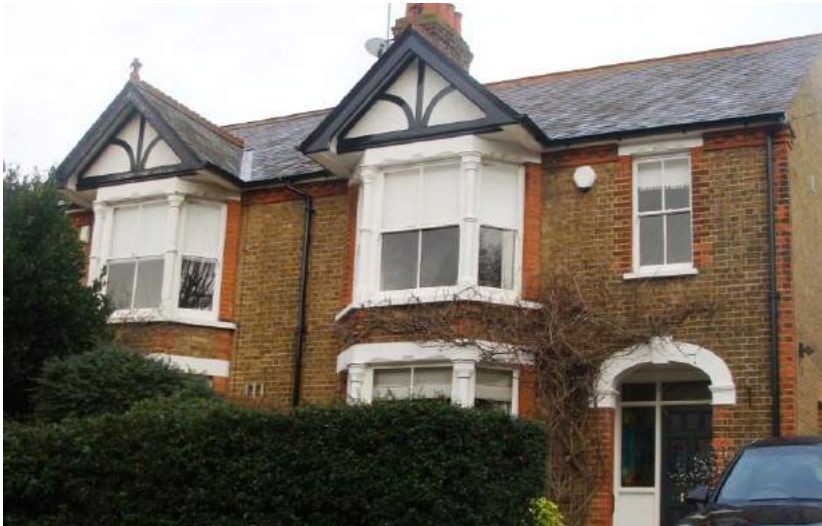
5.133. Nos. 6-32 Church Road. A variety of early/mid 20th century detached and semi detached dwellings. A combination of slate and tiled roofs with prominent chimneys and pots. Brick render and pebbledash. A considerable number of high quality original/early features including window detailing, vertically hung tiles, decorative wooden detailing, finials and recessed entrances. A high quality environment which is largely unspoilt. An Article 4 Direction to provide protection for selected features may be appropriate subject to further consideration and notification.

Picture 66. Good quality early/mid 20th century detailing to typical semi detached property on Church Road.

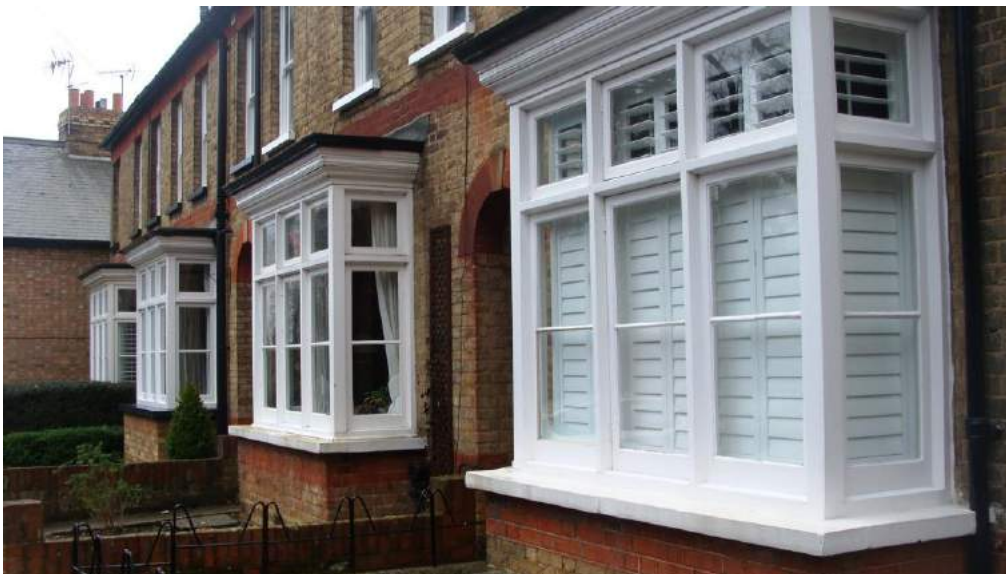
5.136. Nos. 1-25 Elton Road. Of late 19th and early 20th century date. Two storey terraces semi detached and detached dwellings with slate roofs and prominent chimneys with pots. Many good architectural features including decorative ridge detailing, recessed entrances, bay windows with scalloped slate detailing over. Fine box shaped bay windows and many early/original windows of traditional design. An Article 4 Direction to provide protection for selected features may be appropriate subject to further consideration and notification.

Picture 67. Nos. 15-21 Elton Road, part of a street that has retained many early features of quality.

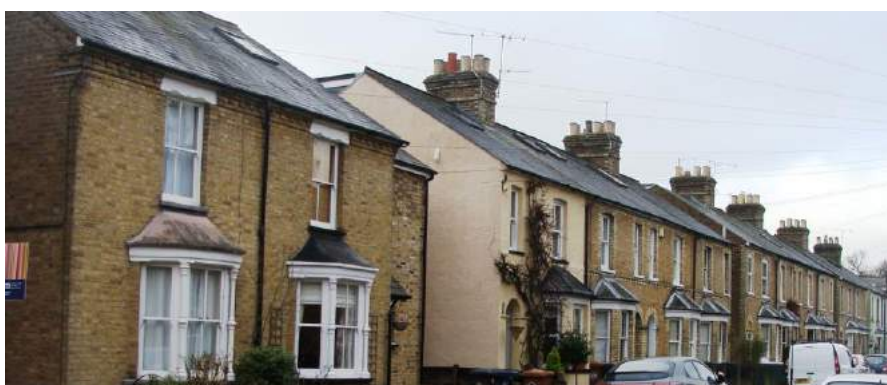
5.138. Yew Villa and Nos.4-36 and 1-37 Parkhurst Road. A late 19th/early 20th century street characterised principally by long terraces of two storey yellow brick cottages with slate roofs and prominent chimneys with pots. A number of bay windows provide strong features in some locations. Some inappropriate detailing but much of street remains intact. Early street sign attached to No.36. An Article 4 Direction to provide protection for selected features may be appropriate subject to further consideration and notification.

Picture 68. View along Parkhurst Road, a pleasant historic street with strong architectural rhythm provided by roofscape and repetitive bay windows.

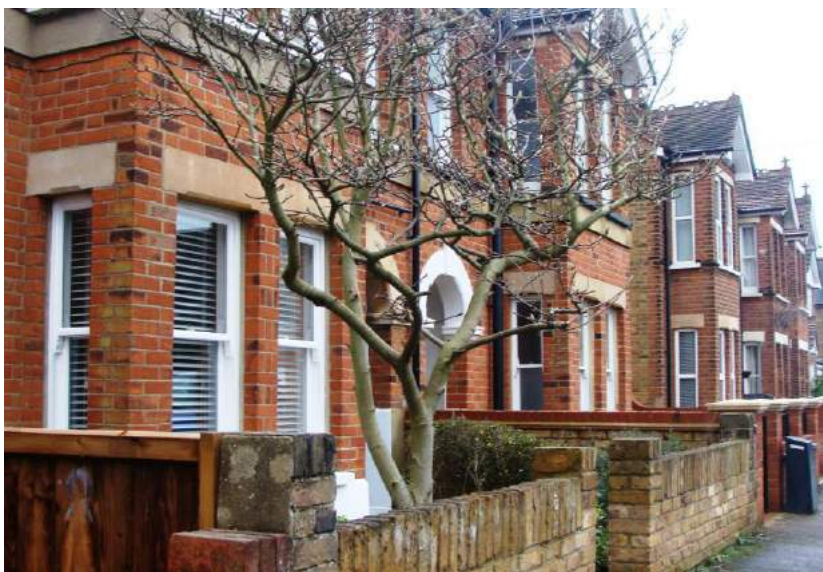
5.140. Nos. 10-26 and 30-46 Fanshawe Street, north side. A variety of housing types from the late 19th/early 20th century. Some slate roofs; others tiled. Good quality detailing includes prominent chimneys, recessed entrances with house names inscribed in stone arches above; bay windows to both floors with barge board and finial detailing. Some replacement windows. An Article 4 Direction to provide protection for selected features may be appropriate subject to further consideration and notification.

Picture 69. Good quality bay window detailing and recessed entrances, Fanshawe Street.

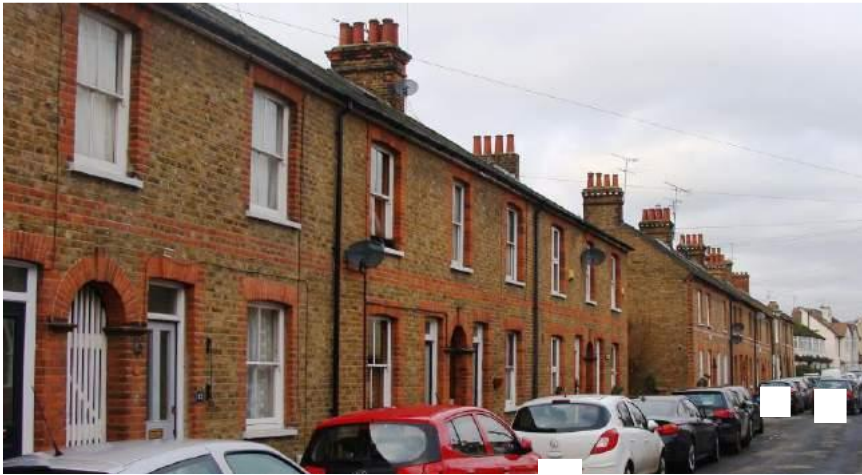
5.150. Nos. 7-31 and 23-39 (excluding Nos.21A-21B) Molewood Road. Early 20th century high quality long two storey terraces with slate roofs and prominent chimneys. Of yellow brick construction with strong horizontal

banding; rubbed lintels; regrettably some modern inappropriate replacements but many early/sympathetic remain. Arched entrance points to rear. A strong and attractive streetscape. An Article 4 Direction to provide protection for selected features may be appropriate subject to further consideration and notification.

Picture 71. Molewood Road most attractive terraces of early 20th century date to the south side.

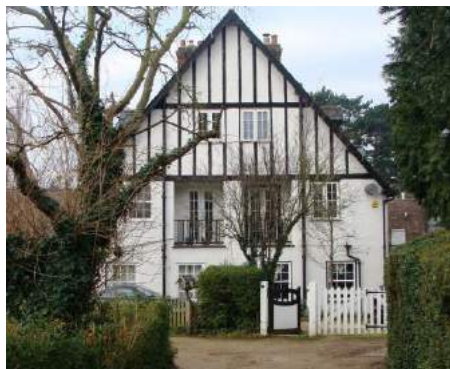
5.155. Nos.10-12 off ~~Farquar~~-~~Farquhar~~ Street. A tall 20th century building that appears in this location on the 1920-24 mapping. Very tall building of render with areas of decorative wooden detailing. Steeply sloping roof with chimneys. A visually interesting building.

Picture 72. Nos.10-12 off ~~Farquar~~-~~Farquhar~~ Street an interesting building probably dating from the 1920's.

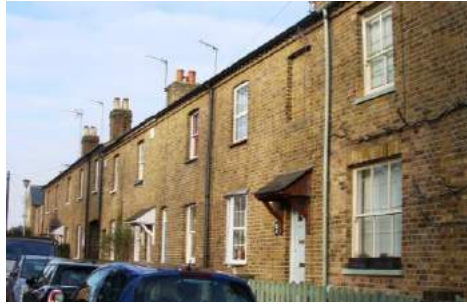
5.160. Nos. 6-34 Balfour Street. Continuous two storey yellow brick 19th century terrace with slate roofs, prominent chimneys with pots. Some early porch detailing. Some early/sympathetic windows, other altered. Despite this the overall mass of the group outweighs individual unsympathetic alterations. An Article 4 Direction to provide protection for selected features may be appropriate subject to further consideration and notification.

Picture 73. Balfour Street a typical 19th century street with some early porch detailing still remaining. Wouldn't it be nice to carefully replicate this detail above other entrances?

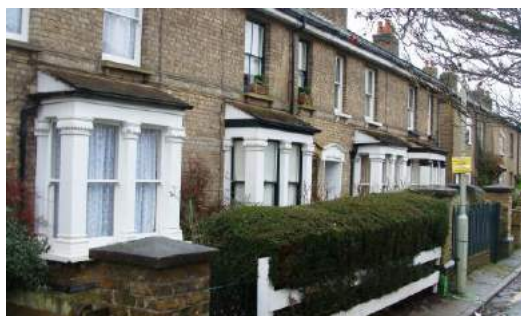
5.163. Nos. 37-43 and 45-57 Port Vale. Two terraces of late 19th century two storeys in height with slate roofs and prominent chimneys with pots. Nos. 37-43 have decorative bay window and some recessed entrance detail and sympathetic/ early windows. An Article 4 Direction to provide protection for selected features may be appropriate subject to further consideration and notification.

Picture 74. Distinctive window detailing to Nos. 37-43 Port Vale most worthy of retention.

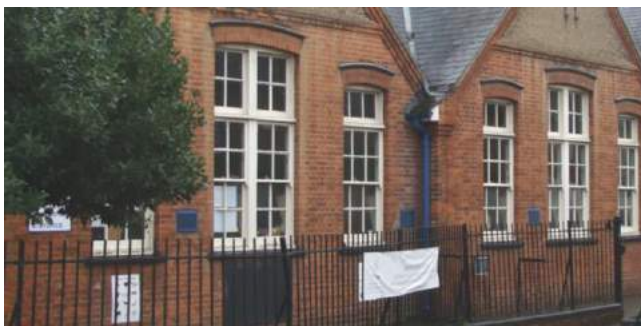
5.165. Mill Mead School (early element at eastern end of site). Dating from the early 20th century constructed of red brick with slate roof and prominent chimneys. Tall original windows worthy of retention in original form and possibly subject to an Article 4 Direction subject to notification and further consideration. The remainder of the school site is not visually pleasing (see below).

Picture 75. Early 20th century historic element of Mill Mead School.

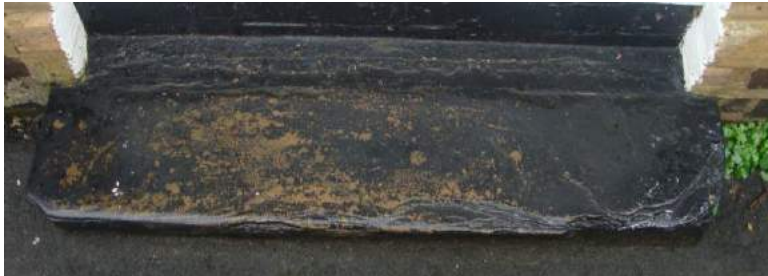
5.167. Nos. 6-28 Port Vale and Russell Court Mews. 19th century terraces of yellow brick construction and principally slate roofs (some tile replacement). Prominent chimneys; one prominent shop window; a number of original steps.

Picture 76. A well worn slate step to Port Vale terraced house.

An Article 4 Direction to provide protection for selected features may be appropriate subject to further consideration and notification.

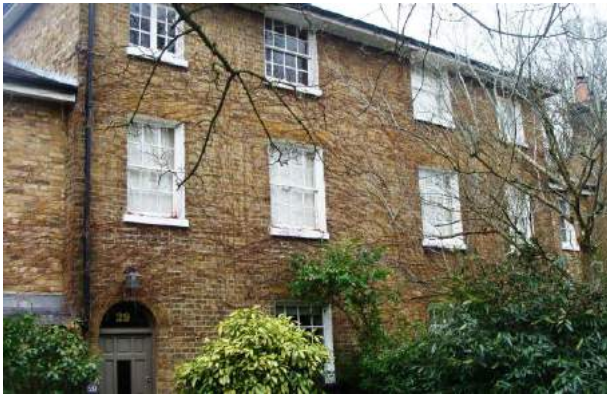
5.173. Nos. 29-31 Port Hill. Imposing three storey pair probably dating from late 19th/early20th century with later sympathetic extensions. Prominent building in the local street scene of yellow brick construction with slate roof and large central chimney. Early/ sympathetic windows. An Article 4 Direction to provide protection for selected features may be appropriate subject to further consideration and notification.

Picture 77. Nos. 29-31 Port Hill a prominent pair with sympathetic window detailing.

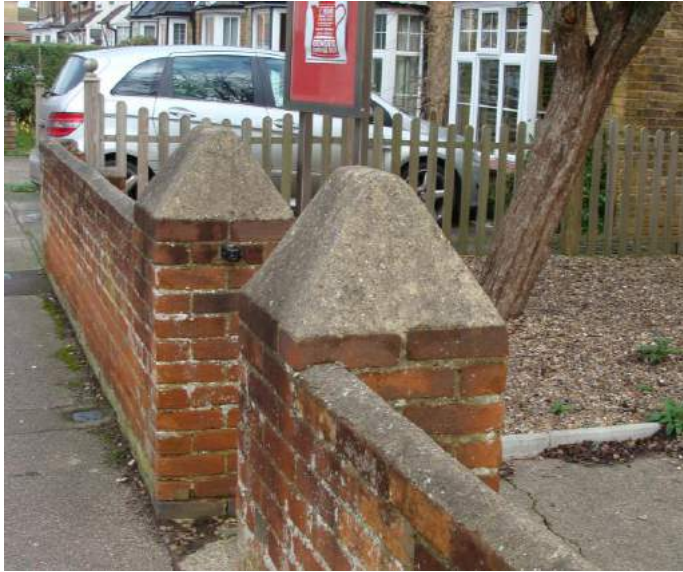
5.183. Wall to front of Bengoe Parish Church Hall, Duncombe Road. Of single skin construction with buttresses to rear. 2 No. substantial entrance piers. Less than 1m in height and thus unprotected from demolition. Adds to character and variety of street scene. An Article 4 Direction to provide protection may be appropriate subject to further consideration and notification.

Picture 79. Brick wall to front of Bengoe Parish Hall which on balance is considered worthy of retention and additional protection subject to further consideration and notification.

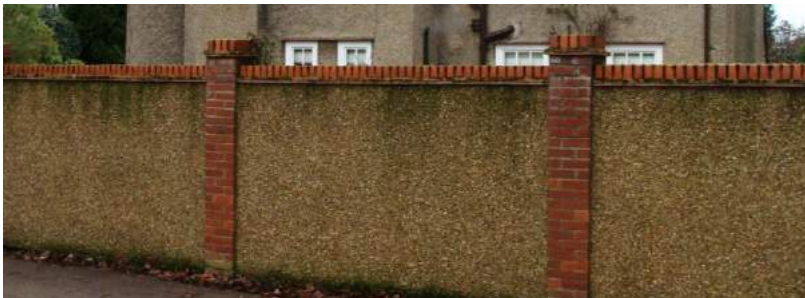
5.186. Brick wall to Duncombe Road frontage and return to No. 2 Church Road (Wisteria Place). Brick piers, pebble dash panels, unusual.

Picture 80. Unusual 20th century wall detailing to Wisteria Place.

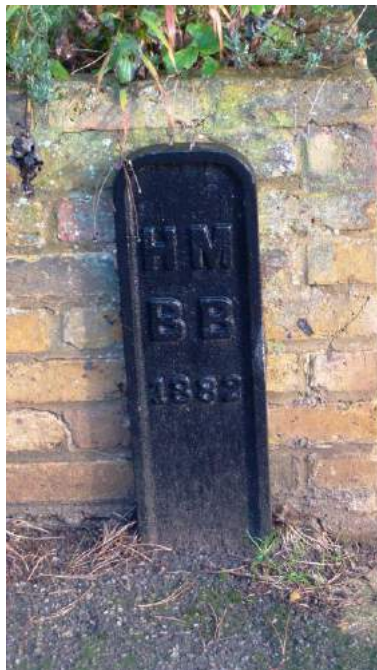
5.188. Metal plaque near No. 4 Fanshawe Street whose lettering is interpreted as reading Hertford Municipal Borough Boundary the alignment of which appears in this location on the 1874-1894 mapping.

Picture 82. Interpreted as being a 19th century boundary marker for Hertford Municipal Borough.

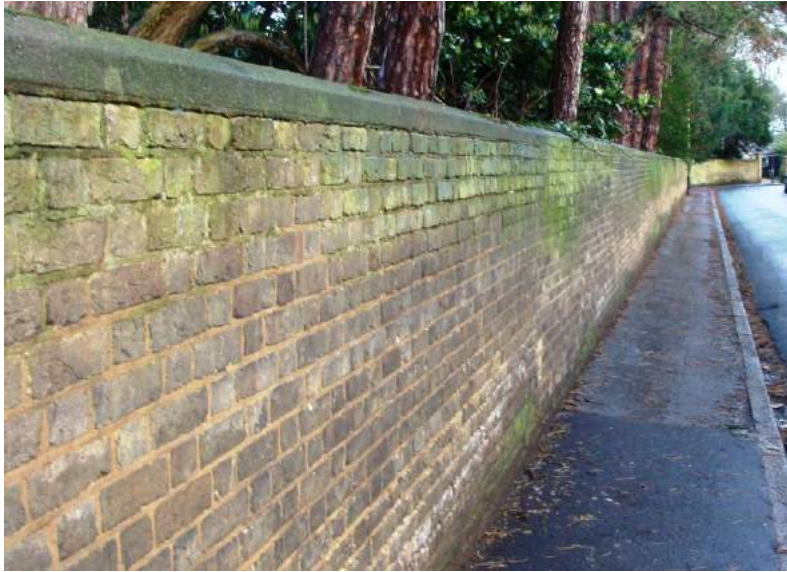
5.189. Long uninterrupted run of yellow brick wall west side of Byde Street. About 2m in height and a highly important visual feature in the street scene.

Picture 83. Long uninterrupted run of 19th century brick wall which makes a significant visual contribution to the quality of Byde Street.

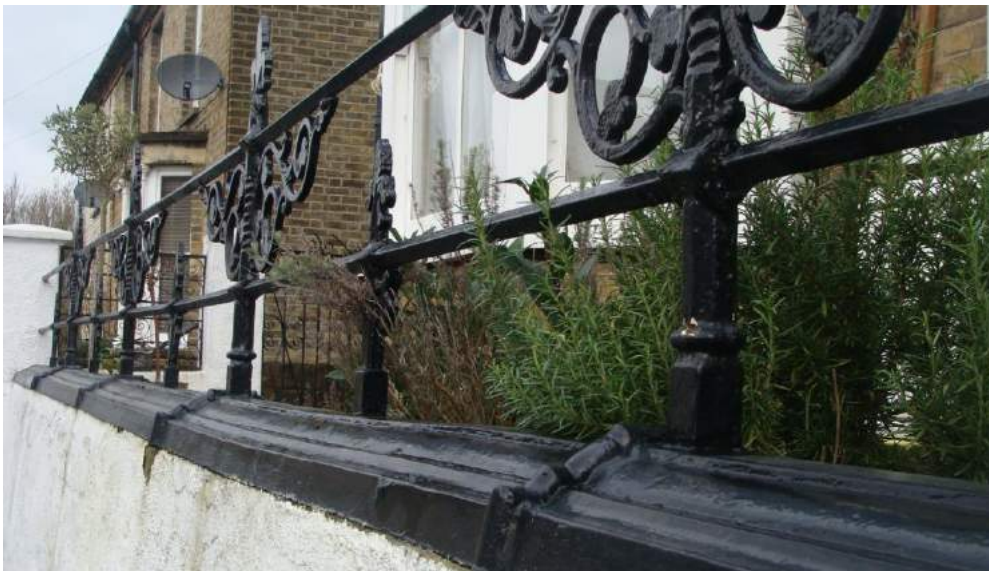
5.191. Traditional railings on wall dating from early 20th century to front of Nos. 45-51 Wellington Street.

Picture 84. Very good quality early 20th century railings that are protected and which should be retained.

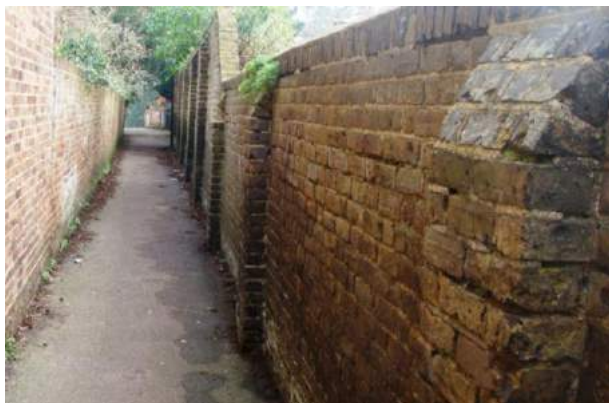
5.192. Brick walls various locations opposite Byde Street (including public footpath 85 to Bengoe Street). Various heights. Add interest particularly to footpath access.

Picture 85. Walls enclosing public footpath 85.

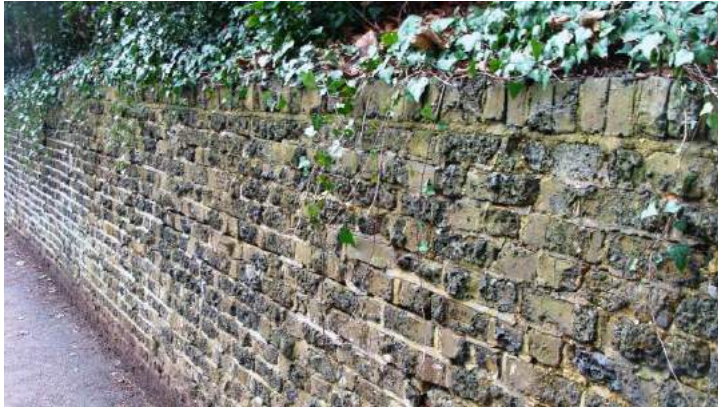
5.199. Two long lengths of brick walls of varying height about 1.5m. -In part capped with clinker/industrial waste. Many bricks seem to have industrial residue attached and may be 'seconds'. It is believed this process resulted to those brick surfaces exposed to excessive heat in the manufacturing process.

Picture 86. Interesting wall detailing on west side of Port Hill. Some bricks appear to be malformed with clinker residue attached.

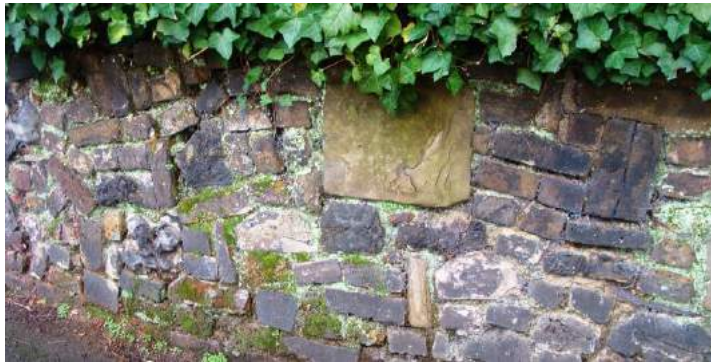
5.200. Length of low wall of random construction corner of Bengo Street and Warren Park Road.

Picture 87. Interesting wall of random construction.

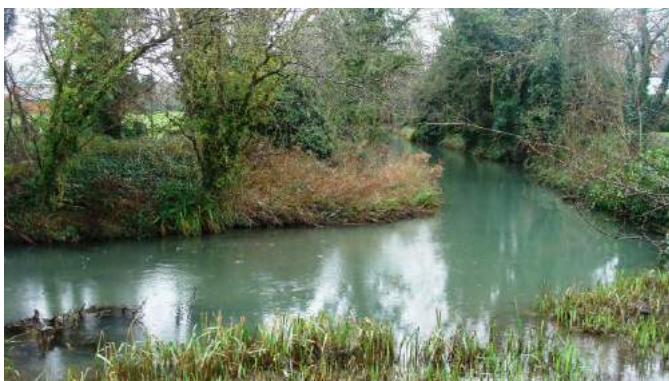
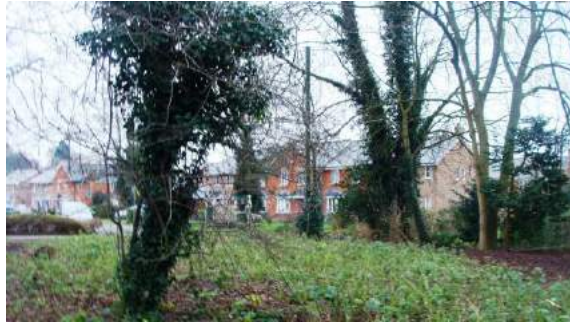
5.204. Large tract of open space to the south west of Millmead Way and playing field to east. This extensive area is more formal in character to the above but nevertheless can be considered as an important area of open space which together with the river forms part of the special character of the town. During survey work the fieldworker received a local representation regarding the detrimental effect of ivy on many of the trees in this much used open space. The Millmead Way development itself is modern but of a coordinated design which reflects the characteristics of the nearby late 19th/early 20th century developments. In itself it is of generally pleasing design for its period ~~and whilst~~ but cannot be considered of special architectural or historic interest. It is located in a key location adjacent to a well used open space network. Its removal from the conservation area could not be achieved without very odd boundary consequences. On balance therefore no changes to the boundary in this location are proposed.

Pictures 91-92. Very well used open space to the west of Millmead way. Top picture shows the river and its western bank which forms the conservation area boundary in this location. The lower picture shows trees with ivy cover that needs removing.

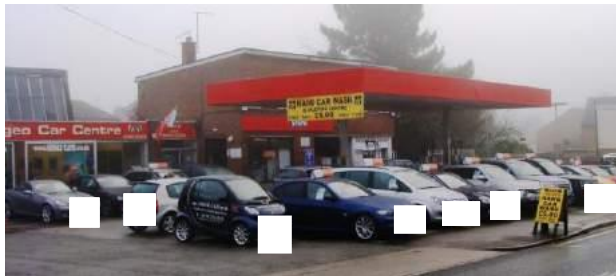
5.208. Elements out of character with the Conservation Area. Bengeo Car Centre and store. This is a prominent site in the street scene and linear part of the Conservation Area. No doubt it performs an important commercial and community function but its appearance does detract. Practically any meaningful improvements could only be secured by redevelopment. Historically the site would appear to have been developed in the late 19th century, assumed as houses. Opportunities to achieve improvements to the existing site are limited but could include reducing the impact of the prominent red paintwork by a more restrained colour choice.

Picture 93. The Bengeo Car Centre site detracts from this part of the Conservation Area. Opportunities for improvements are worthy of pursuing with the owner.

5.211. **Opportunities to secure improvements.** Remove ivy from Holy Trinity boundary wall whilst task remains minor. Consider future of Bengo Car Centre site. Consider future of former railway line south east of Nelson Street which is overgrown and untidy. Following site survey representation, remove ivy as necessary from selected trees on open space land to the south west of Mill-mead Way. Repair yellow brick wall of late 19th/early 20th century date, adjacent to ~~Pilleway~~ Pitteway Walk (assumed to be in ownership of Millmead School). Seek to achieve comprehensive visual improvements to selected parts of Millmead school site. Remove graffiti on railway bridge supports, south end of Bengo Street.

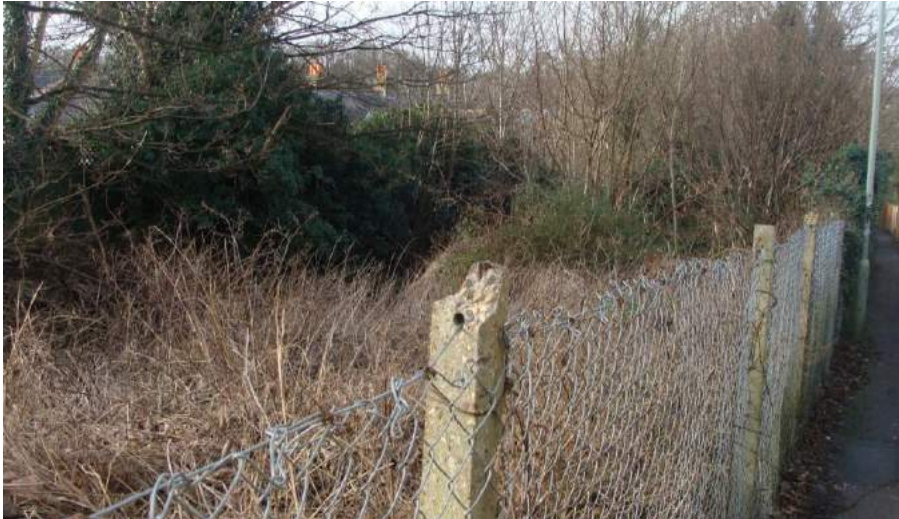
Picture 94. Former railway line now abandoned overgrown and untidy. What views does the community have regarding its future?

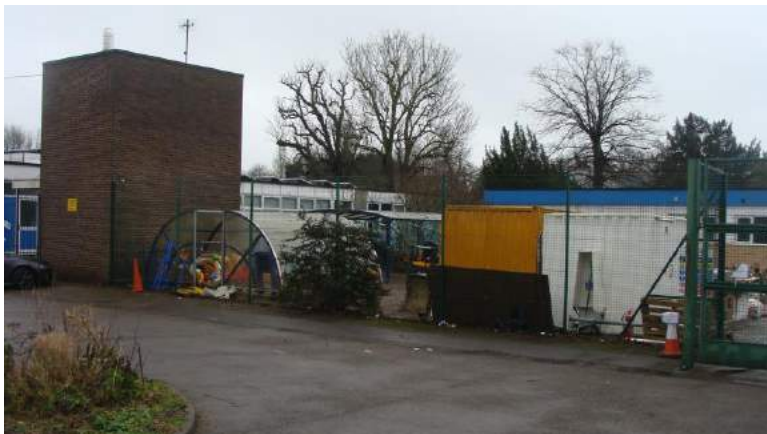
Picture 95. Part of Millmead school site detracts from quality of the conservation area and would benefit from comprehensive improvements.

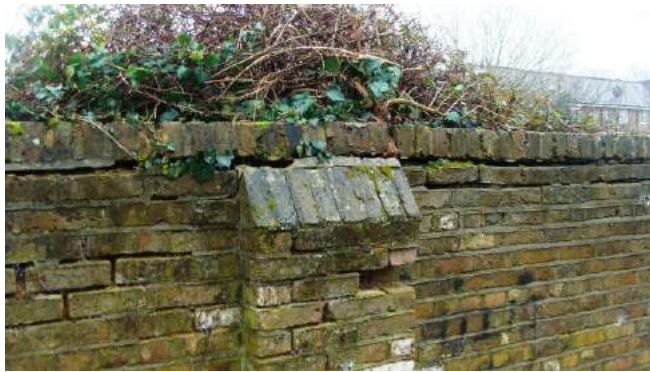
Picture 96. Wall at ~~Pilleway~~ Pitteway Walk in need of repair.

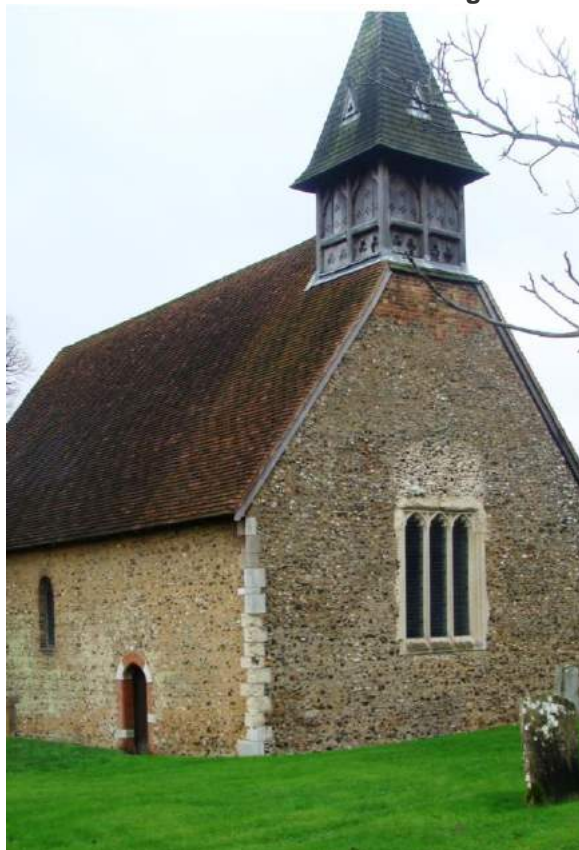
5.219. Church of St Leonard Grade 4⁺. 12th century origin. Alterations 13th to 15th centuries. 18th century porch, late 19th and early 20th century restoration. Flint rubble with ashlar, clunch and Barnack stone long and short quoins and red brick stitching, traceried stone windows. Chancel windows, 13th century. Nave with 19th century collared roof, west end with arch bracing. 12th century chancel arch. Paintings on wall of chancel arch discovered 1938. The church was held by the de Tany family in the 12th century and was given to the Priory of Bermondsey, remaining their property until the Dissolution. The church passed to the Byde and Fanshawe families and in 1846 the Abel Smiths of Woodhall purchased the rectorial tithes and turned the living into a rectory.

Picture 98. Church of St Leonard an ancient church dating from the 12th century with later alterations.

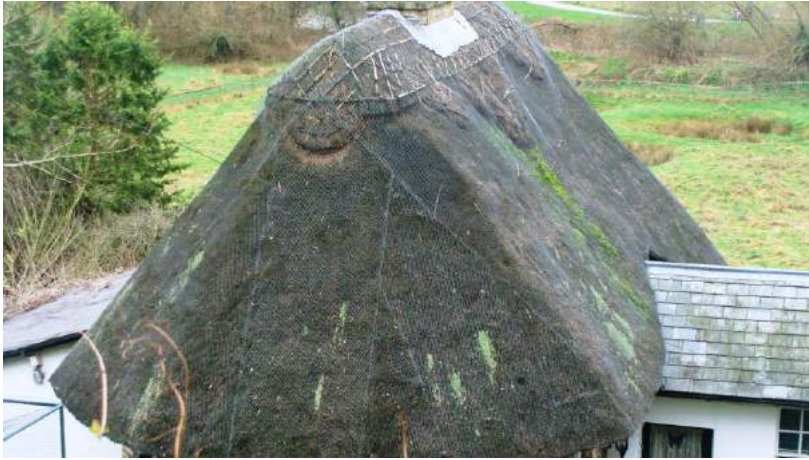
Picture 99. The Vineyard - thatched ridge appears in need of repair which may be eligible for EHDC grant assistance.

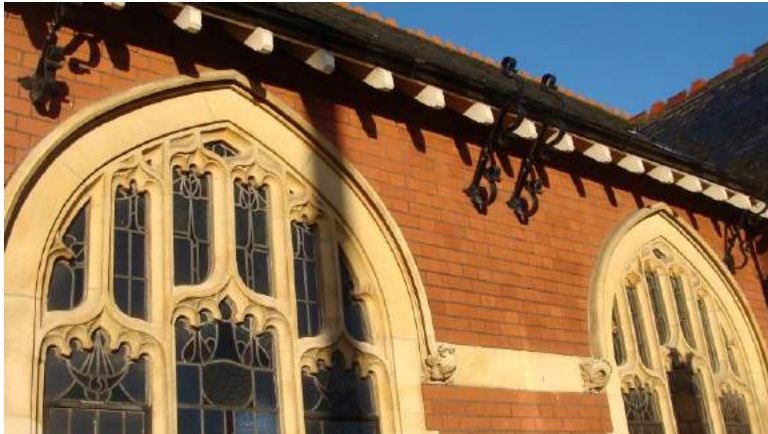
5.221. Hertford Baptist Church, church hall and attached railings, Cowbridge - Grade II. Non-conformist church, and attached hall. 1905-6. Red engineering brick, laid to Flemish bond with black pointing, with stone bands, dressings, windows and cupolas, beneath Welsh slated roof, with steep-profile red clay ridge tile in Perpendicular Gothic revival style with Arts and Crafts overtones. Cast-iron railings, with curved braced supports at intervals, and arches over spearheads and scroll and spade ties, run around western boundary of site where Cowbridge turns into Port Hill.

Picture 100. A finely detailed early 20th century listed building - the Hertford Baptist Church, Cowbridge.

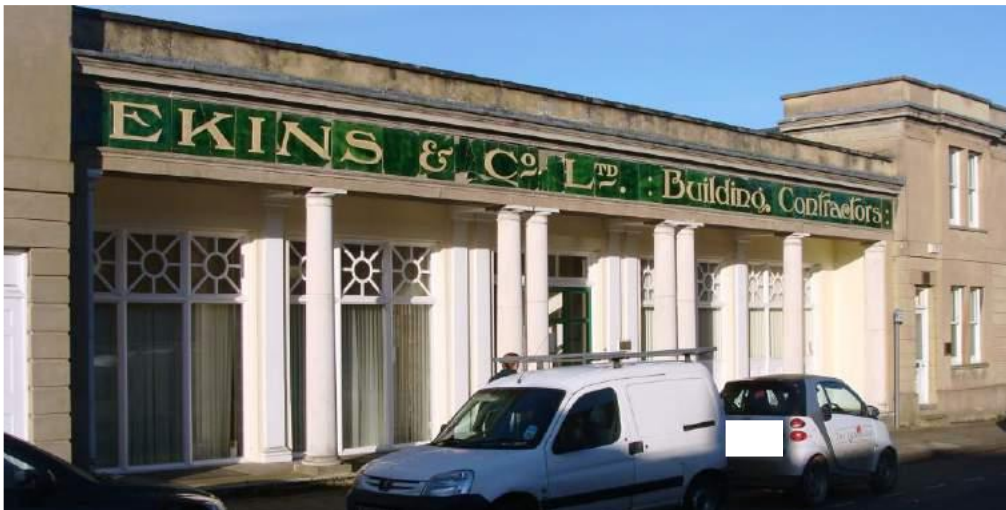
5.223. Great Northern Works, Hartham Lane - Grade II. Former furniture showroom circa 1905. Brick covered by stucco and artificial stone, Welsh slated and flat roofs behind parapet. Centre has arcade with stucco Tuscan columns forming loggia. Built as commercial premises on the approach to the former Cowbridge Station (demolished circa 1980), the building takes its name from the Great Northern Railway which served Hertford from 1858. It became the headquarters of a local building contractor, Ekins & Co shortly after its construction.

Picture 101. A fine early 20th century listed building on Hartham Lane.

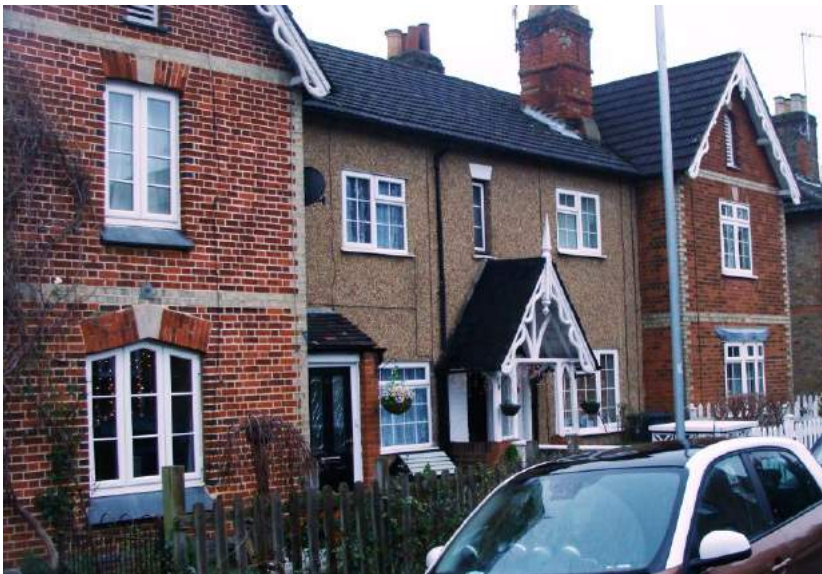
5.230. Nos. 9-19 Warren Terrace. Terrace of late 19th century two storey properties which are dominant in the street scene. Red brick with decorative brick detailing, pebble dash; chimney stacks with pots; decorative barge boarding and central decorative porch with steeply sloping roof and intricate wooden detailing. Some modern windows detract. Nevertheless overall mass and selected detail contributes to the street scene. An Article 4 Direction to provide protection for selected features may be appropriate subject to further consideration and notification.

Picture 103. Nos. 9-18 Warren Terrace - a prominent grouping that provides visual and historic interest to this late 19th century street.

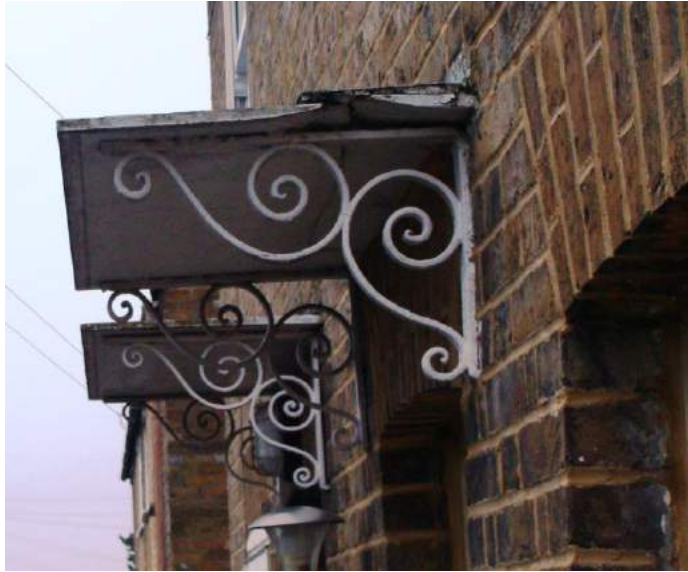
5.231. Nos. 33-51 Warren Terrace. Late 19th century terraces of brick construction with slate roofs (some brickwork painted, some roofs with later replacement tiles), chimneys and pots. Some modern windows detract. Interesting early canopies supported by metal brackets which add to the group's character and architectural diversity. An Article 4 Direction to provide protection for selected features may be appropriate subject to further consideration and notification.

Picture 104. Early canopies on metal bracket supports which add to the interest of the street scene and which are worthy of retention.

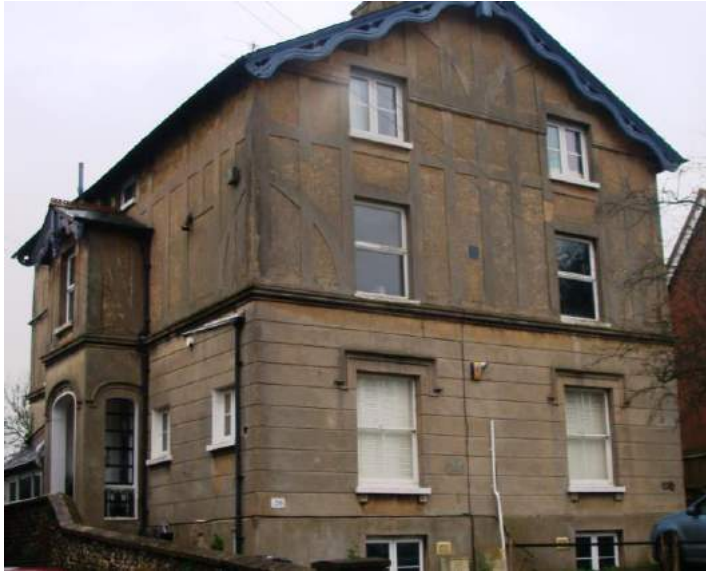
5.234. Nos. 18- 20 ~~Ware Park~~ New Road. Late 19th century building now divided into flats. Tall and very prominent in street scene. Some original windows, some replacements. Ashlar finish with decorative concrete detailing simulating wood to first floor. Slate roof, chimneys with pots, barge board detailing and porch detailing to both side elevations. An unusual and good quality building most worthy of retention; features protected by existing legislation, virtue of being flats.

Picture 105. Nos. 18-20 ~~Ware Park Road~~**New Road**. An unusual building of quality in this part of the Conservation Area.

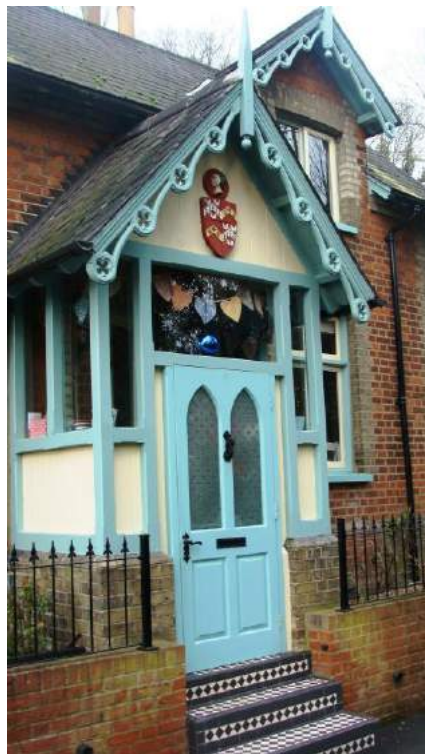
5.238. Nos. 38-40 Port Hill. Two ornate buildings probably of 19th century date. Two storey variously with slate and tiled roofs, chimneys; both with ornate detailing including barge boarding and finials. No. 40 has decorative hung tiles to first floor. No. 38 also known as Warren Lodge appears on late 19th century mapping as *Lodge*. Two delightful buildings and prominent in the street scene. An Article 4 Direction to provide protection for selected features may be appropriate subject to further consideration and notification.

Picture 106. Ornate porch detailing to Warren Lodge.

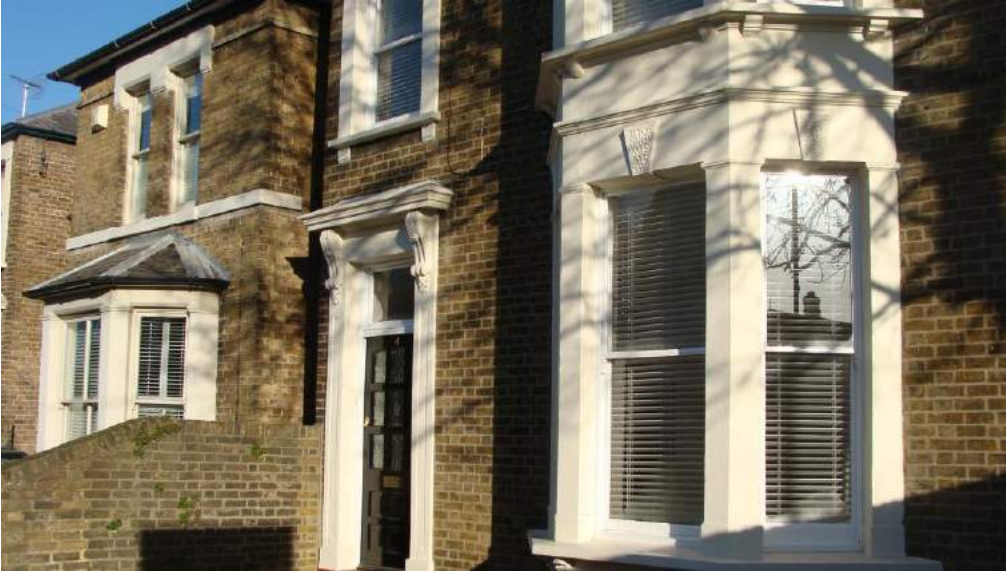
5.241. Nos. 1 Conrads Yard east to and including No.4 Cowbridge. A fine group of large town houses principally of 19th century date. Of yellow brick construction with slate roofs and chimneys with pots. Good door surround and window detailing. A very fine group and most worthy of retention. An Article 4 Direction to provide protection in relation to residential properties

Picture 107. Fine town houses on Cowbridge whose visual contribution to the street scene is considerable, both in terms of mass and detail.

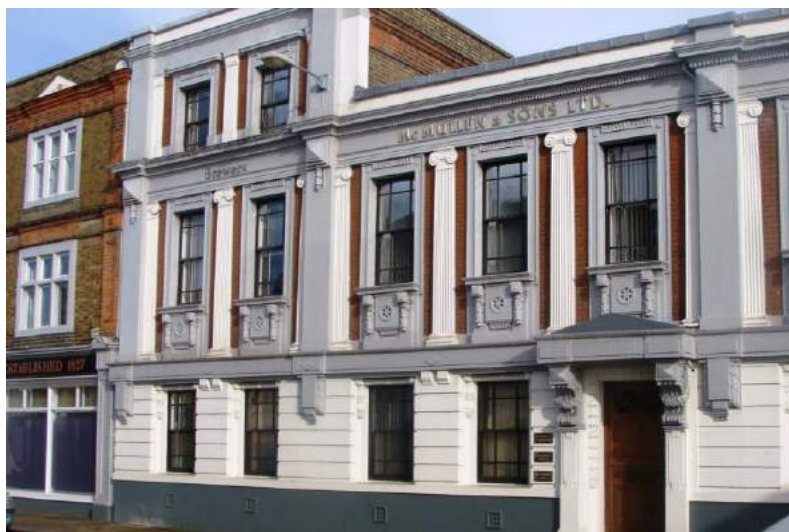
5.243. Group of three buildings south of the McMullens principal listed building, south east corner Hartham Lane. Two are typical 19th century industrial buildings of good quality yellow brick construction, some early windows; some red brick detailing. The third building principally fronting onto Cowbridge has an exceedingly handsome façade probably of late 19th century date in classic revival style with pilasters with Ionic capping detail. Rustication and other fine decorative detailing. Of very significant value to the street scene that must be protected.

Picture 108. Part of the McMullen complex. Although not individually listed this building is one of the finest such buildings in Hertford and one most worthy of retention.

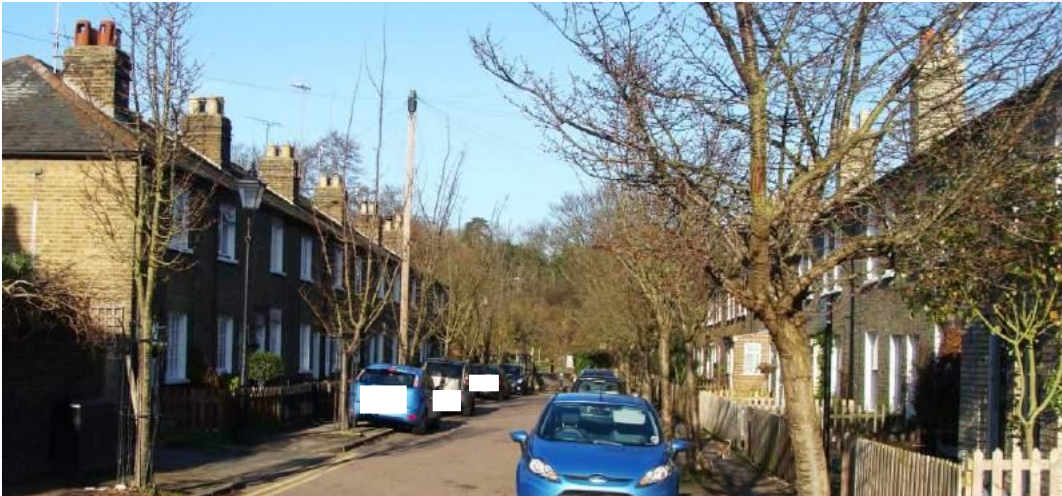
5.244. Folly Island. Principally of late 19th century date (some modern replacements). Consists of The Folly, Thornton Street, Old Hall Street and Frampton Street. Most streets are tree lined and some terraces front onto the river. Two storey and of yellow brick construction with slate roofs and prominent chimneys. A mixture of traditional and historically inappropriate window detailing together with some porches and roof lights noted. Overall a most delightful area and one worthy of careful protection. Parking on streets detracts. In this respect would there be support for making some addition such provision on the adjoining allotment land? An Article 4 Direction to provide protection for selected features may be appropriate subject to further consideration and notification.

Picture 109. The delightful late 19th century area of Folly Island.

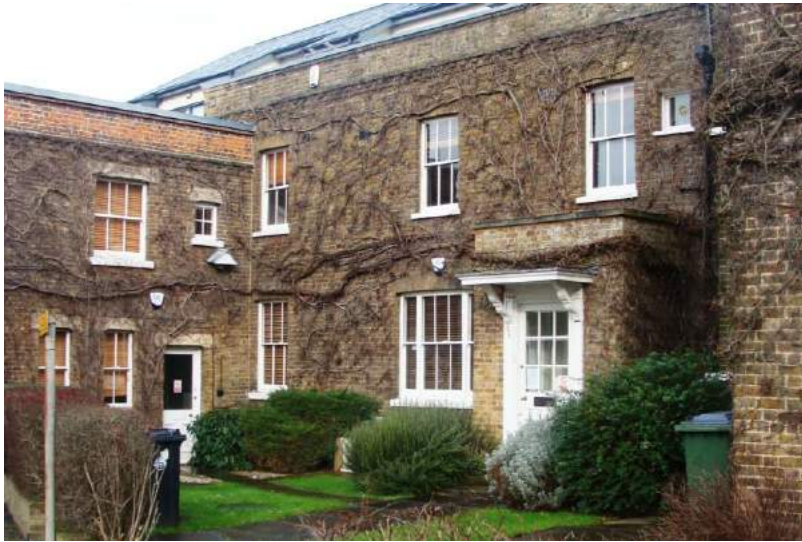
5.248. Supporting Herts. Project office and Hertford Optometry and Contact Lens Practice corner Railway Street/ Priory Street. Handsome yellow brick building of 19th/early 20th century date with good window detailing. Most worthy of retention and details administered by normal planning control.

Picture 110. Handsome building corner Railway/Priory Street; most worthy of retention.

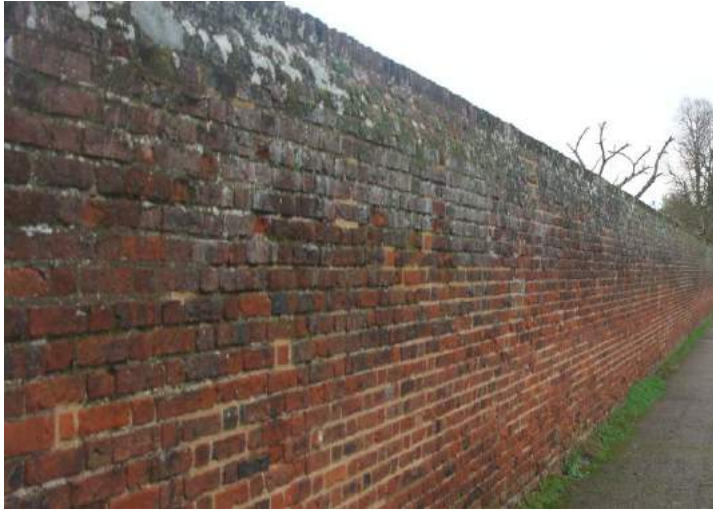
5.253. Brick wall St. Leonard's Road. Prominent and important wall in the street scene height approximately 2m.

Picture 111. Prominent brick wall fronting a Listed building that is an important element in the street scene.

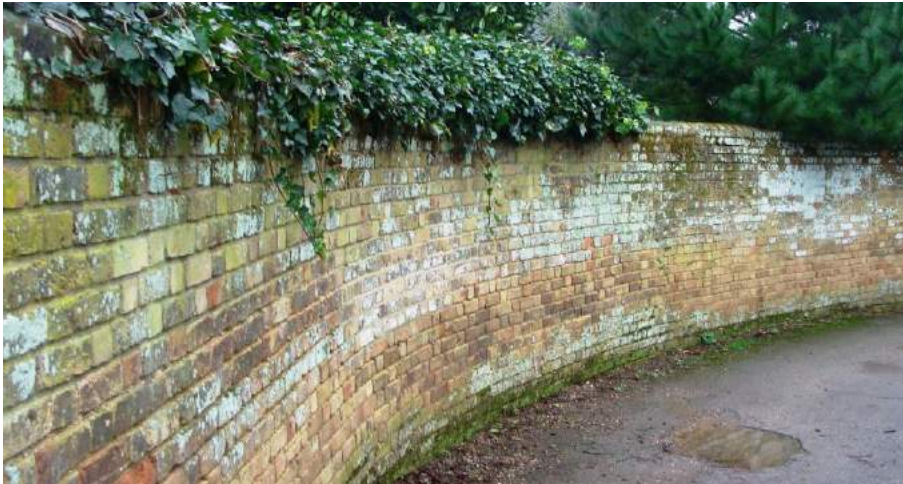
5.254. Brick and flint and brick wall to Revels Hall. Height varies.

Picture 112. Attractive curved brick wall to Revels Hall. Adds to the quality of the street scene near St. Leonard's church.

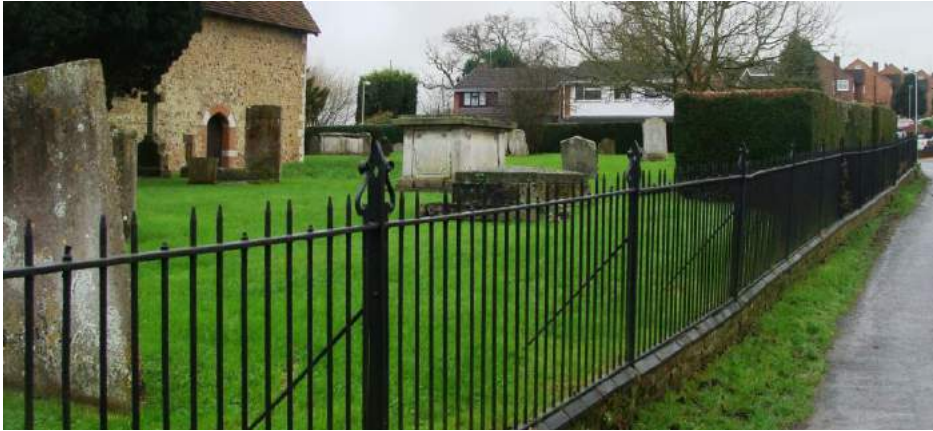
5.255. Railings surrounding St. Leonard's churchyard. Iron railings on dwarf wall probably of mid 20th century date. Attractive and most worthy of retention.

Picture 113. Attractive railings probably of mid 20th century date but which make a very positive contribution to the street scene in this location.

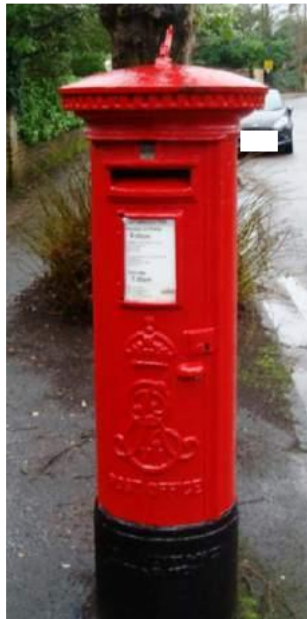
5.256. Edward VII Pillar Letter Box, south side Warren Park Road. Pillar letter box from the brief reign of Edward VII with decorative royal cipher inscription below crown. Note broken element on top which may have been housing for a telephone directional sign.

Picture 114. A fine example of an Edward VII pillar letter box that may once had a telephone directional sign on top.
