HERTFORD CONSERVATION AREA APPRAISAL AND MANAGEMENT PLAN

DRAFT FOR CONSULTATION 2016

East Herts. District Council

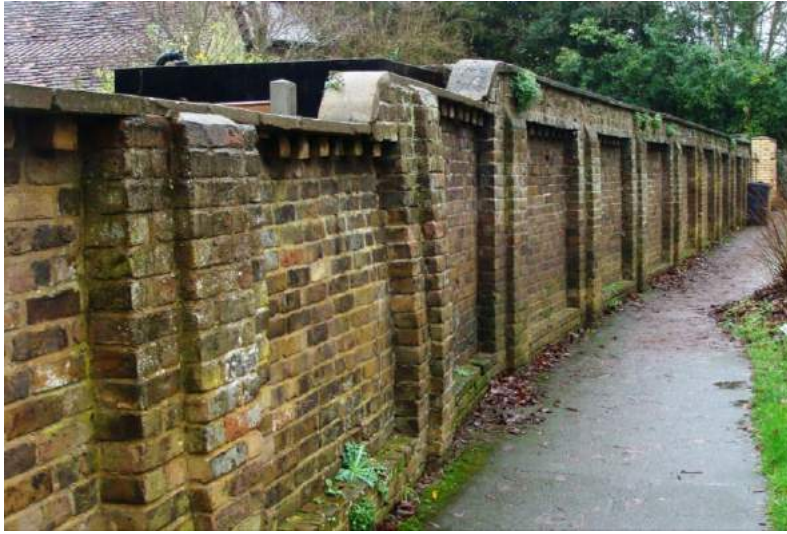
5.257. Prominent wall to south side of Warren Park Road. Of yellow brick construction with piers and dentil detailing. Height varies, approx. 2m. Important in the street scene.

Picture 115. Prominent brick wall important to the quality of Warren Park Road.

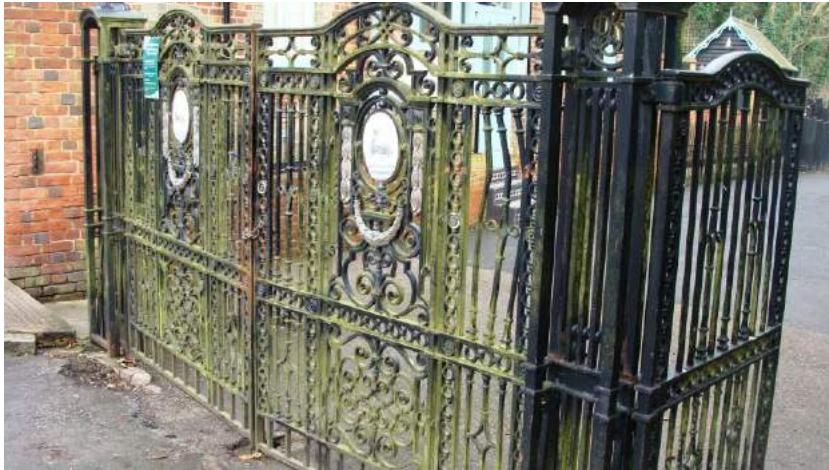
5.258. Gates to Hartham Common, Port Hill. Ornate metal gates and descriptive metal plaque at entrance to Hartham Common. Plaque reads *The Warren Meadows Lodge & these gates were presented to the town of Hertford by Philip Raynsford Longmore 1928-35*. Gates need cleaning and adjacent surface could be improved.

Picture 116. Decorative metal gates assumed to date from the earlier part of the 20th century are imposing and a strong feature in the street scene. Minor remedial works required.

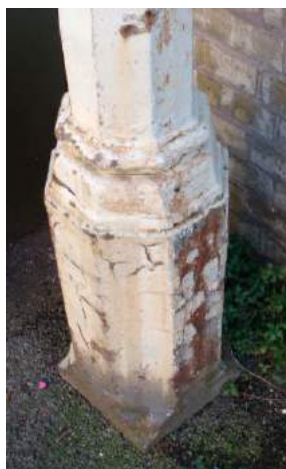
5.259. Early street lamp outside No.12 Chambers Street. In need of repainting and refurbishment. Should be retained.

Picture 117. Detail of base of early street lamp on Chambers Street in need of refurbishment. Several of these have been noted.

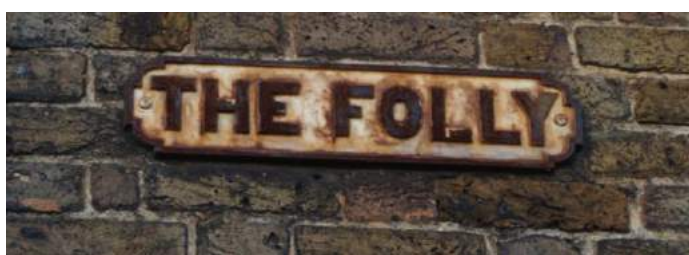
Picture 118. Throughout the conservation area, principally on 19th century terrace developments early/original street names can be found. They are part of the rich tapestry of the town that should be retained.

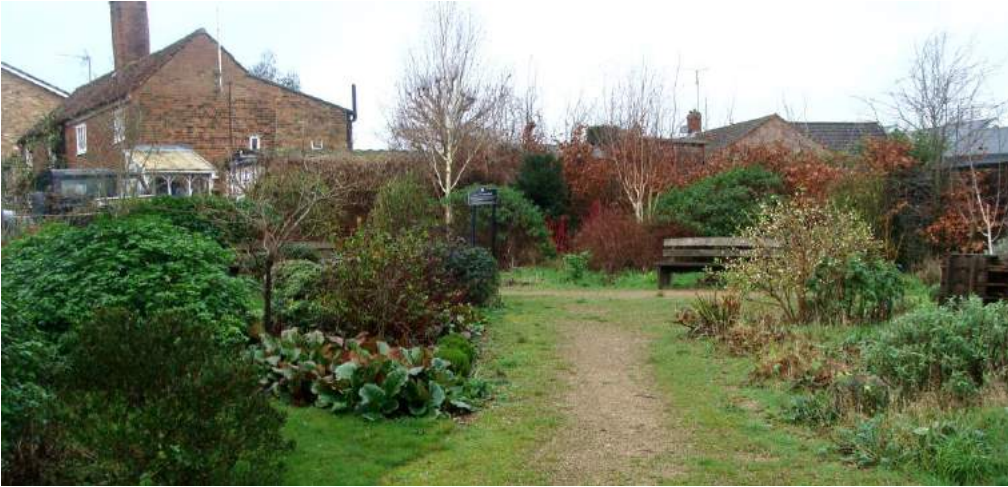
5.261. Important Open Spaces. St. Leonard's Garden managed by Hertford Town Council. A small but important open space where some additional and appropriate boundary planting might be worthy of consideration to screen and limit impact of adjoining modern development. An entry available on line written by the Hertford Civic Society briefly sets out the genesis of its creation and purpose part of which was to preserve and enhance the setting of the nearby ancient church. Additional planting as suggested might also be relevant in this respect.

Picture 119. St Leonard's Garden - a small but important open space where additional planting to reduce the impact of modern development is worthy of consideration.

5.275. Opportunities to secure improvements. Consider addition planting at St. Leonards Garden to reduce impact of adjoining modern development. Consider repairs to damaged chest tomb at St. Leonard's churchyard and in this respect and without prejudice to outcome, grant assistance may be available. Similarly consider grant assistance to thatched roof The Vineyard. Consider minor refurbishment to ornate entrance gates to Harham Common. Port Hill. Refurbish early street lamp Chambers Street. Repair boundary fence to Hertford Town Church play area. Redevelop untidy site opposite The Hertford Brewery.

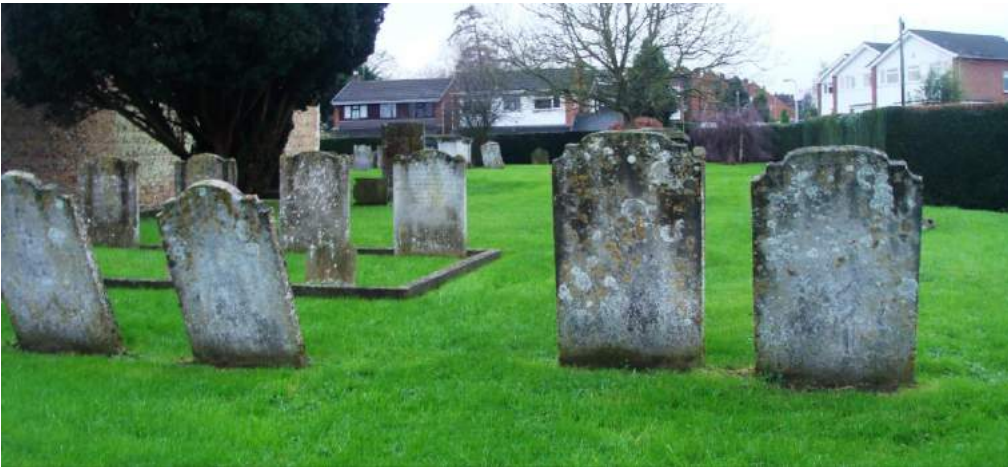
5.262. St. Leonard's churchyard. A well kept churchyard with some mature trees and many tombstones, some chest and one such chest tomb in urgent need of repair. Iron railings to front (see above).

Picture 120. Important and well kept churchyard with many interesting tombstones.

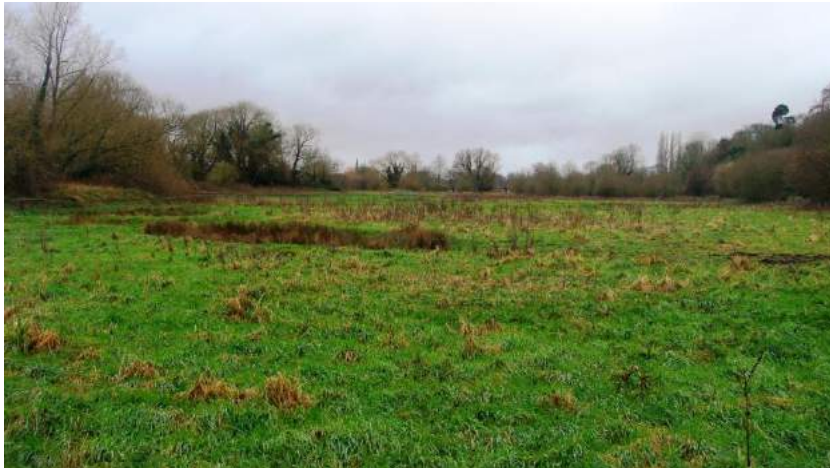
5.263. Hartfordham Common. Hartham Common is a 'Green Finger' and an extensive area of open space of high quality which provides recreational and accessible open space some of which is of great environmental, wildlife and ecological importance. It is crossed by the River Beane and the River Lea and its woodlands, open areas and playing fields are accessed by an extensive network of footpaths actively used by pedestrians, joggers, cyclists, sportspersons and fishermen. There is a large Leisure Centre and car parking

Picture 121. Hartham Common, an accessible recreational area of great environmental and communal interest to the town. Its retention is most important.

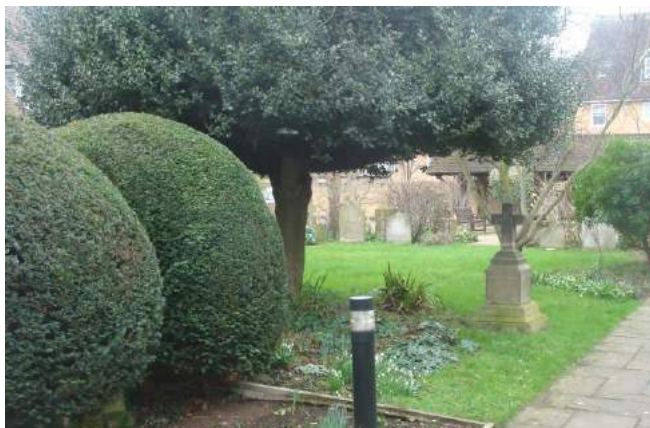
5.265. The churchyard of Our Lady and St. Joseph, St. John's Street. A small open space in a dense urban area with gravestones. Site of former Benedictine Priory. Traditional churchyard trees.

Picture 122. St Joseph's churchyard, St John's Street, a delightful small space in a densely built up area.

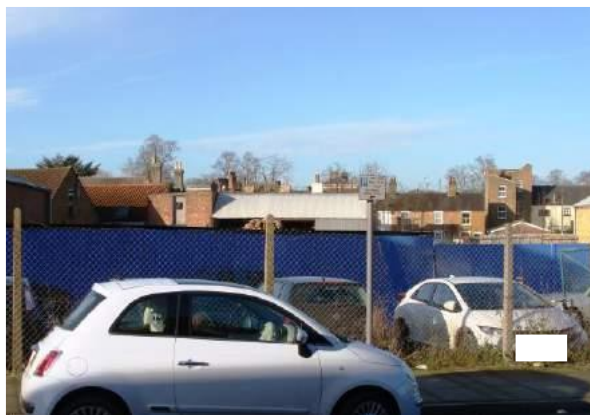
Picture 124. Untidy site opposite The Hertford Brewery, an iconic Hertford landmark. This site is in urgent need of appropriate redevelopment. Planning permission has been granted.

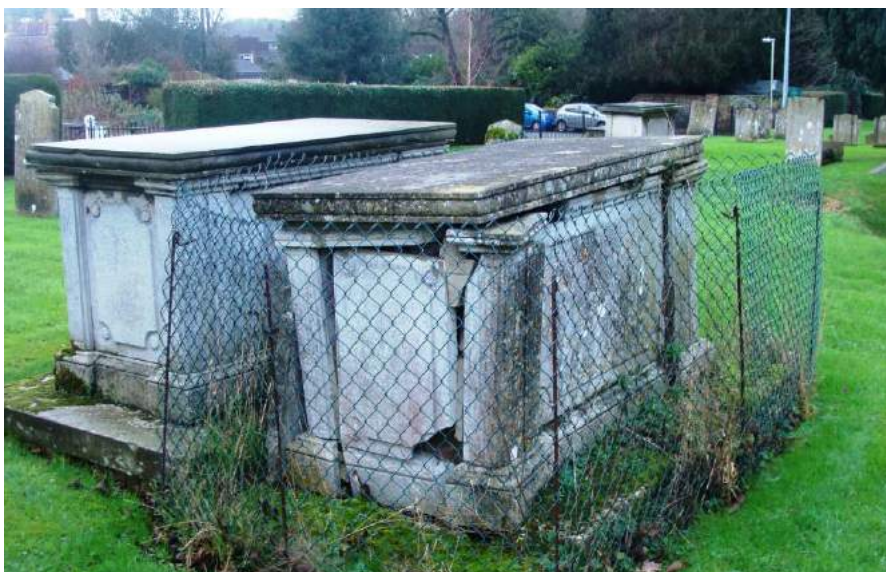
Picture 125. Damaged chest tomb at St. Leonard's churchyard in urgent need of repair which may be eligible for grant assistance from EHDC.

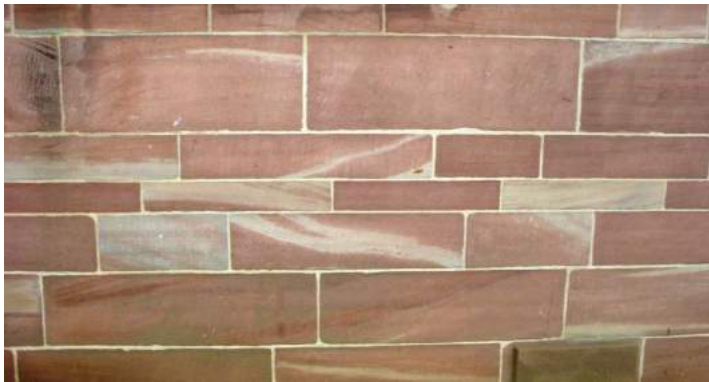
5.281. Church of All Saints with St John - Grade II* (*All Saints*). Parish church. 1893-95, replacing earlier building destroyed by fire in 1891, west tower added 1905, Memorial Chapel completed 1934. Architects Paley, Austin and Paley of Lancaster. Of pink Runcorn sandstone with plain clay tiled and lead roll roofs in Northern Gothic Revival perpendicular style. All Saints Parish dates from prior to the 10th century and in the 11th century was joined with the Liberty of Brickendon which was held by Waltham Abbey under a charter from Edward the Confessor. The 'old' All Saints church had been rebuilt in the 15th century but caught fire in December 1891 and was completely gutted. The tower was completed in 1905, as the Victoria Tower in memory of Queen Victoria. The Memorial Chapel was dedicated in 1934.

Picture 126. Beautiful external sandstone detailing of All Saints.

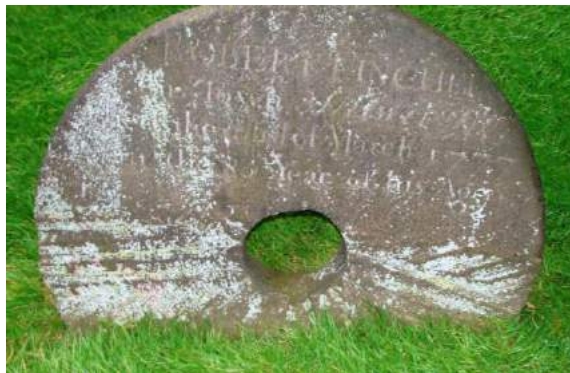
5.282. Two gravestones 8 metres west of north porch of church of All Saints - Grade II. 18th century and fashioned from used millstones, with incised inscriptions: the first, 'Robert Fincher of this town, Millwright, died the third of March 1777 in the 86 year of his age; the second, 'Elizabeth, Wife of Robert Fincher Millwright died the 18th July 1764 aged 60 years'.

Picture 127. Most unusual gravestone markers fashioned from millstones.

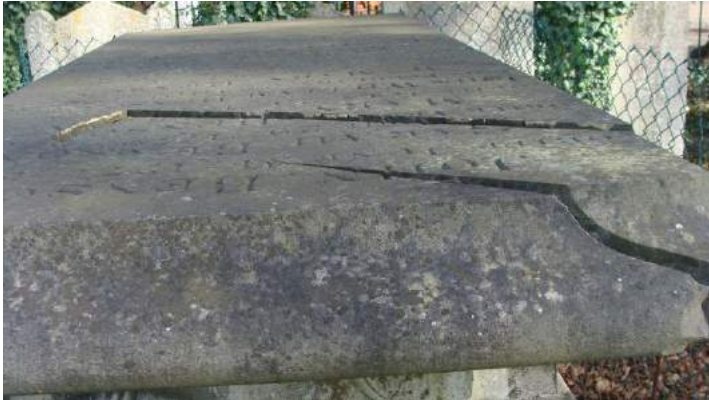
Picture 128. 18th century Benson tomb in need of repair. ~~Potential candidate for entry~~ Now included - on the Council's Heritage at Risk Register.

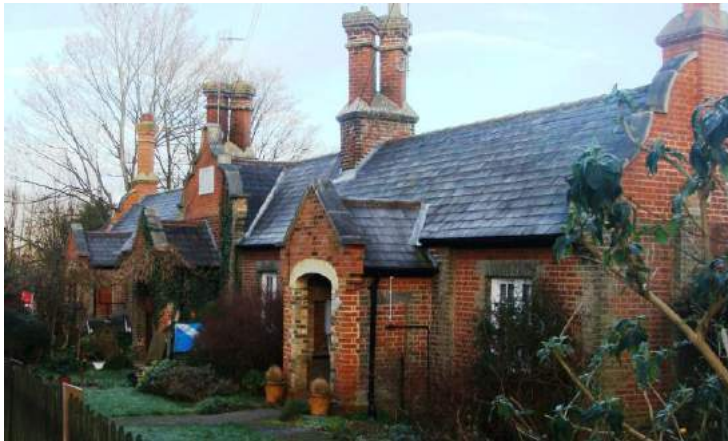
5.284. Harrison Almshouses - Grade II. Almshouses, originally a block of 6 but now refurbished as 3. Dated 1854, with 20th century alterations. Red brick, Flemish bond, with cream brick dressings, Welsh slated roof with single and double diagonally shafted chimneystacks with band and oversailing cap.

Picture 129. Typical almshouses with attractive chimney detail.

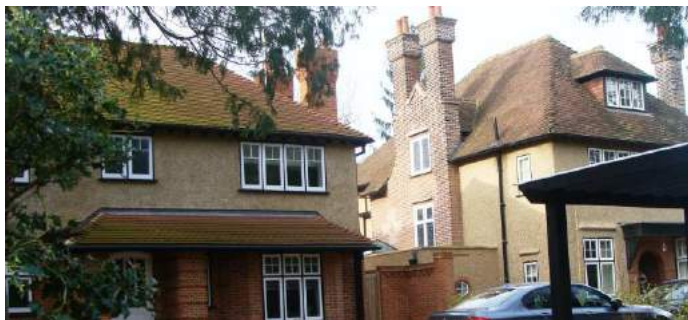
5.290. Nos. 8, 12 Morgans Road (set back some distance from road and accessed by cul de sac), 14, Foxrock, 16 (Nortonbury set back from road with private access), 18A, and 22 Morgans Road. Large detached houses of 20th century date, some from the earlier part of the century of various constructions (brick, render, pebbledash); with hipped tiled roofs and frequently prominent chimneys with pots. Other architectural features of note including decorative brick and entrance detailing. The whole group make a valuable contribution to the street scene. An Article 4 Direction to provide protection for selected features may be appropriate subject to further consideration and notification.

Picture 130. Quality 20th century housing on Morgans Road, note impressive chimney detail.

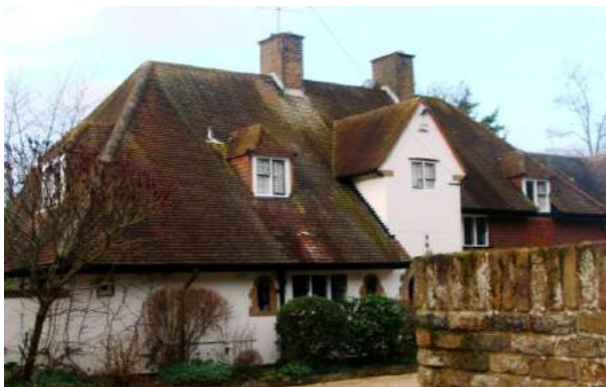
5.291. No. 2 Morgans Road. Probably dates from the mid 20th century. Single storey with huge steeply pitched roof chimneys. Imposing building and representative of its type and period. An Article 4 Direction to provide protection for selected features may be appropriate subject to further consideration and notification.

Picture 131. A single storey building with imposing roof probably dating from the mid 20th century constructed of good materials and playing its role in painting a picture of the towns more recent history.

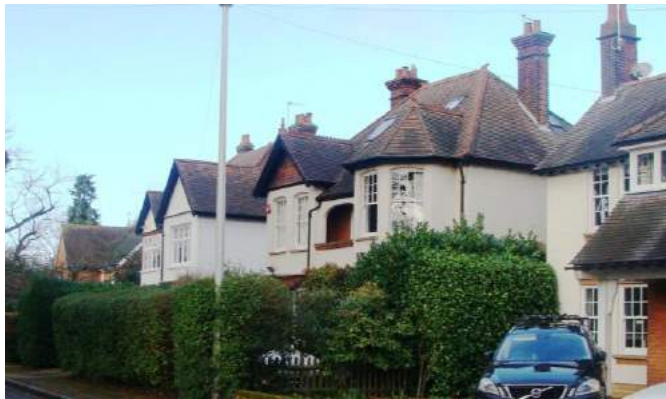
5.294. Highfield Road. North side- Highfield Court, Nos. 4-18 (omit 18A) and No. 20. South side - Nos. 1, 3A and 5. A variety of housing types, mostly large two storey detached; some date from earlier 20th century, others later 20th century. Of render/red brick construction with tiled roofs and chimneys. Many quality details include turrets, decorative tile detailing, finials barge boarding, balconies, recessed entrances, bay windows some good window detailing. An Article 4 Direction to provide protection for selected features may be appropriate subject to further consideration and notification.

Picture 132. Good quality 20th century housing at Highfield Road, north side, displaying many interesting features typical of the period.

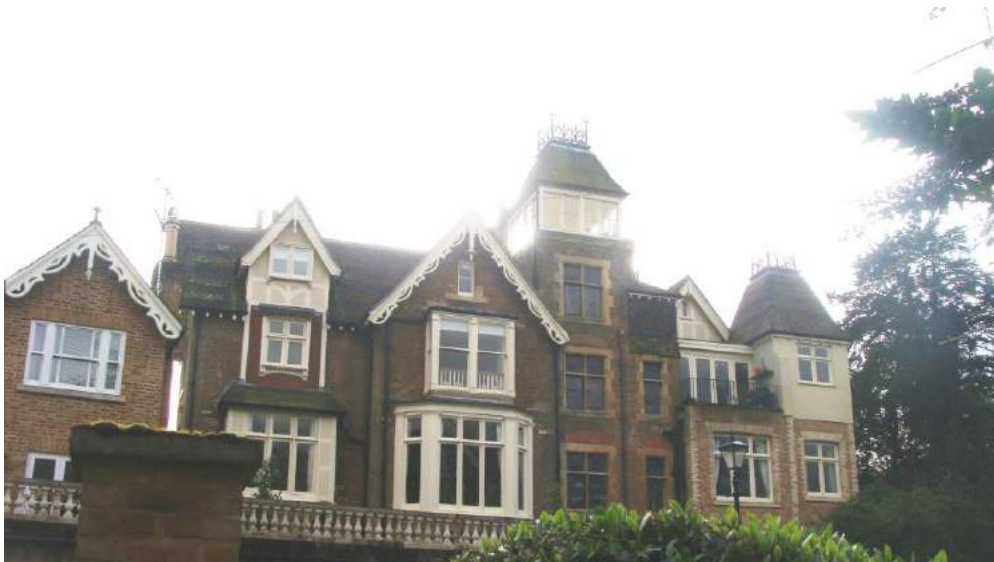
5.300. Springfield Lodge, Mangrove Road/ Hagsdell Road. Dating from the 19th century this tall 3/4 storey yellow brick building with decorative tiled roof and chimneys dominates the local street scene. Many decorative features including barge boarding. Unusual feature with metal detailing protrudes above roof and overlooks the town which may have been an observation tower. Now divided into flats and thus protected by normal development control.

Picture 133. Springfield Lodge. Is the curious 'tower' for purposes of observation and overlooking the town? Is there any local knowledge?

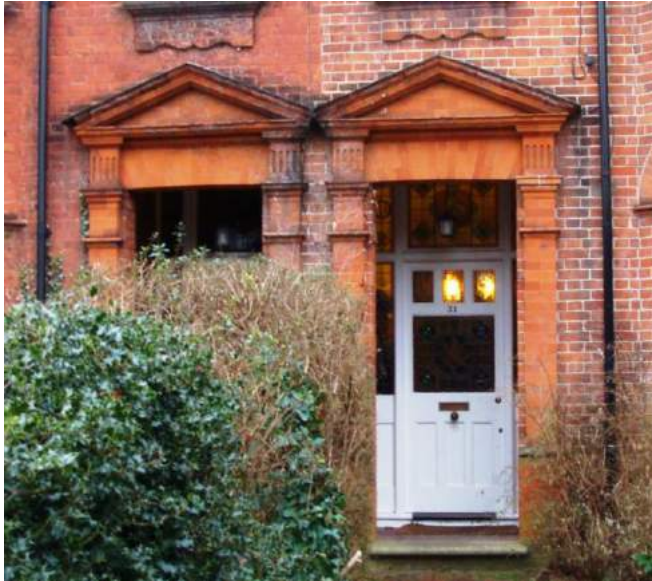
of roof materials and chimneys. Good quality detailing throughout includes prominent bay windows, date plaques, recessed entrances and some original glass detail. Various of yellow brick with red brick banding; red brick, some render with decorative wooded detailing. Window detailing is generally sympathetic. An Article 4 Direction to provide protection for selected features may be appropriate subject to further consideration and notification.

Picture 134. Recessed entrance detailing to properties east side of Queen's Road.

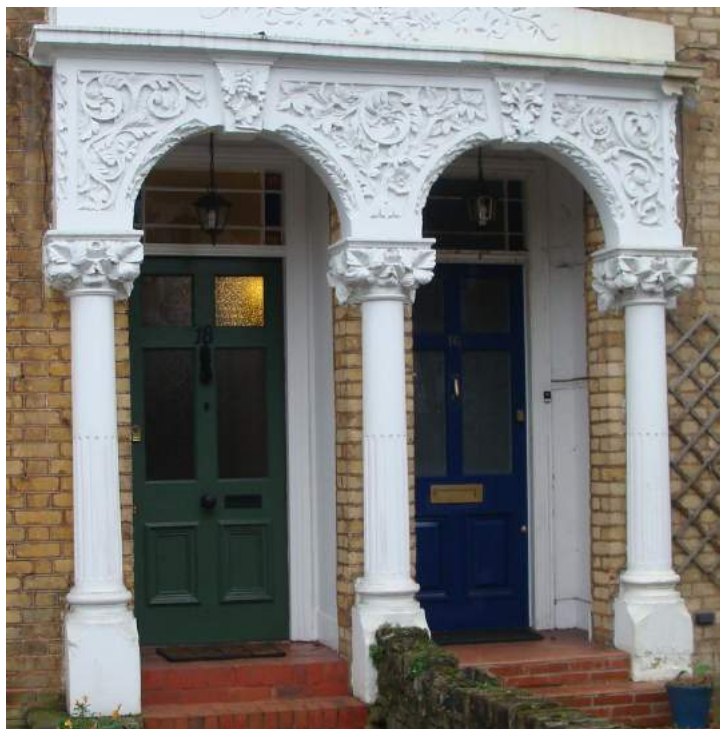
5.304. Nos. 16 - 46 Queens Road. Distinctive range of residential properties principally dating from the late 19th century. Various constructed of red or yellow brick with slate or tiled roofs. Good quality detailing includes recessed entrances, decorative woodwork, bay windows and porch and canopy detailing. Windows generally sympathetic. An Article 4 Direction to provide

Picture 135. Highly decorative late 19th century detailing to properties west side of Queens Road.

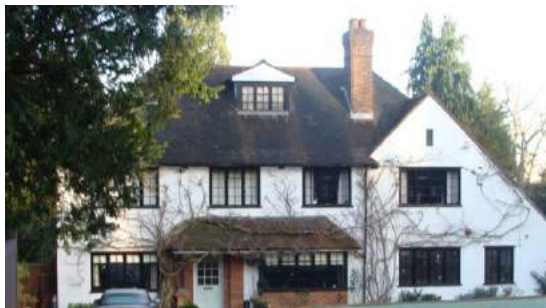
5.309. The Dell, Hagsdell Road. Large detached house probably dating from the first half of the 20th century. Render with tiled roof, tall chimneys with pots. Good window detailing. Typical of type and period. An Article 4 Direction to provide protection for selected features may be appropriate subject to further consideration and notification.

Picture 136. The Dell, Hagsdell Road - probably from first half of 20th century, nice proportions.

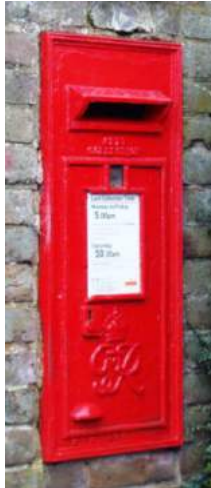
5.313. George VI letter box, Hagsdell Road. A more decorative intertwined lettering design when compared with earlier models.

Picture 138. A George VI letter box, note more decorative lettering detail.

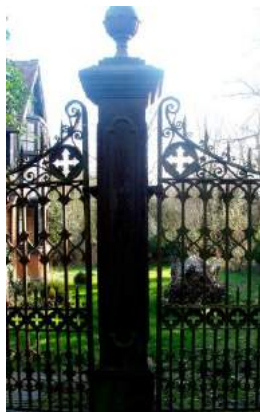
5.314. High quality metal gates supported by robust metal posts with ball finials atop. Access to unoccupied Hertford Lodge (? see above).

Picture 139. Access gates to Hertford Lodge (?)

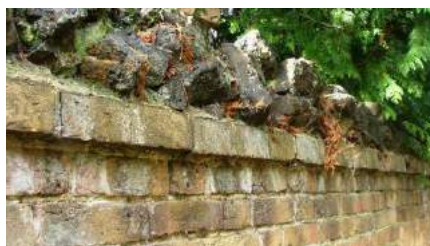
5.315. Walls lining public footpath 82 which links Mangrove Road and Hagsdell Road. A well used high quality enclosed urban space bounded by walls of varying heights and construction. Some taller elements of wall constructed of brick capped with industrial clinker waste. 2 No. bollards defining entrance points probably of 19th century date.

Pictures 140-141. Good quality bollard probably dating from the 19th century and brick wall capped with industrial clinker waste defining public footpath 82. An important and well used component of the urban scene.

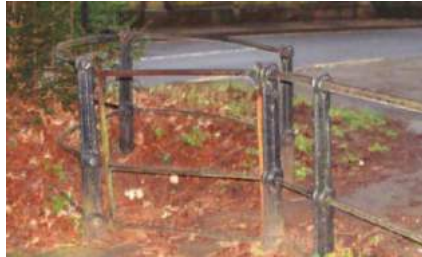
5.317. Railings and entrance point, South west boundary All Saints churchyard and nearby bollard. Probably of 19th century date. Constructed of 2 No. horizontal railings supported by metal posts about 2m centres.

Picture 142. Boundary railing detail and entrance point to All Saints churchyard, south western corner.

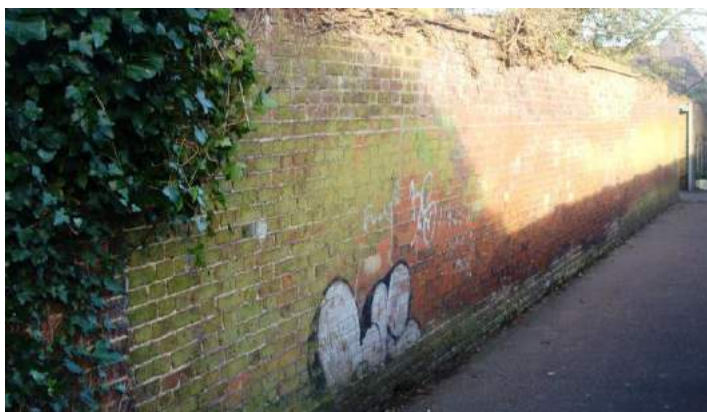
5.322. Tall wall to playing field of Abel Smith School adjacent to footpath. Graffiti needs removing.

Picture 143. Wall forming boundary to Abel Smith playing field and adjacent to footpath need graffiti removing.

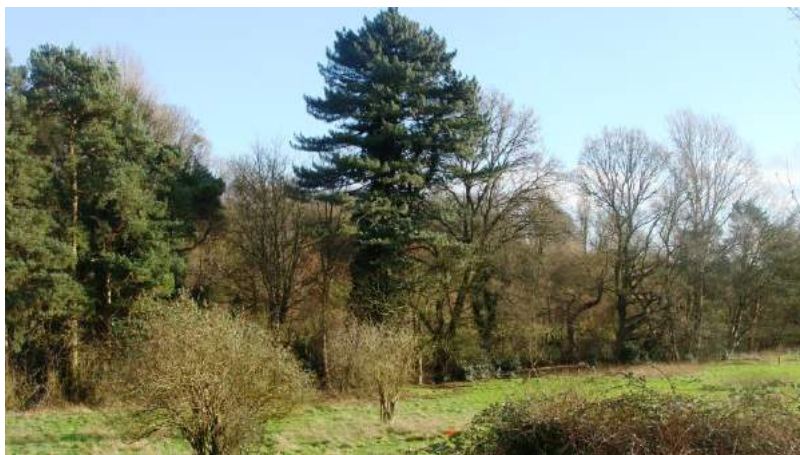
5.323. Important Open Spaces. Tract of grassland and treed areas between Queens Road and Mangrove Road and to the south of a well used metalled footpath connecting the above two roads. This land consists of grass fields and heavily treed areas which include visually important specimens including a number of Scots Pine. The land acts as a buffer between several principal blocks of development. It is distinct from the open countryside beyond both to the south and north. Its function and visual importance are reasons for it properly remaining within the conservation area. It is one of Hertford's 'Green Fingers'.

Picture 144. Open and treed land of considerable visual importance and which separates blocks of residential development from each other.

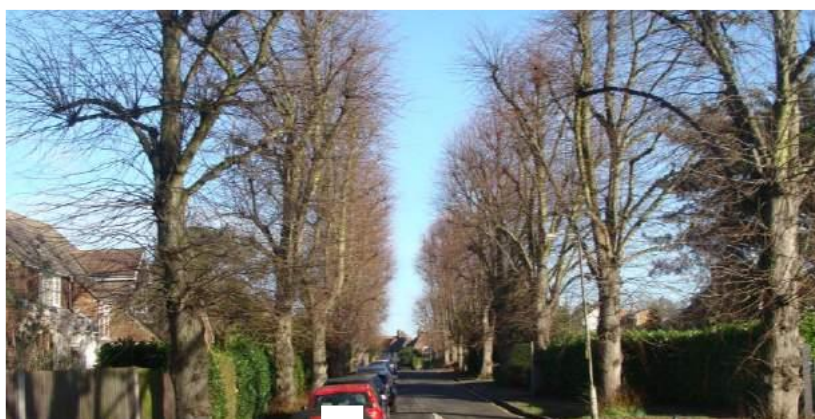
5.324. Southern end of Queens Road. Accessible to the public This tree lined street adds great visual quality to this part of the street scene that would otherwise be neutral.

Picture 145. The high environment quality of the southern end of Queens Road is almost entirely due to the tree lined street.

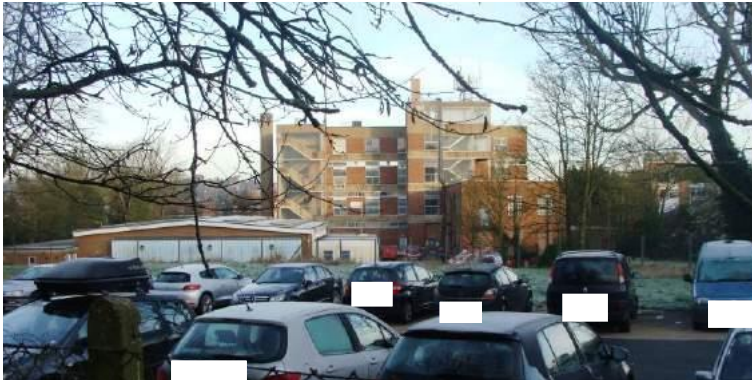
(b) Large Gateway site to Hertford corner of Gascoyne Way and London Road. This site has potential for long term redevelopment opportunities at least in part. It currently consists of a large undistinguished 20th century building open land parking areas and other low key buildings. There is also a residential element called Gwynns Walk consisting of modern terraces.

Picture 148. View across undistinguished site corner of Gascoigne Way and London Road. The commercial element may have some potential for long term redevelopment so as to improve this gateway site.

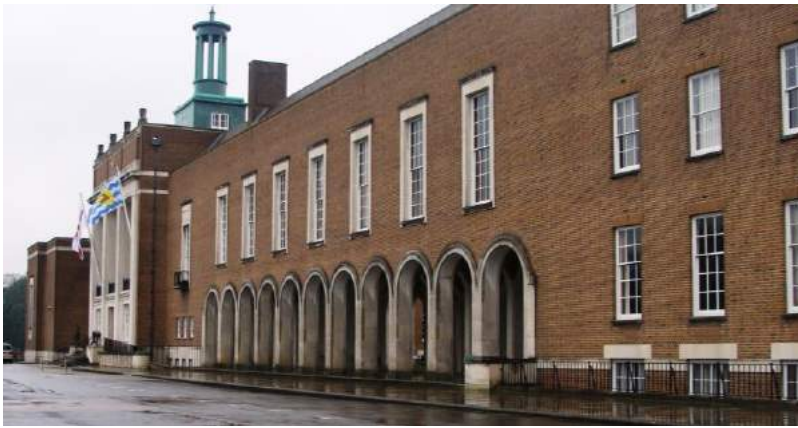
5.338. County Hall including terraces and fountain - GV II*. County Council Offices, Council Chamber and Committee Rooms. 1935-39. Architects James and Bywaters and Rowland Pierce. Design influenced by Swedish Romantic and Neo-classical architecture of the earlier 20th century and the work of Sir John Soane. In centre of courtyard is a fountain with a raised scalloped centre, 12 sided outwards curving basin, with recessed plinth, on a raised circular step; raised stone curbs to lawns at either side. County Hall resulted from the decision of the County Council to seek a unified headquarters. The Clerk to the Council, a Hertford solicitor Sir Charles Longmore purchased Bailey Hall in 1930 to supplement the inadequate Shire Hall in Fore Street, and in 1934 Leahoe

Picture 149. County Hall Architects James and Bywaters and Rowland Pierce. Design influenced by Swedish Romantic and Neo-classical architecture of the earlier 20th century and the work of Sir John Soane.

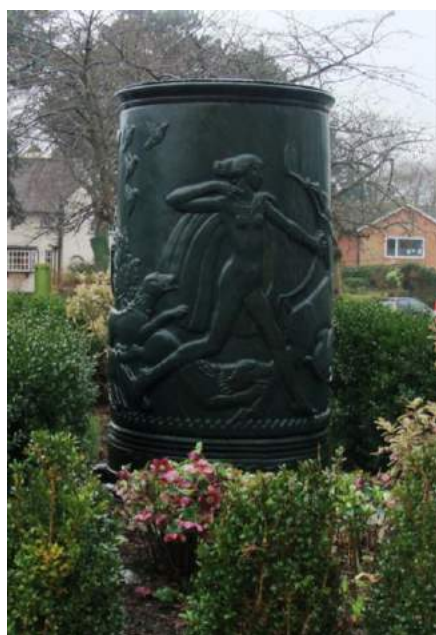
5.339. Forecourt to County Hall including bas relief drum, lamp posts and boundary marker - Grade II. External sculpture, lamp posts, gate piers and boundary curb. 1938-9. Architects as above. Bas relief cast-iron drum, with figure of Diana the Huntress, harts and hounds stands on York stone paving adjoining the Members' car park outside the main entrance portico of County Hall: Lamp posts purpose designed with bronze lanterns with conical copper tops. The gateways are flanked by dwarf Portland stone octagonal piers with moulded caps; Portland stone moulded boundary curb with steles at intervals. Several of the listed lamp posts have lantern missing which should be replaced.

Picture 151. Bas relief drum to front of County Hall.

5.368. **Opportunities to secure improvements.** Seek selected owners' cooperation in improving selected rear garden environments - adjacent footpath between West Street and County Hall. Removal of ivy to expose historic railings of quality to front of 16-18 Bullocks Lane. Seek improvements to area around Hertford Football Club. Discuss with HCC prospect of replacing missing lantern to listed lamp posts at County Hall.

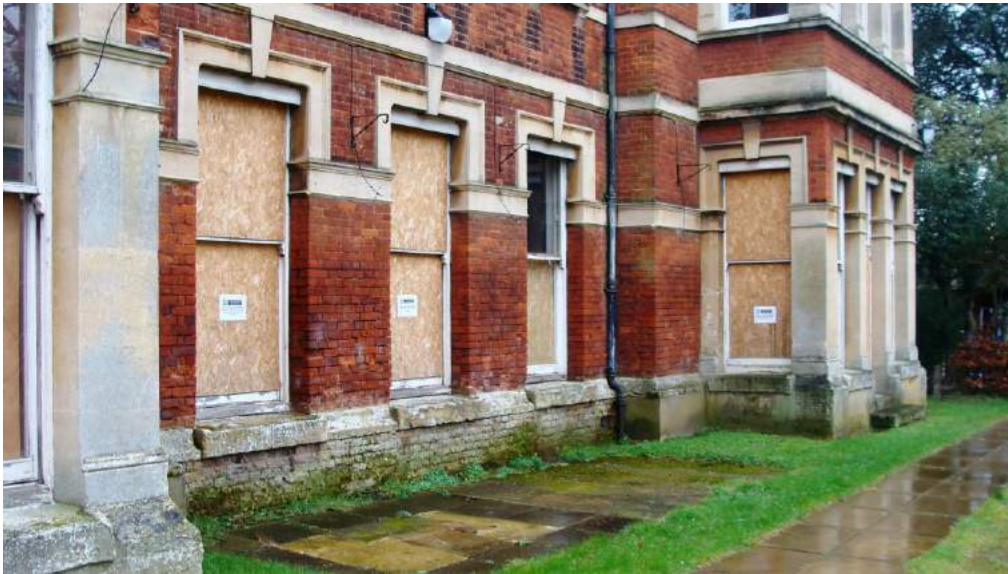
Picture 152. Leahoe House within the County Hall complex. A fine 19th century building in declining condition whose retention is important and whose future needs ascertaining.

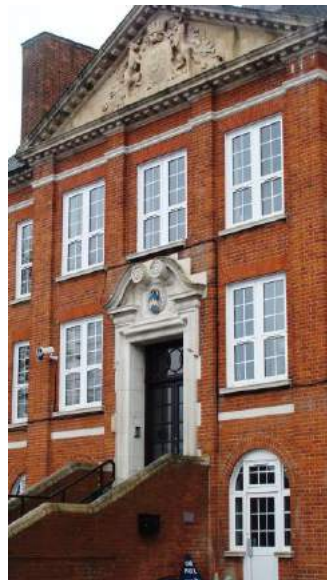
5.348. Original Richard Hale School. Interpretation of mapping indicates the original school building was erected about mid 20th century. A tall red brick prominent building with tiled roof. Elaborate main entrance detailing approached by steps with pediment containing ornately carved heraldic detail with cupola above.

Picture 153. Imposing entrance to Richard Hale School, interpreted as being of mid 20th century date.

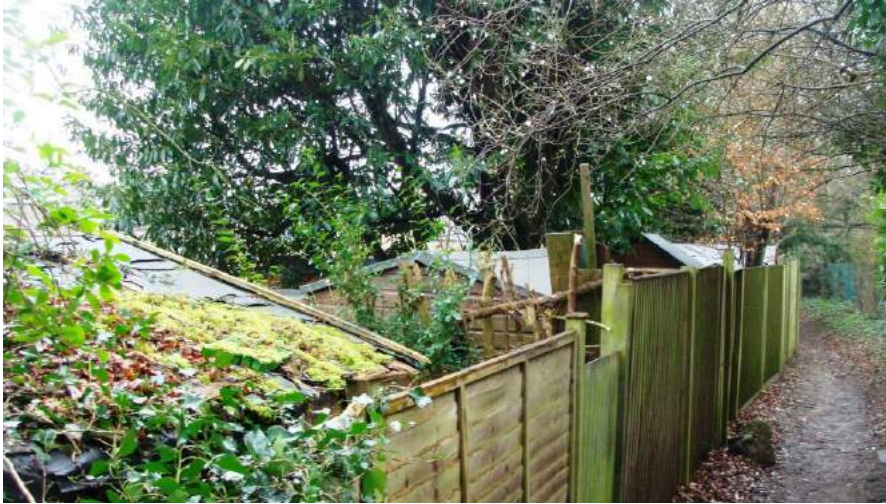
5.366. Elements out of character with the Conservation Area. Selected rear garden sheds/fencing etc to some properties on West Street, particularly adjacent to public footpath running between the latter and County Hall.

Picture 155. A mixture of fencing and dilapidated garden sheds in some locations adjacent to this public footpath detract.

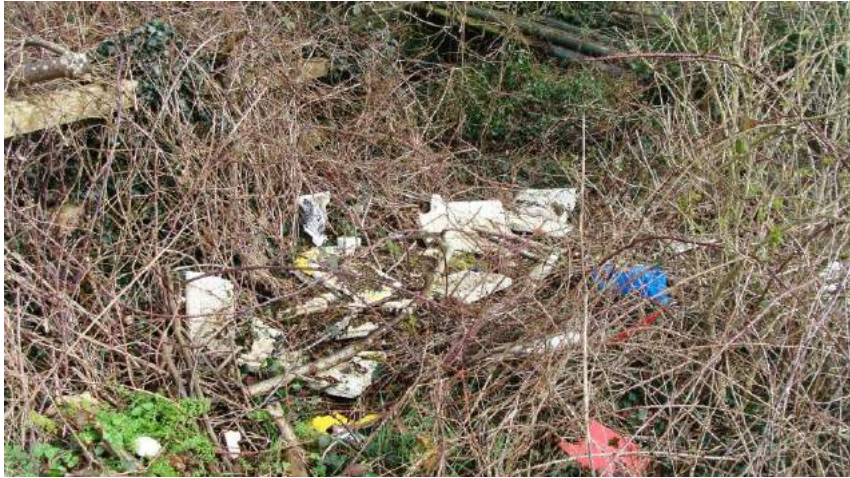
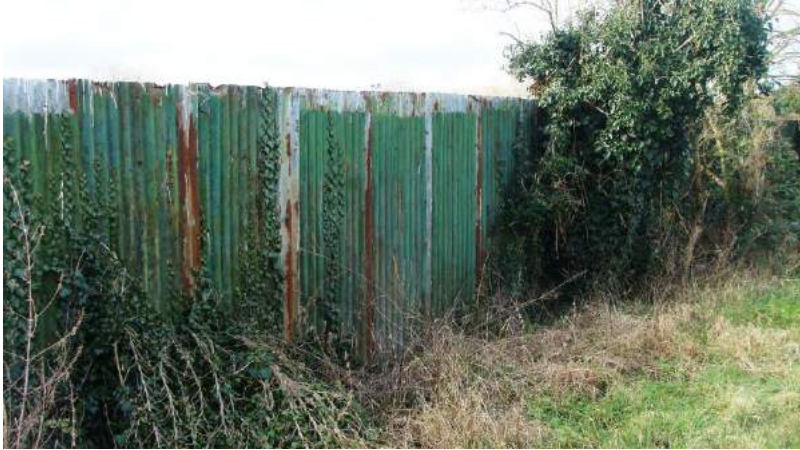
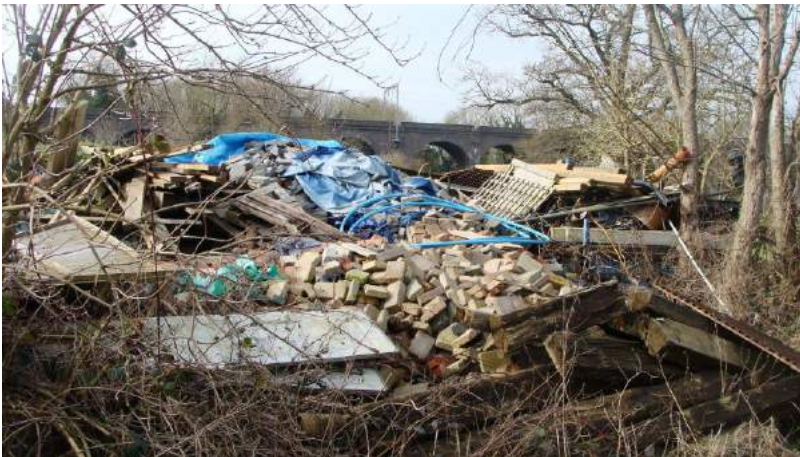
5.367. Area around Hertford Town FC. This area is located within the Hertford Green Finger and adjacent to the well used Cole Green Way well used by walkers, cyclists and horse riders. The football club itself is bounded by a variety of fencing types including corrugated iron, breeze block and prefabricated horizontal concrete slabs supported by posts. Nearby are miscellaneous stabling and other poor quality buildings together with areas of outdoor storage or material that has either been dumped or fly tipped. The whole is in much need of improvement. Such improvements could take place at several levels, ~~with the minimal being removal of tipped material.~~

Pictures 156-158. Areas adjacent to Cole Green Way in and around Hertford FC where modest action could achieve significant improvements.

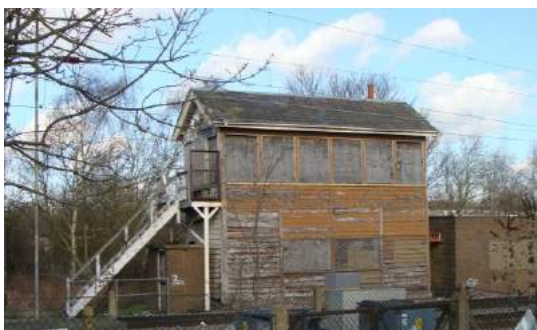
Picture 160. Signal box from late 19th century, lies just beyond the conservation area and is on the Council's Heritage at Risk Register. Could it be suitably moved to an alternative location in the town and provided with an appropriate alternative use?

5.433. Opportunities to secure improvements. Discuss further the potential of improving the visual appearance of garaging at Davies Street. Seek to secure repairs to the signal box located just beyond the conservation area near Railway Street (see picture above).

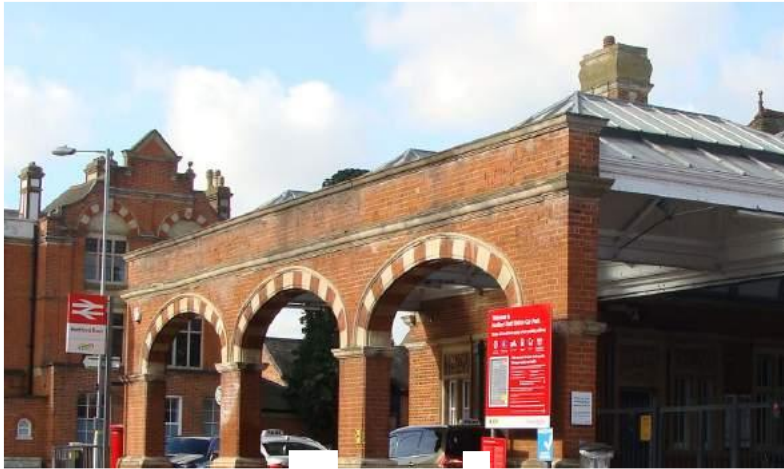
5.375. Hertford East Station - Grade II. Railway station with terminal booking hall, concourse, 1888, with 20th century alterations. Built for the Great Eastern Railway. Architect W. N. Ashbee. Orange-red brick with stone windows, bands, dressings and cornices. Hertford East replaced the earlier Eastern Counties Railway Station further east along Railway Street, but this survived as a goods terminal until 1964.

Picture 161. Hertford East railway station built in 1888, listed grade II.

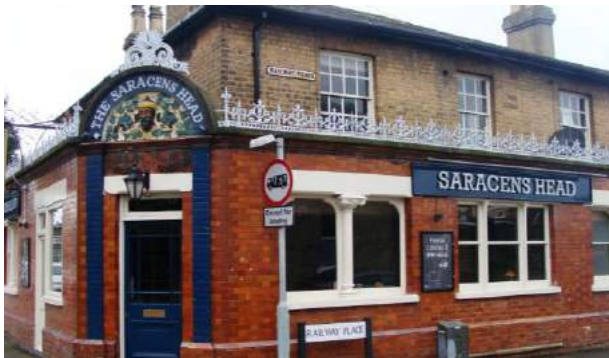
5.376. The Saracen's Head Public House, Ware Road - Grade II. Mid 19th century, extended late 19th century. Yellow stock brick, Flemish bond, ground floor orange-red glazed brick, Flemish bond. Hipped Welsh slated roof. The 'Saracen's Head' was probably built as a house.

Picture 162. The Saracen's Head PH, a colourful listed building adding character to the street scene.

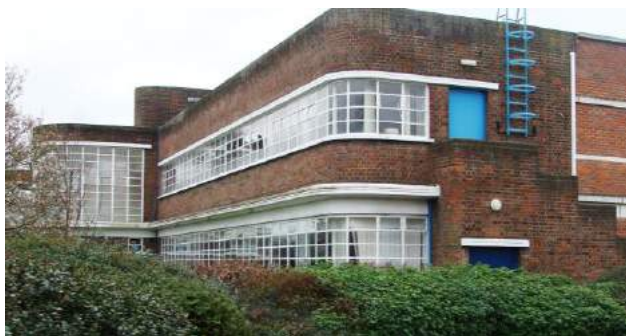
5.377. The former Addis Factory, western range - Grade II. Office range, formerly part of factory (workshops now demolished). 1935 with late 20th century alterations. By Douglas Hamilton for the Addis Company. Red brick with profiled concrete detailing, continuous steel framed glazing and a flat concrete roof. Main body of office building to the west, with curved north-west corner. Full-length expanse of steel framed glazing. An increasingly rare example of a streamlined 'moderne' design of the 1930s, as applied to industrial architecture.

Picture 163. Former Addis factory, an increasingly rare example of modern architecture from the 1930's.

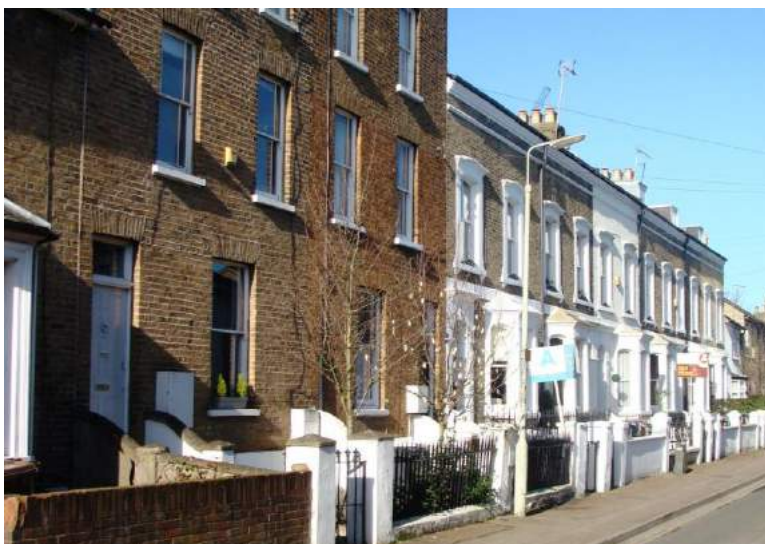
5.384. Nos. 3-37 Villiers Street west side. Very attractive 19th century group with variety of types of yellow brick construction with slate roofs and chimneys with pots. Heights vary including one prominent three storey building. Bay windows. Good canopy, window surrounds and recessed entrance details noted. An Article 4 Direction to provide protection for selected features may be appropriate subject to further consideration and notification.

Picture 164. West side of Villiers Street, an attractive grouping with a wide range of good quality detailing most worthy of retention and preservation.

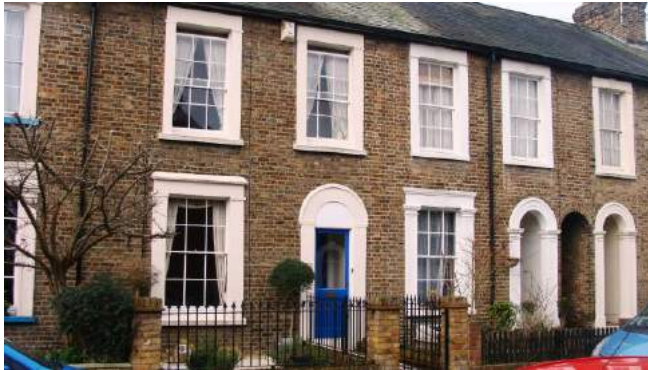
5.395. Nos. 25-39 Currie Street. Dating from the 19th century. Of yellow brick construction. No. 25 has traditional tiled roof, the remainder slate roofs with chimneys and pots. High quality window and recessed door detailing (one

regrettably enclosed). A most attractive grouping most worthy of retention and preservation. An Article 4 Direction to provide protection for selected features may be appropriate subject to further consideration and notification.

Picture 165. Nos. 25-39 Currie Street, an imposing 19th century terrace that makes a significant contribution to the street scene.

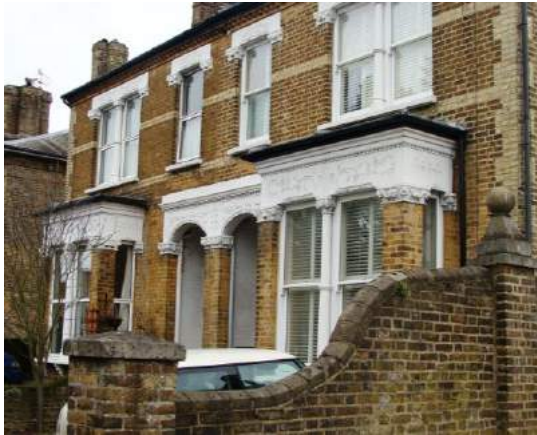
5.401. Nos. 47-63A Ware Road (includes The Old School, set back from road). A 19th century group of yellow brick with slate roofs, prominent chimneys with pots. Some recessed entrances, some bay windows. Also 2 No. walls at right angles to road, height varies under 2m. Nos. 51-53 have highly decorative

detailing. Mix of window types. An Article 4 Direction to provide protection for selected features may be appropriate subject to further consideration and notification.

Picture 167. Decorative detailing to Nos. 51-53 Ware Road. Note boundary wall worthy of retention.

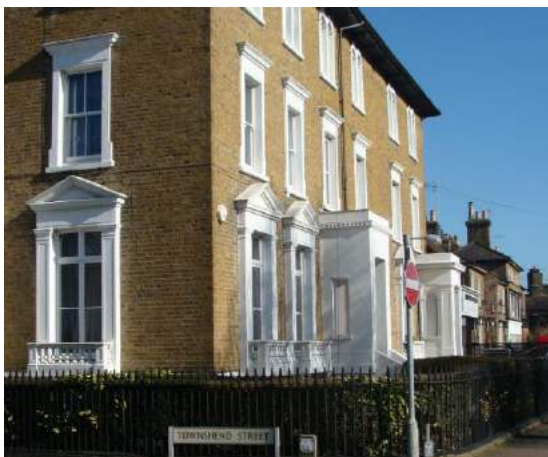
5.403. Nos. 19/19A Ware Road and No. 2 Townshend Street . A tall three storey yellow brick building probably dating from the late 19th century. Slate roof and chimneys. High quality window detailing, imposing entrances and deep eaves detailing. A very fine building which if not flats, should be protected by Article 4 Direction subject to further consideration and notification.

Picture 168. Very fine unspoilt building corner of Ware Road and Townshend Street that makes a most imposing presence in this part of the conservation area.

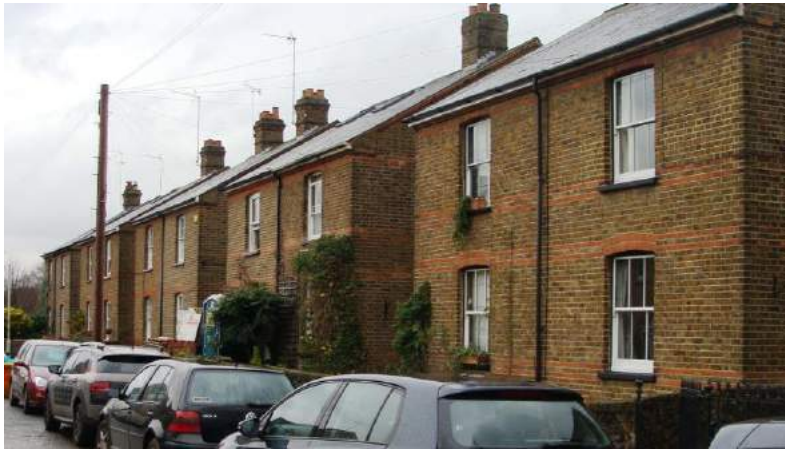
5.410. Nos. 80-102 Tamworth Road. Two storey group probably of early 20th century date of yellow brick construction with red brick banding. Slate roofs and prominent chimneys; unusually entrances are to sides. Mix of window types but many of traditional vertical sliding sash design. An Article 4 Direction to provide protection for selected features may be appropriate subject to further consideration and notification.

Picture 169. Nos. 80-102 Tamworth Road. Simple cottages of pleasing whose entrances are to the sides.

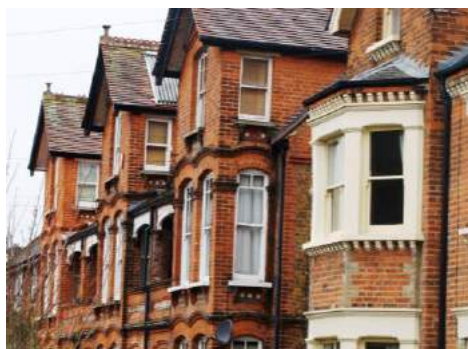
Picture 171. Good quality three storey early 20th century housing, Ware Road, within the eastern end of the extended conservation area.

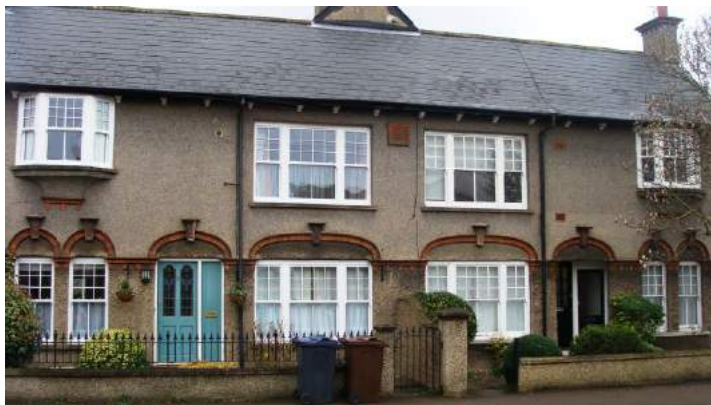
5.414. Nos. 9-11 Fairfax Road. An unusual early 20th century grouping of pebble dash finish with slate roof and chimneys. A decorative range of brick features above window and door range to ground floor, each with keystone feature. Two oriel windows. Date plaque 1914 with initials E.R.K. An Article 4 Direction to provide protection for selected features may be appropriate subject to further consideration and notification.

Picture 172. An unusual and attractive early 20th century group being Nos. 9-11 Fairfax Road.

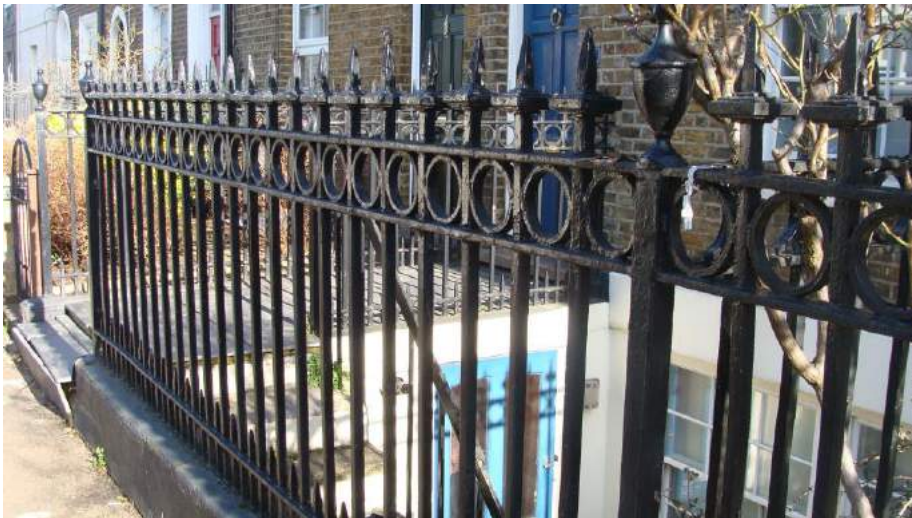
5.417. Historic and later railings to frontages of Nos. 4-16 Villiers Street and frontage and return to No.36. The former define and enclose accommodations below ground whilst the latter are more recent but interpreted as being erected on earlier dwarf wall capped with engineering bricks.

Picture 173. High quality railings to front of Nos. 14 -16 Villiers Street. Note basement accommodation below ground level.

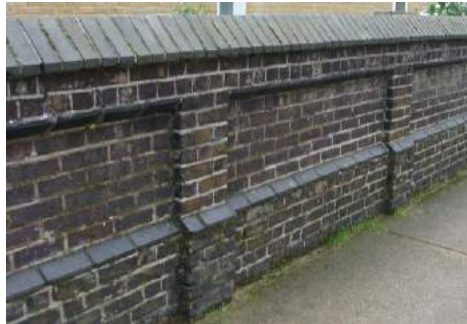
5.422. Dark brick wall with triangular capping detailing - corner Currie Street/ Talbot Street. Properly retained to enclose later development.

Picture 174. Dark brick wall with triangular capping detailing.

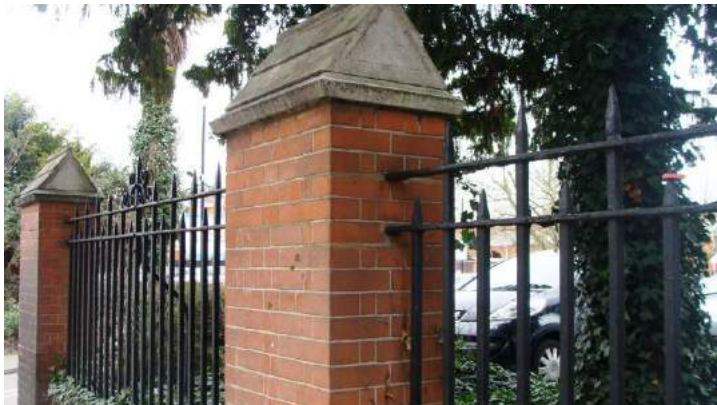
5.423. Wall to Ware Road frontage of Tesco car park. Substantial railings on dwarf brick wall supported by piers surmounted by stone capping detail. Prominent and important in local street scene.

Picture 175. Prominent historic railings are important features surrounding what is now Tesco's car park.

Within proposed extension to Conservation Area.

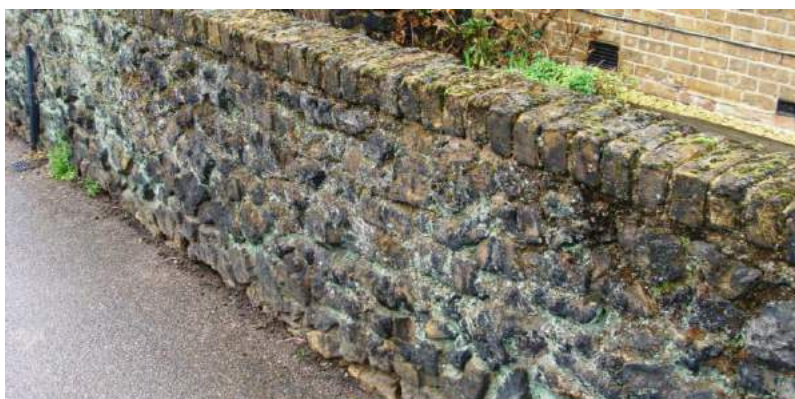
5.424. Wall to frontages of Nos. 84-100 Tamworth Road. Less than 1m and thus unprotected. Of unusual clinker construction. Also boundary walls of similar construction forming boundaries at right angles to road. An Article 4 Direction to provide protection for selected features may be appropriate subject to further consideration and notification.

Picture 176. Unusual clinker wall construction to front of properties on Tamworth Road, worthy of retention and additional protection.
