HERTFORD CONSERVATION AREA APPRAISAL AND MANAGEMENT PLAN

DRAFT FOR CONSULTATION 2016

East Herts. District Council

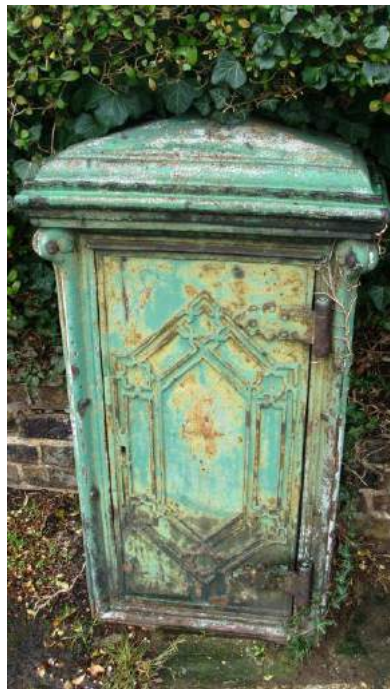
5.425. Metal box, probably that of a utility company corner of Ware Road/ Rowley's Road.

Picture 177. Unusual unidentified item corner of Ware Road/ Rowley's Road, possibly that of a utility company. Does the reader have any information?

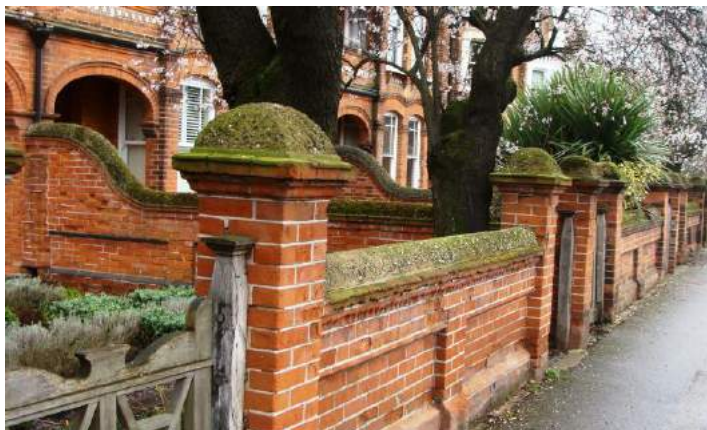
5.426. Good quality boundary walls to front and forming right angle boundary divisions to Nos. 111-115 Ware Road. Worthy of retention and where appropriate an Article 4 Direction subject to further consideration and notification.

Picture 178. Good quality boundary and division walls to Nos. 111-115 Ware Road within the proposed extended conservation area.

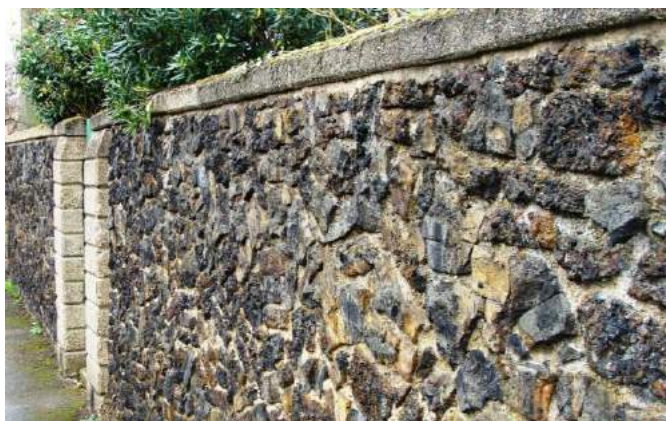
5.427. Wall to No. 135 Ware Road, returning into Fairfax Road. Height varies mostly over 1m but some being unprotected under 1m. Of clinker construction with coarse concrete/ aggregate capping detail.

Picture 179. Unusual clinker wall of historic interest that adds variety to the local street scene and worthy of retention. Wall of similar construction on Tamworth Road.

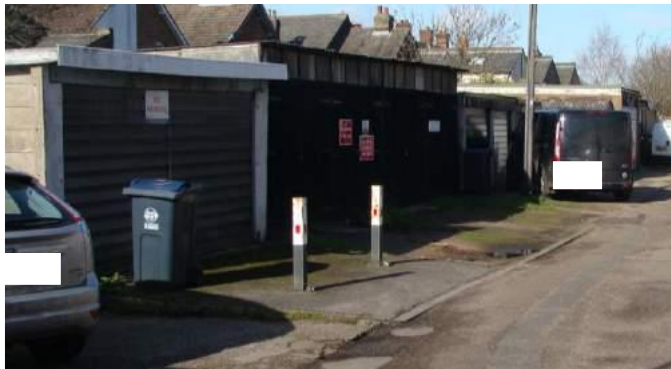
5.432. Elements out of character with the Conservation Area. Garage complex to west side of Davies Street. A combination of this garaging complex and very narrow street with parked vehicles degrade this part of the conservation area. Even if only limited visual improvements could be made this would represent a worthwhile achievement.

Picture 180. Garaging Davies Street. Is there any interest in negotiating some improvements here?

5.433. Opportunities to secure improvements. Discuss further the potential of improving the visual appearance of garaging at Davies Street. Seek to secure repairs to the signal box located just beyond the conservation area near Railway Street (see picture above).

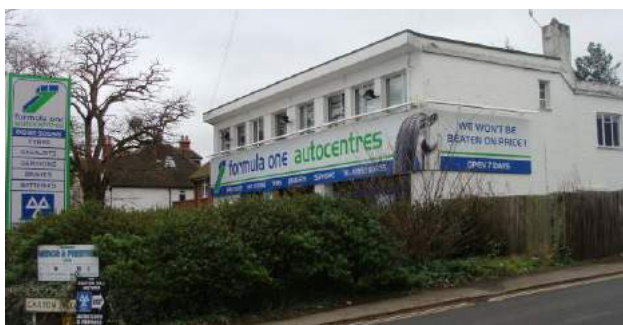
5.434. Formula 1 Autocentres, Ware Road. This large flat roof building does little to improve the street scene where the potential of appropriate redevelopment might be an option to consider as a catalyst for achieving improvements.

Picture 181. The potential of appropriate redevelopment of this site might be worthy of consideration to improve this part of the conservation area.

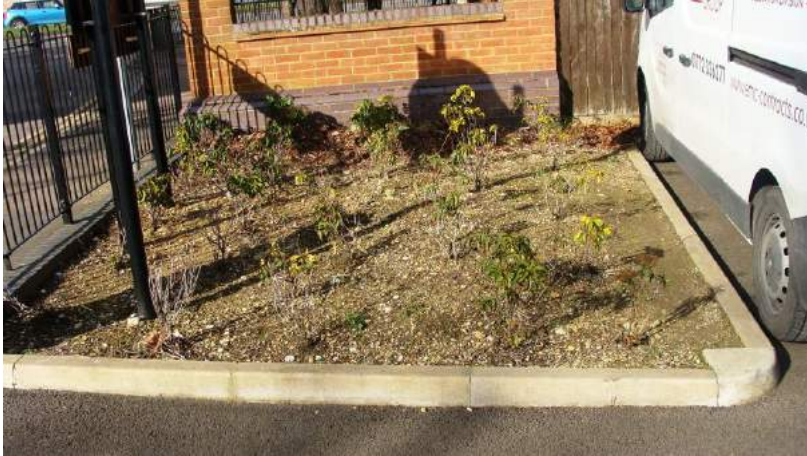
Picture 182. One of several potential areas within the car park where tree planting could provide additional height and replace low shrubs whose visually contribution is limited.

5.435. Although proposed for exclusion from the conservation area it is suggested additional landscaping could benefit the EHDC car park corner of Ware Road and London Road. Trees of appropriate species to provide height and additional screening could make improvements in the longer term.

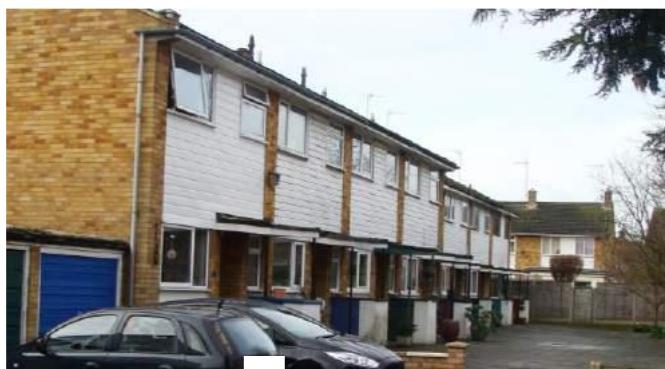
(b) Exclude Nos. 1-8 Albion Close and adjoining garage block north west corner of Currie Street and properties Nos. 16-24 Railway Place. These properties date from the 20th century and have little architectural and historic qualities.

Picture 183. Mid/late 20th century properties proposed for exclusion from the conservation area.

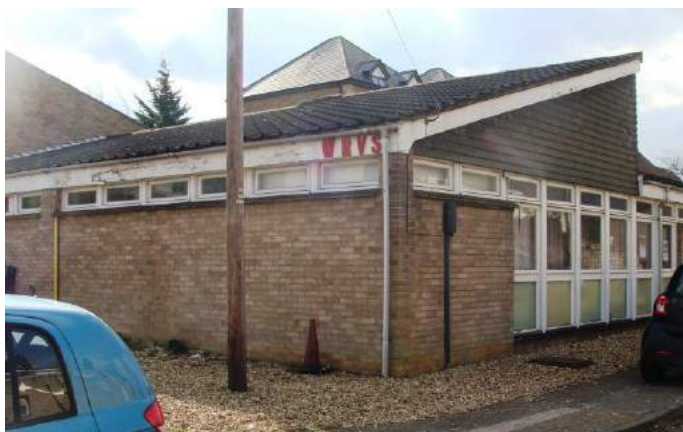
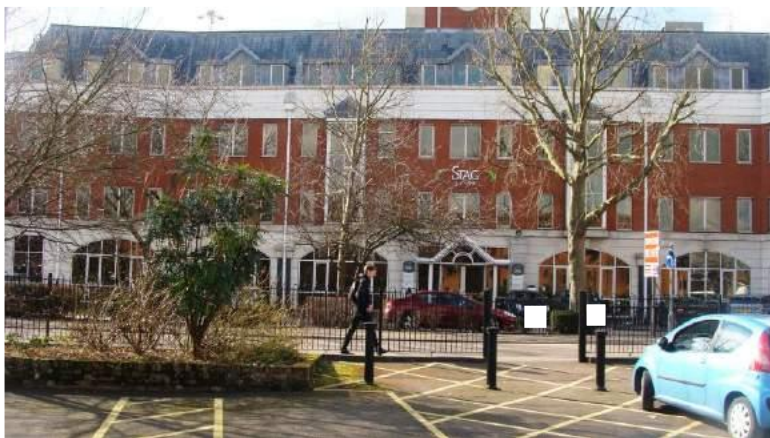
(d) Exclude area corner of Ware Road and London Road which includes Yeomans Court, The Rotunda, Stag House, WVRS building and EHDC car park. This area occupies a strategic entrance to the town and is occupied by a number of modern buildings in commercial and other uses. Their qualities, styles and heights vary but none can lay claim to be of architectural or historic interest. For the most part the buildings are large scale and tall. The later ones are better designed. Centrally located is an EHDC car park, the landscaping of which could be improved (see above).

~~Pictures 184~~Pictures 184-185. The WVRS building and Stag House part of the complex proposed for exclusion from the conservation area.
