COTTERED CONSERVATION AREA APPRAISAL AND MANAGEMENT PLAN

DRAFT FOR CONSULTATION 2017

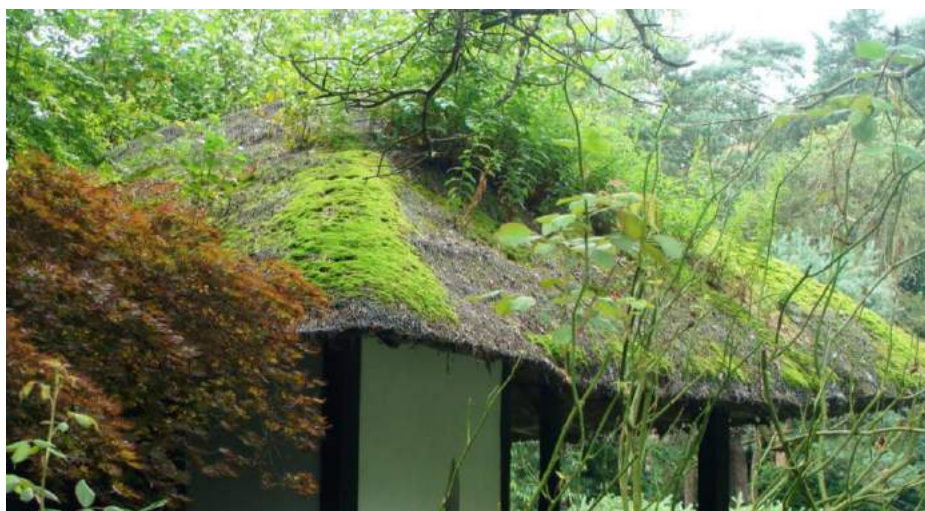
5.10. Resting House in Japanese Garden at Garden House - Grade II. 1923-6. Personally constructed by garden designer S. Kusumoto for Herbert Goode (1865-1937) a wealthy glass and china merchant who began the Japanese Garden in 1905. Timber frame with hipped thatched roof. A single-storey open-sided shelter facing north, with low screens to front and side and traditional roof-structure of interwoven beams built up in stages, called AZIRO-GUMI. Floor made to represent the back of a tortoise signifying good luck.

Picture 2. A listed structure in the Japanese Garden with deteriorating thatched roof; a candidate for the Council's Heritage at Risk Register subject to further investigation. This building was observed and photographed from adjoining Cheynes House.

5.67. Opportunities to secure improvements. Seek further information relating to listed thatched building in Japanese Garden (illustrated previously) and discuss potential of improvements with owner. Secure improvements to cricket pavilion and associated facilities. Secure improvements to parish notice board. Re-erect No entry sign at north end of Warren Lane. **Seek removal of dumped material in field north of footpath 007.** Undertake selective repair works and removal of vegetation to church boundary wall. Consider improvements within the churchyard including a new avenue of trees of traditional churchyard species on the main approach path. Consider improving appearance of pond area to east of Childs Farm. Discuss with owner potential for improving thatched roof to ancillary building to Old Forge, Baldock Road. Consider improvements and rationalisation of signage on triangular green to east of The Old Off License.

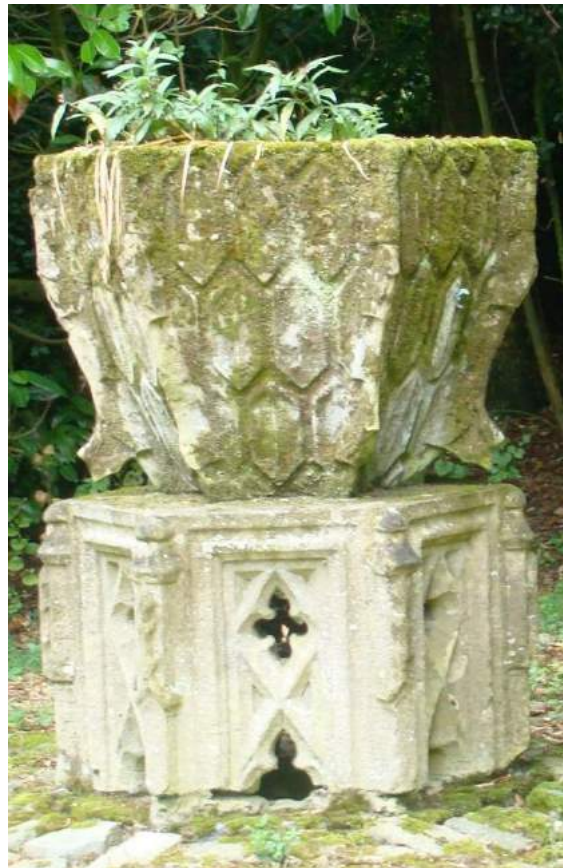
5.12. Architectural fragments in Italian Garden - fragments now in the grounds of Cheynes House. Mid 19th century said to be from Barry's Palace of Westminster, brought here after being displaced in a Fenian outrage of 1932. Carved freestone. A large octagonal drum with each face panelled with Gothic arches. Reversed on top of this stone is a large pointed octagonal capstone with chevron grooving on each face.

Picture 3. Octagonal Drum architectural fragment - Garden fragments now in the grounds of Cheynes House and said to be from Barry's Palace of Westminster- listed grade II.

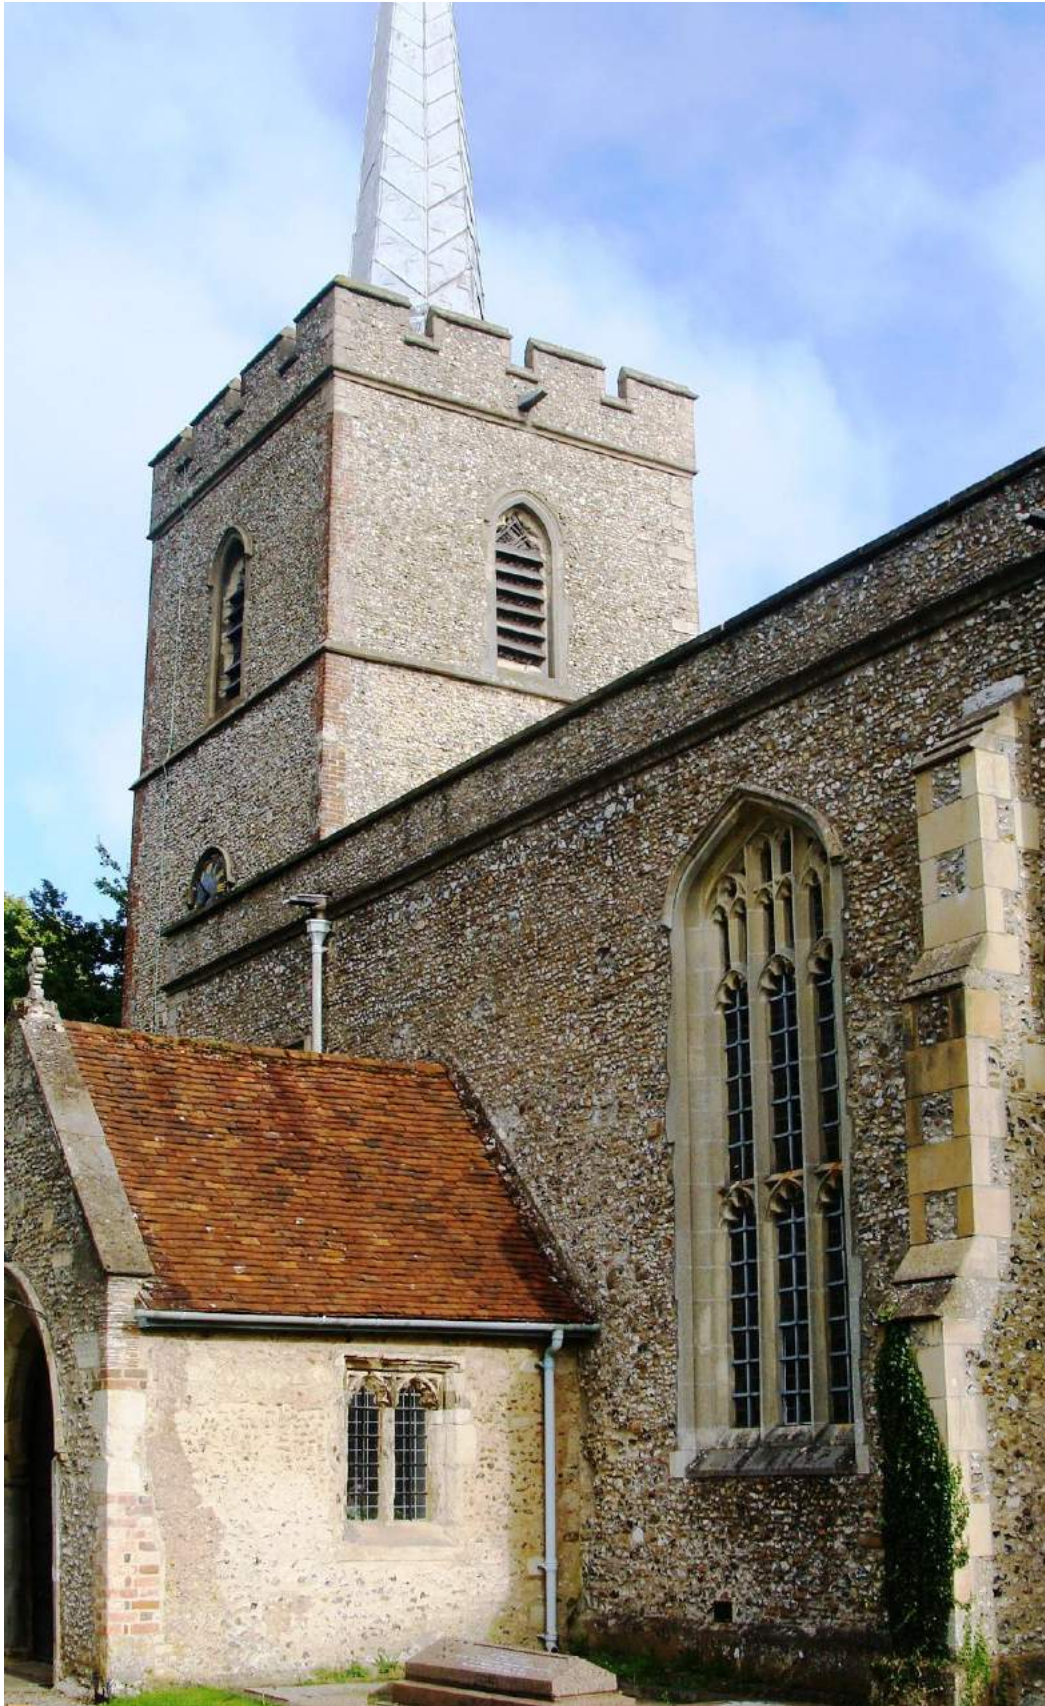
5.13. Parish church of St John the Baptist Grade II*. Mid 14th century, possibly incorporating earlier fabric, with 15th, 16th and 18th century alterations and additions, restored and re-seated in 1886. The Lady Chapel was restored in 1954. Rubble walling with flint facings and clunch dressings. West tower with

spire, nave with south porch, chancel with Lady Chapel and vestry along the north side of the chancel. The tower is of three stages without buttresses, with an embattled parapet and a slender octagonal spire. The nave has a six-bay, 15th century arch-braced king-post roof of low pitch. On the north wall of the nave is a large 15th century polychrome mural of St. Christopher in a landscape of roads and villages. On the north wall is a rococo marble cartouche to Martha Forester of 1755, and a Neo-Classical monument to the Reverend Anthony Trollope, grandfather of the novelist. The church is almost wholly of medieval fabric of high quality, illustrative of the best medieval constructional techniques, masonry and carpentry skills. Many medieval features survive.

Picture 4. The church is almost wholly of medieval fabric of high quality, illustrative of the best medieval constructional techniques, masonry and carpentry skills.

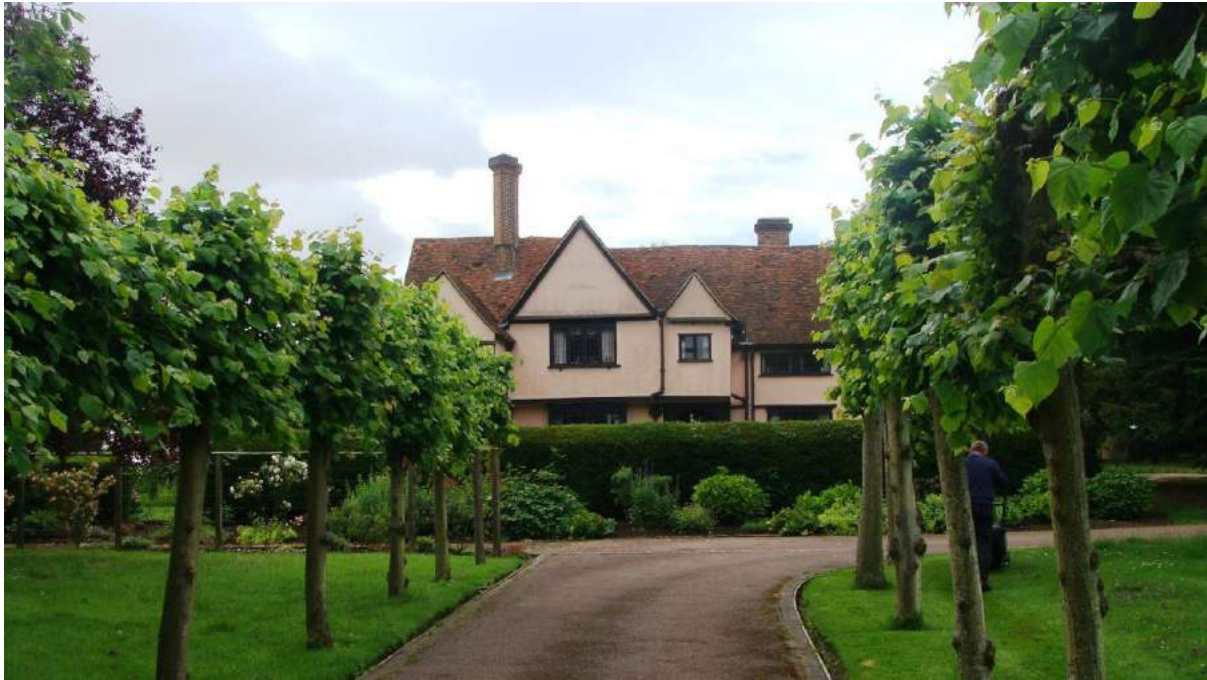
5.14. The Lordship - Grade I. Early-mid 15th century (probably for John Fray who held the manor 1428-1461, altered in early 17th century (possibly by Edward Pulton between 1600 and 1608). Timber frame on low red brick sill, roughcast with steep old red tile roofs. Hall finally floored over and large external south chimney built in late 18th century. Other special features include pilastered 17th century fire surround and fine octagonal crown posts. A fine mid 15th century manor house with original structure and early 17th century wall paintings.

Picture 5. The Lordship is listed grade I and is a fine 15th century manor house.

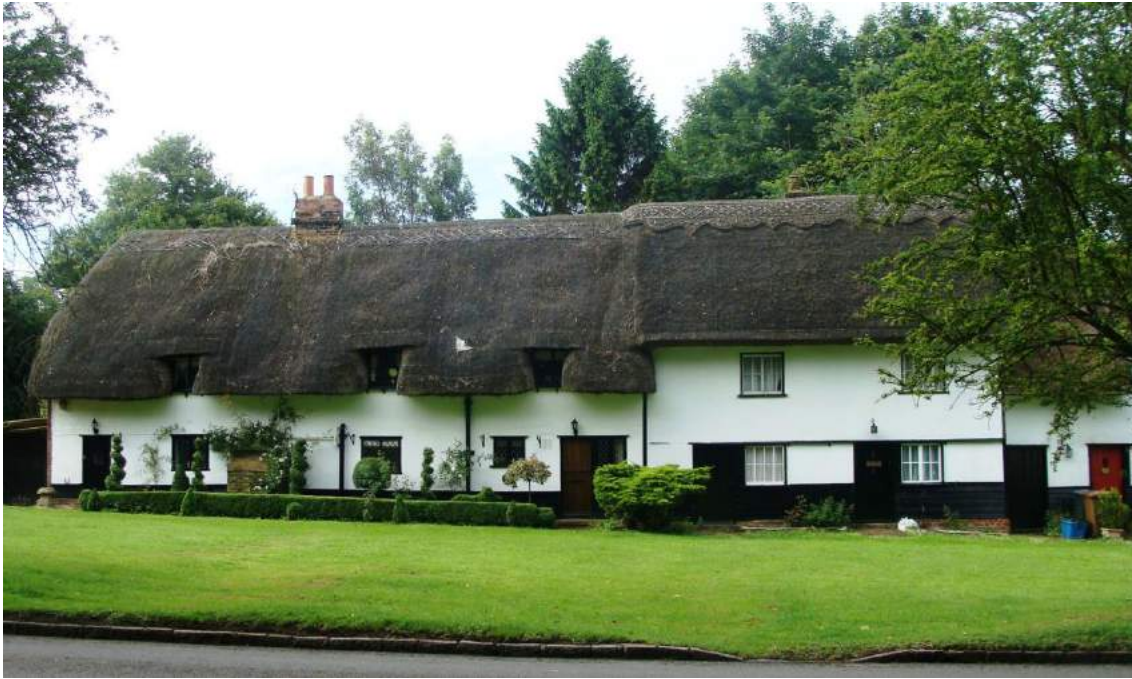
5.15. Home Close Cottages Baldock Road - Grade II. A range of houses, 17th century or earlier, altered in 18th and 19th centuries. Timber frames on brick sills, roughcast with dark weatherboarded aprons. Steep thatched roofs. Eyebrow dormers. A most picturesque thatched group.

Picture 6. Home Close Cottages, picturesque with steeply sloping thatched roof and eyebrow dormers.

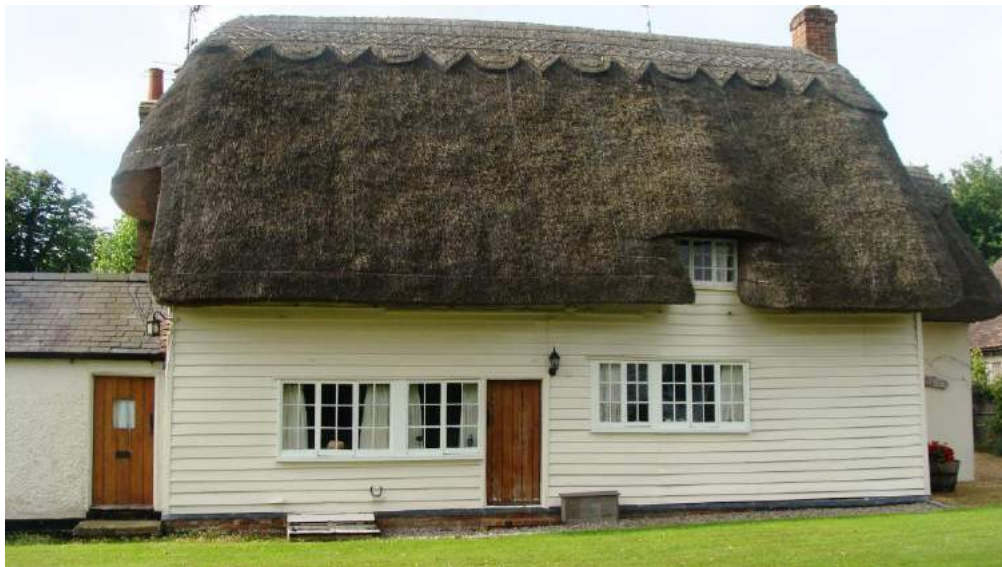
5.17. The Bell *former* P.H- Grade II. Early 18th century or earlier, low 19th century east extension. Timber frame weatherboarded with a steep thatched roof. Once a wheelwright's house and The Chequers Public House.

Picture 7. The former Bell PH. One of a number of important listed thatched properties in Cottered.

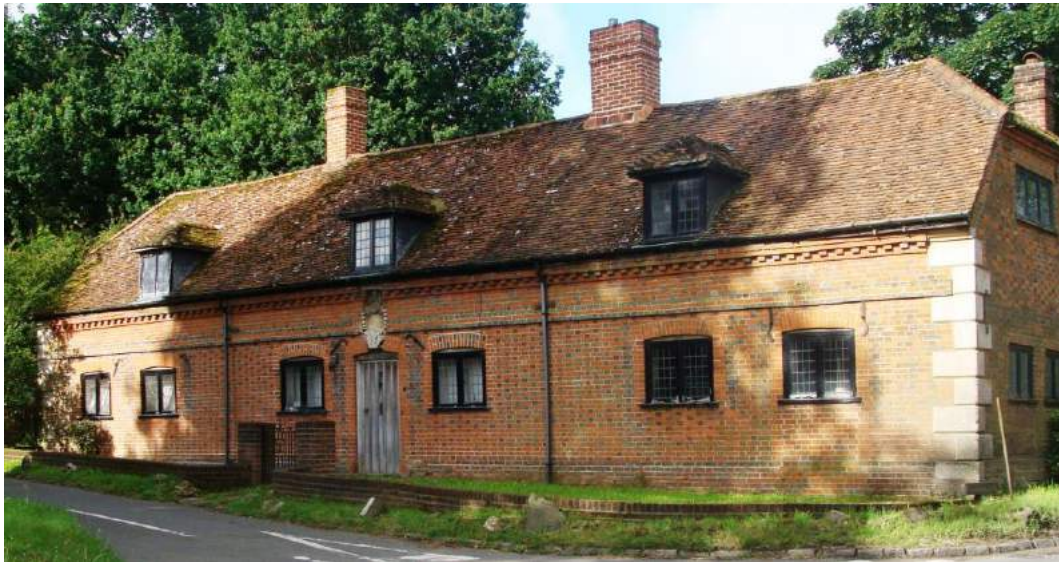
5.18. The Town House - Grade II. Block of 3 almshouses, now one house. '1767' cut in brick beside central cartouche. For Rev. Angel Chauncy who left £200 to build a house for the poor to replace properties in the churchyard. Red brick 'with black headers, fine red brick dressings and dentilled eaves cornice, rusticated stone quoins and central cartouche, and steep old red tile roof. 3 hipped dormers, similar at rear. 2 central red brick chimneys.

Picture 8. The Town House- picturesque group of former almshouses.

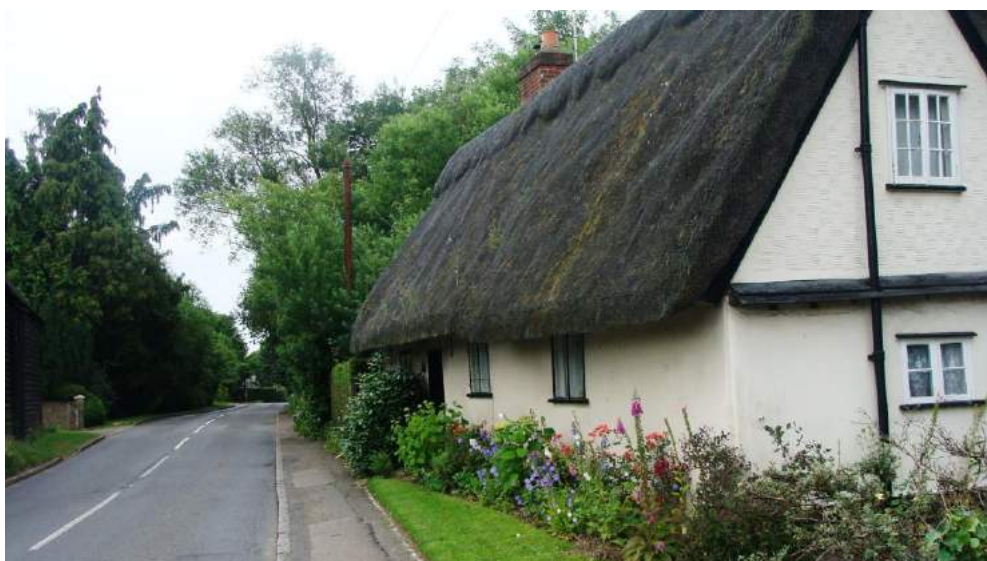
5.19. Paddocks Wells, Baldock road - Grade II. Rebuilt on new site 1691 as part of Page's Charity. Timber frame roughcast with basketwork pargetting at ends, under a steep thatched roof. A long one and a half storeys house facing north with a rear outshut under a catslide roof.

Picture 9. Paddocks Wells - another thatched property of quality which adds to the high visual environmental quality of Baldock Road.

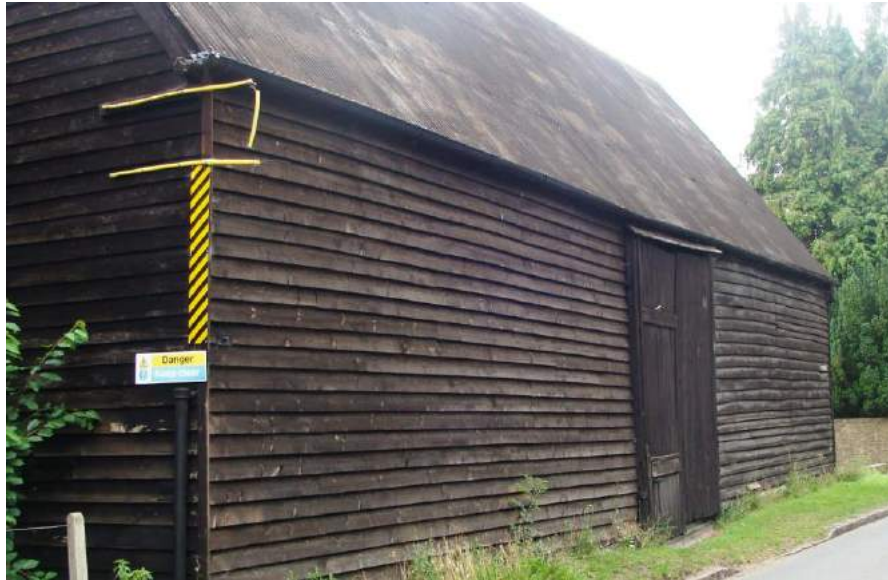
5.20. Barn at Childs Farm - Grade II. Early 17th century. Timber frame on low tarred brick sill, black weatherboarded with a steep pitched roof now covered in black corrugated iron. A tall 5 bay barn facing north alongside road with double doors on each side in middle bay. Prominent feature at entrance to village conservation area.

Picture 10. Prominent listed barn north side of Baldock Road. In all probability the roof would at one time have been thatched. A prominent feature at the entrance to the village and conservation area.

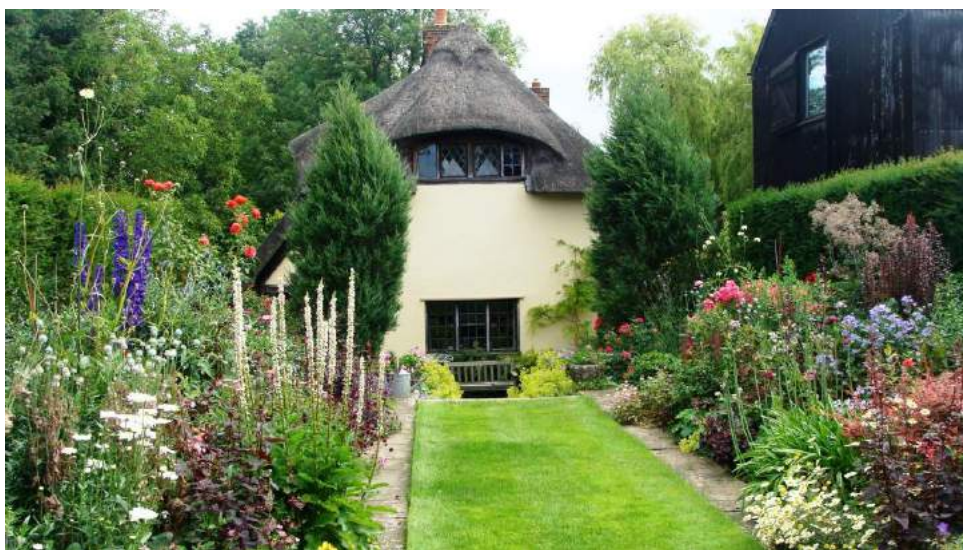
5. 21. Lower Farm Grade II. 16th century, restored, extended to east and porch added in 1930s. Timber frame on red brick sill, roughcast with steep thatched hipped roof. Large red brick panelled front-wall chimney. *The owner advised that the associated gardens were designed by Gavin Jones (associated with garden design works at Chartwell House in the mid 20th century).*

Picture 11. Lower farm viewed from herbaceous garden area.

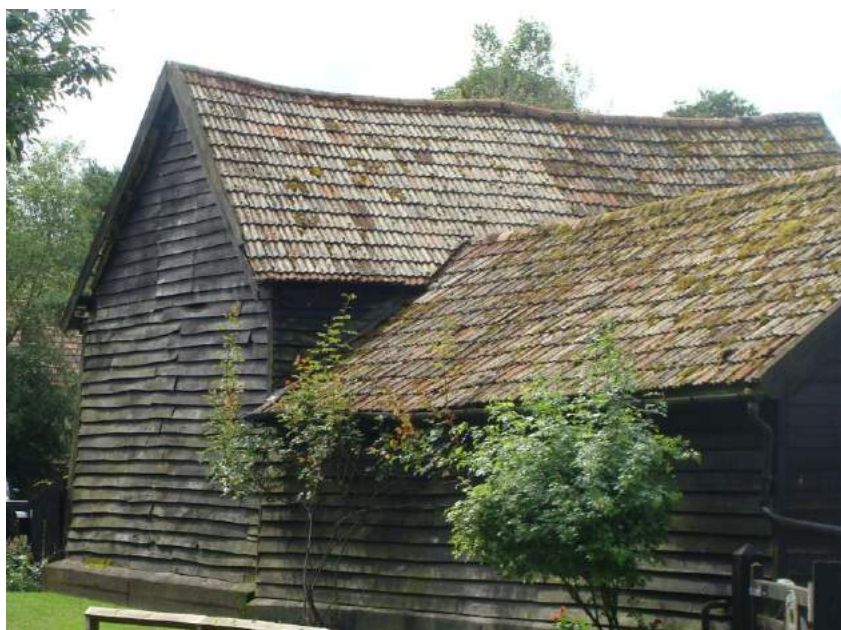
5.25. Ancillary building at Cheynes Farm, Warren Lane. The larger building at the southern end of the site is included on the Council's Heritage at Risk Register. As mentioned previously in the document grant assistance may be available for appropriate repair works. Further investigation needed including discussions with the owner.

Picture 12. Barn at Cheynes Farm that is included on the Council's Heritage at Risk Register. Further investigation needed including discussions with the owner.

5.71. Other Actions. Contact owner of Cheynes Farm and investigate further the condition of the ancillary barn currently included on the Council's Heritage at Risk Register.

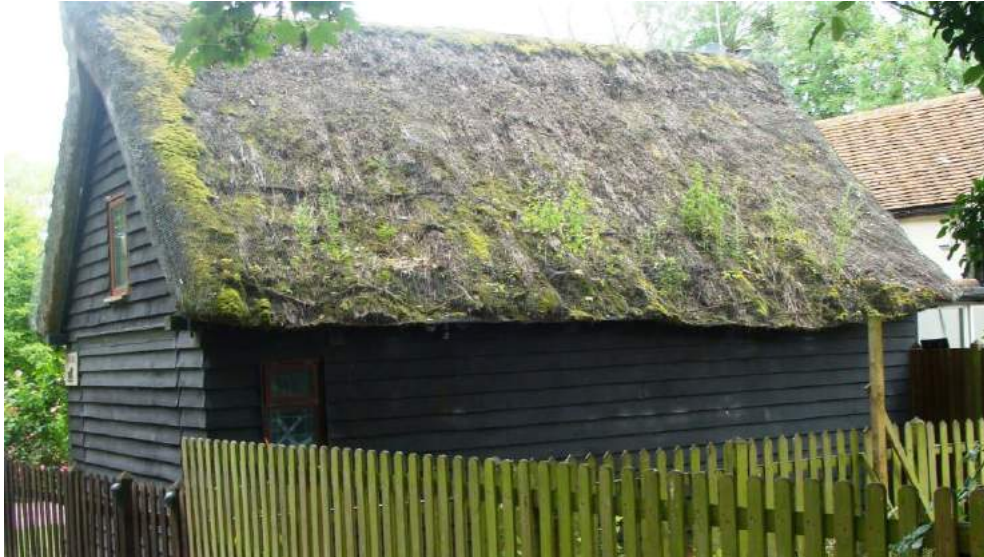
5. 26. Ancillary building to the Old Forge, north side Baldock Road. This building does not appear as part of the listed description and is important in the street scene. Its thatch roof needs attention.

Picture 13. Ancillary building to the Old Forge whose thatched roof needs attention.

Discuss potential of roof repairs to ancillary building, The Old Forge. Without prejudice grant assistance may be available.

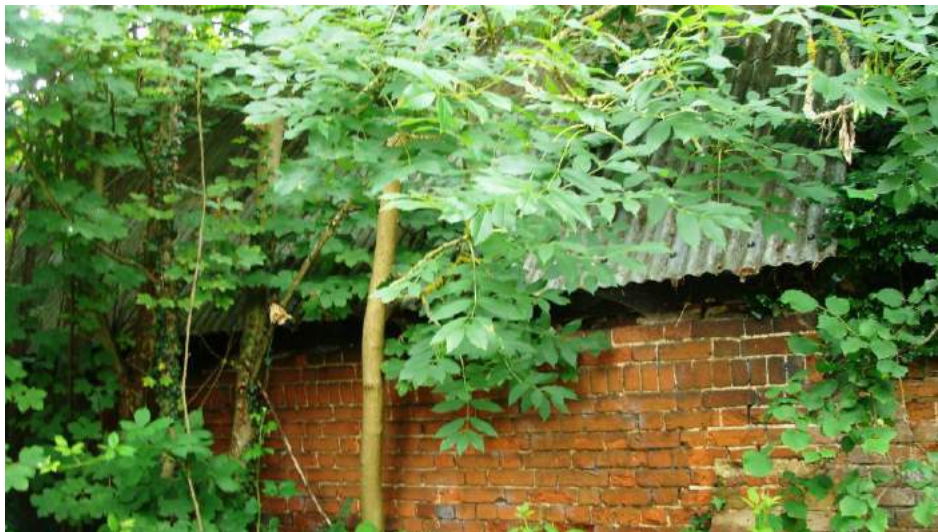
5.27. Ancillary building to the Bull PH. Of brick construction with corrugated iron roof.

Picture 14. Ancillary building to Bull PH. Its corrugated roof may once have been thatched.

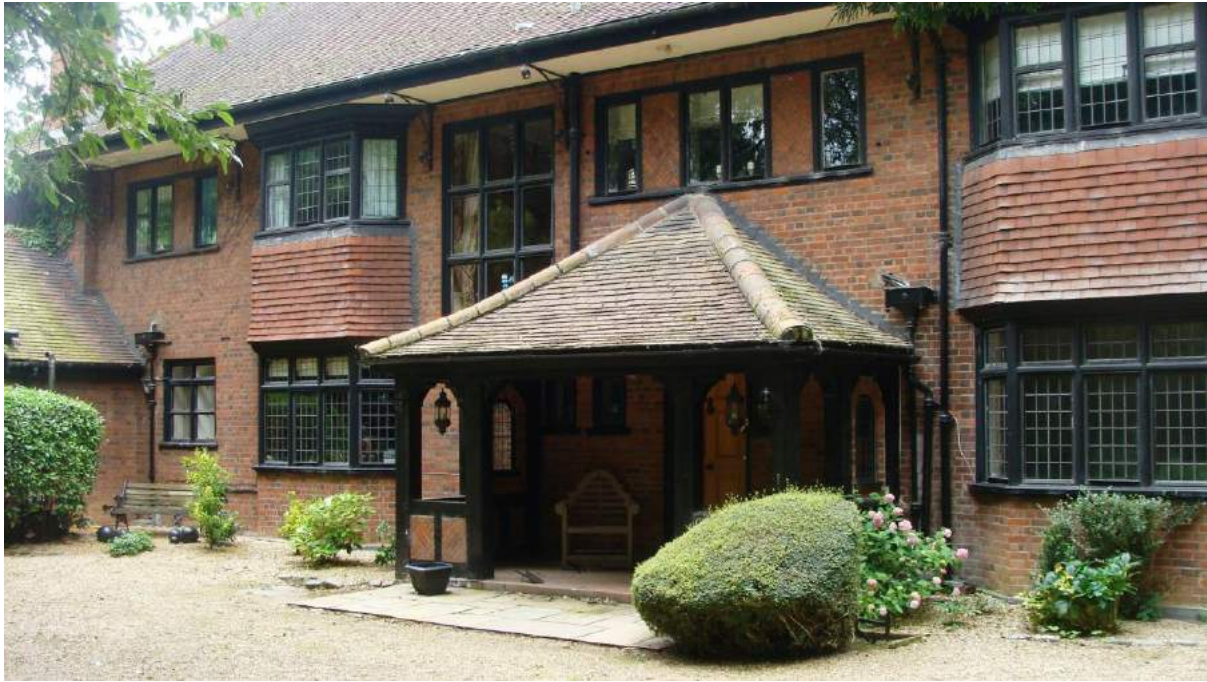
5.29. Cheynes House. Large detached property in an 'Arts and Crafts style' probably dating from the early/mid 1900's. Of red brick construction with tiled

roof and chimneys. Deep eaves and bay windows to both floors with vertically hung tile detailing. Fine small pane window detailing. The entry associated with Historic England's description of the grade II* Registered Park within which the building is situated reads thus *The two-storey brick house was built by Herbert Goode during his second major period of development of the Japanese Garden.* An excellent example of its period most worthy of retention. An Article 4 Direction to provide protection for selected features may be appropriate subject to further consideration and notification.

Picture 15. Cheynes House - a fine early/mid 20th century residence of quality with many features worthy of retention and additional protection.

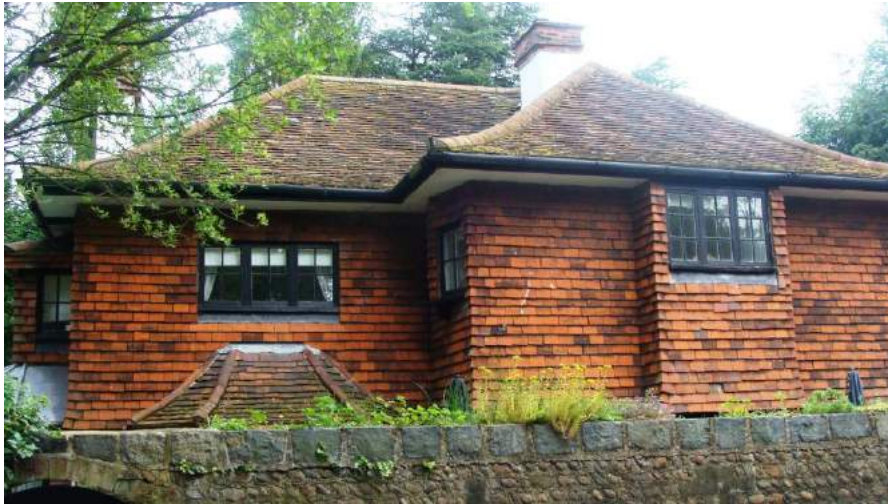
5.30. Cheynes Lodge. Two storey with tiled roof and chimneys probably dating from the late 19th century. Extensive vertically hung tile detailing. Bay window to ground floor. Small pane window detailing. An Article 4 Direction to provide protection for selected features may be appropriate subject to further consideration and notification.

Picture 16. Cheynes Lodge an interesting building the location of which appears on mapping dating from the late 19th century ~~mapping~~.

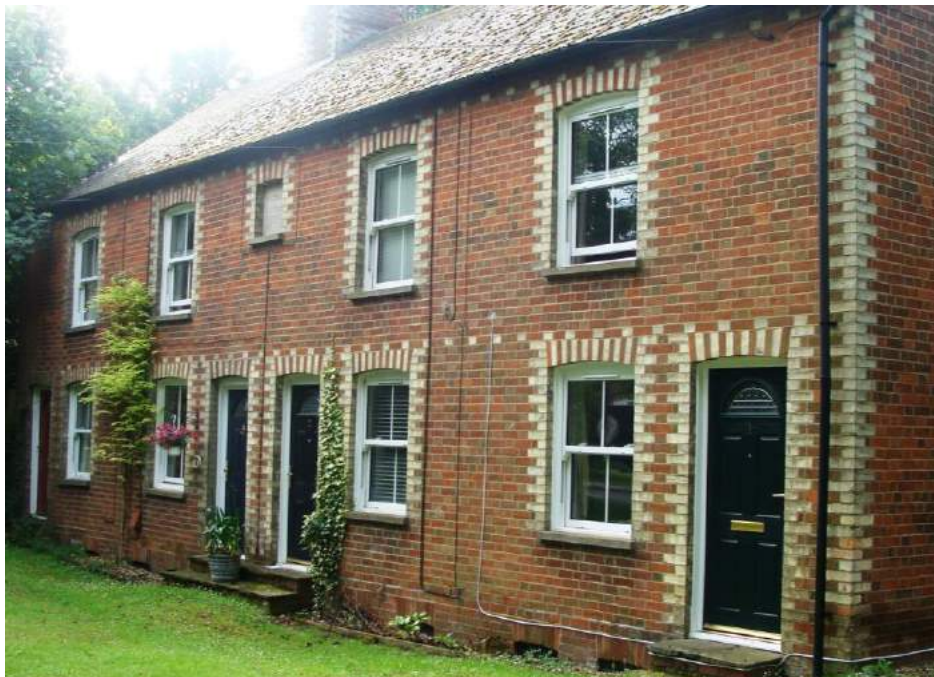
5.31. Victoria Cottages (Nos. 1-4) - Baldock Road. Of red brick construction with contrasting yellow brick quoin and door and window surround detailing. Slate roof; 2 No. chimneys and central plaque interpreted as reading 1887. An Article 4 Direction to provide protection for selected features may be appropriate subject to further consideration and notification.

Picture 17. Nos. 1-4 Victoria Cottages - a prominent and pleasing terrace dating from the late 19th century in the centre of the conservation area and largely unspoilt.

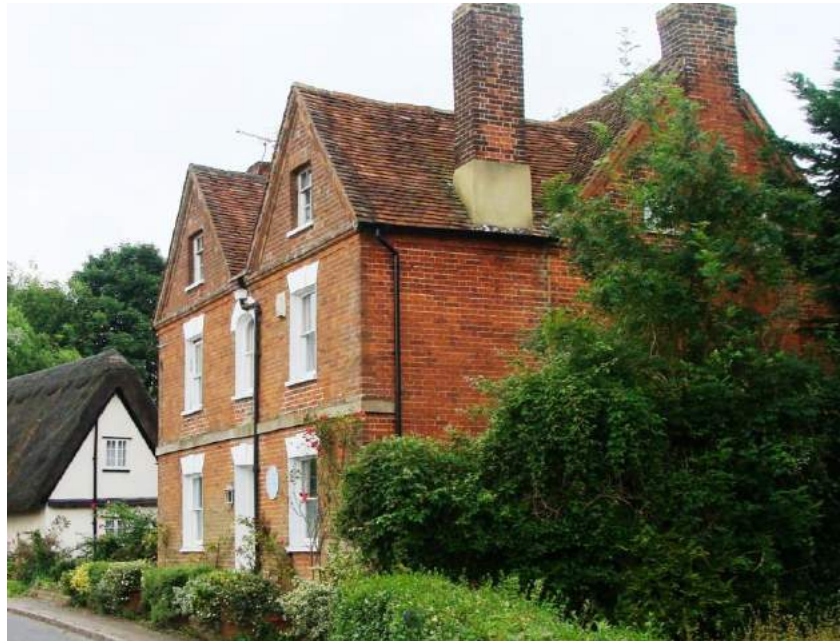
5.32. The Kennels. Tall distinctive red brick red brick building with tiled roof and prominent chimneys. Probably of 19th century date. Central doorway and early/sympathetically designed vertical sliding sash windows. A striking and important building in the street scene. A plaque advises this property was

frequently visited by SUN YAT SEN (between 1896-1911) who is credited with being 'father of modern China'. An Article 4 Direction to provide protection for selected features may be appropriate subject to further consideration and notification.

Picture 18. The Kennels a tall prominent building in the street scene that makes a significant architectural and historical contribution and one most worthy of retention and additional protection.

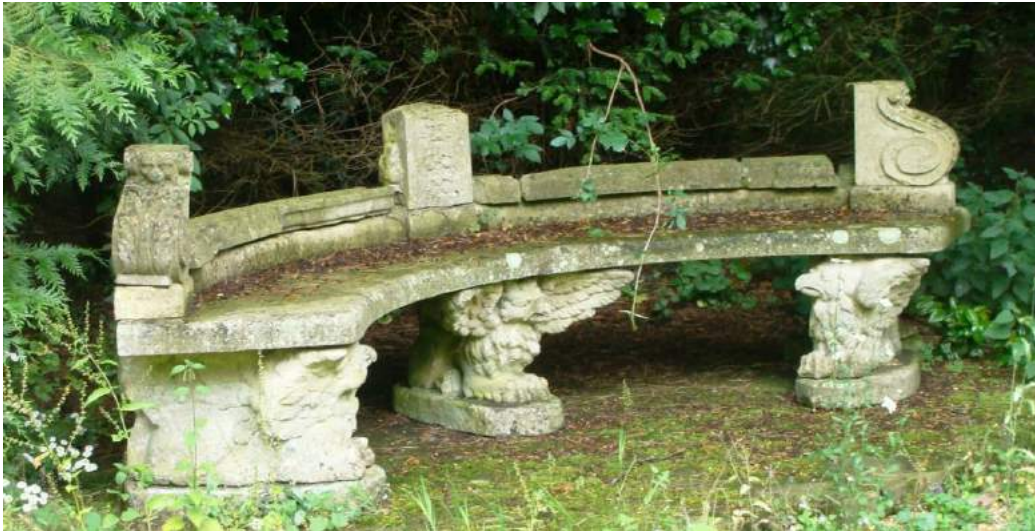
5.38. Classical designed stone seat, probably dating from the 19th century or earlier, in the grounds of Cheynes House.

Picture 19. Classical designed stone seat, probably dating from the 19th century or earlier, in the grounds of Cheynes House.

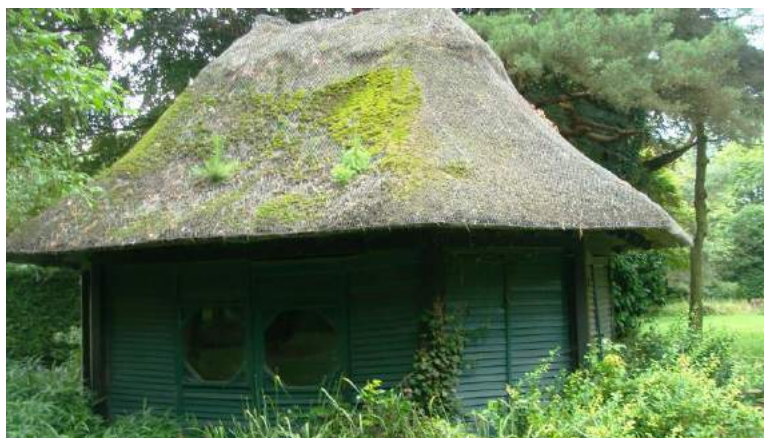
5.39. Small summer house in grounds of Cheynes House. Prominent feature of quality. Not examined but possibly dating from early 20th century and contemporary with planting carried out at that time.

Picture 20. Interesting summer house unlisted in grounds of Cheynes House possibly dating from the early 20th century.

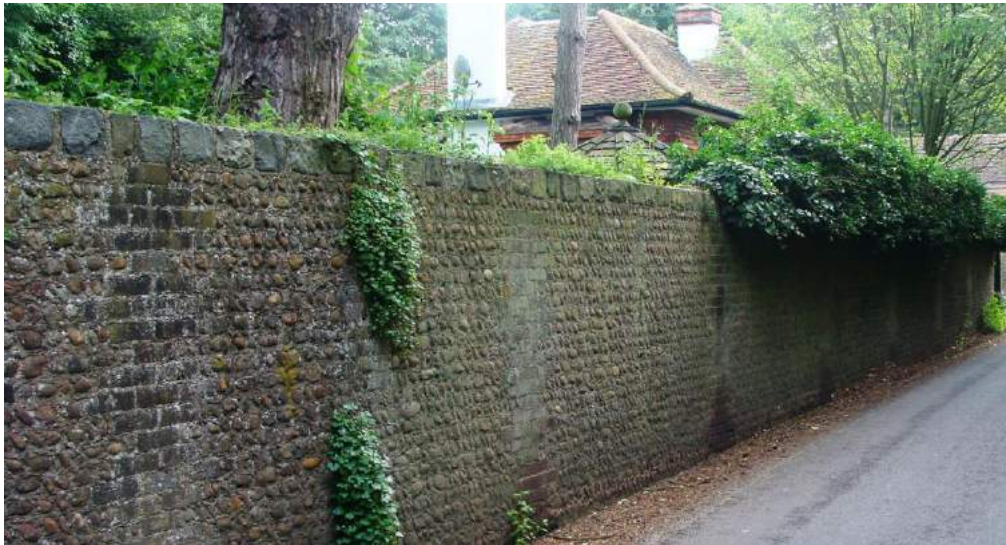
5.40. Wall to front of Cheynes Lodge. Approx 2m in height constructed of brick with rounded pebble detailing and stone capping. An unusual and prominent feature in the street scene. Selected removal of vegetation would be beneficial.

Picture 21. Prominent and unusual wall to front of Cheynes Lodge.

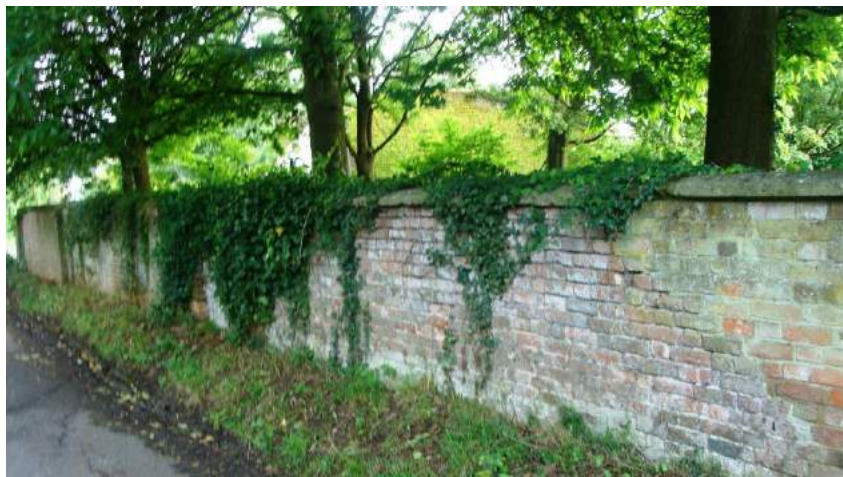
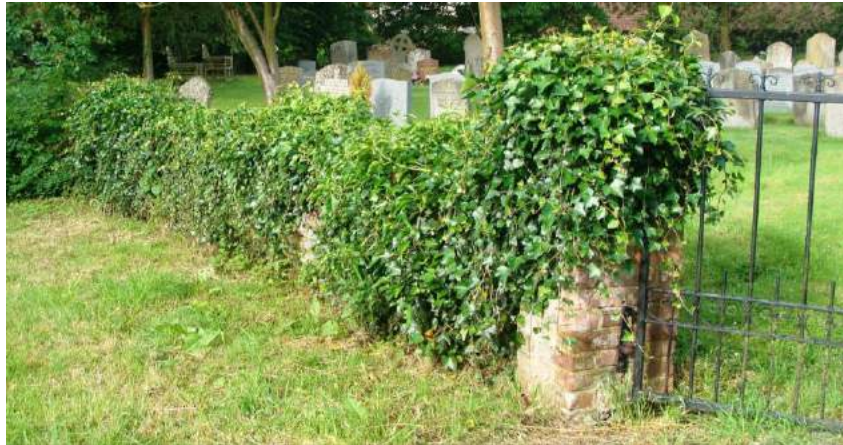
5.41. Boundary wall to church. A wall of varying characteristics, condition and heights. It is in need of selective repairs and would benefit from removal of extensive ivy growth in some locations.

Pictures 22-23. The varied characteristics of the boundary wall to the church. Some repair work needed associated with selective removal of ivy.

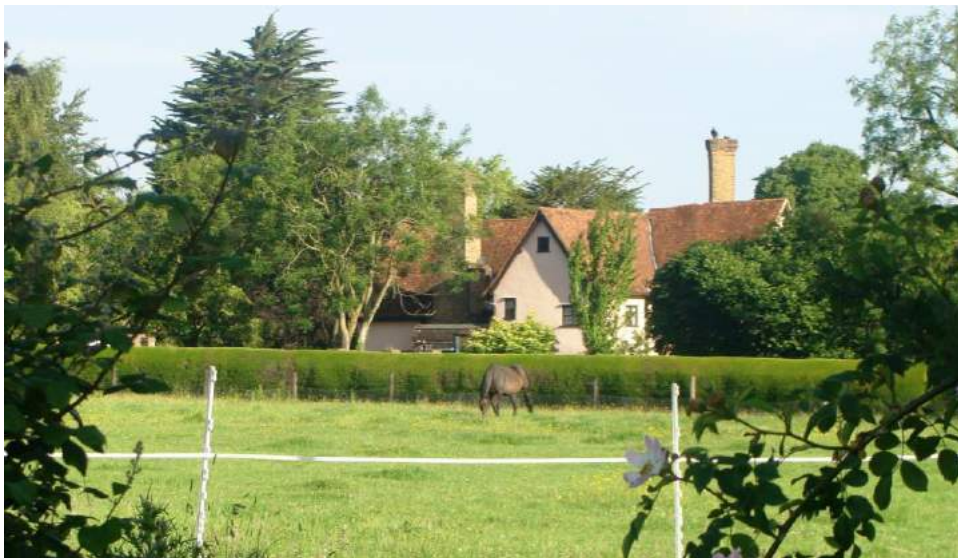
5.45. Similarly other small scale areas of paddock nearby provide a setting for important listed buildings as illustrated below.

Picture 27. Paddock land which provides a setting for the grade I listed building The Lordship as viewed from the adjacent public footpath.

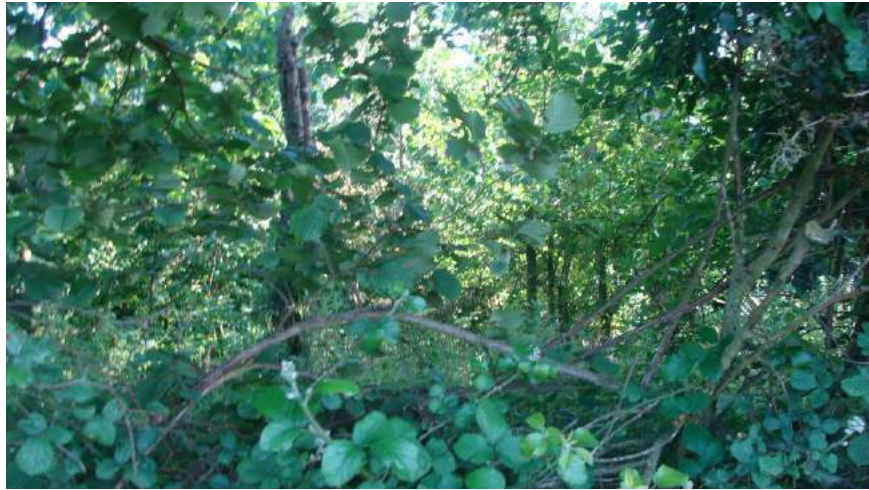
Picture 28. The now totally overgrown Friends burial ground. Is there any opportunity to make improvements and undertake research? Is there any local knowledge as to burials and grave markers that may be present?

signage.	License.	achieving some rationalisation.
Other actions		
Friends burial ground, research history, explore opportunities for making site accessible and initiating improvements dependant on what is discovered there.		
Seek further information regarding condition of listed thatched building in Japanese Garden and if necessary include on Council's Heritage at Risk Register. Without prejudice grant assistance may be available.		
Contact owner of Cheynes Farm and investigate further the condition of the ancillary barn currently included on the Council's Heritage at Risk Register. Without prejudice grant assistance may be available.		
Discuss potential of undertaking repair works to church boundary wall and selective removal of vegetation. Without prejudice grant assistance may be available.		
Discuss potential of visually improving access to church, possibly by the provision of an avenue of traditional churchyard trees (such as Irish Yew).

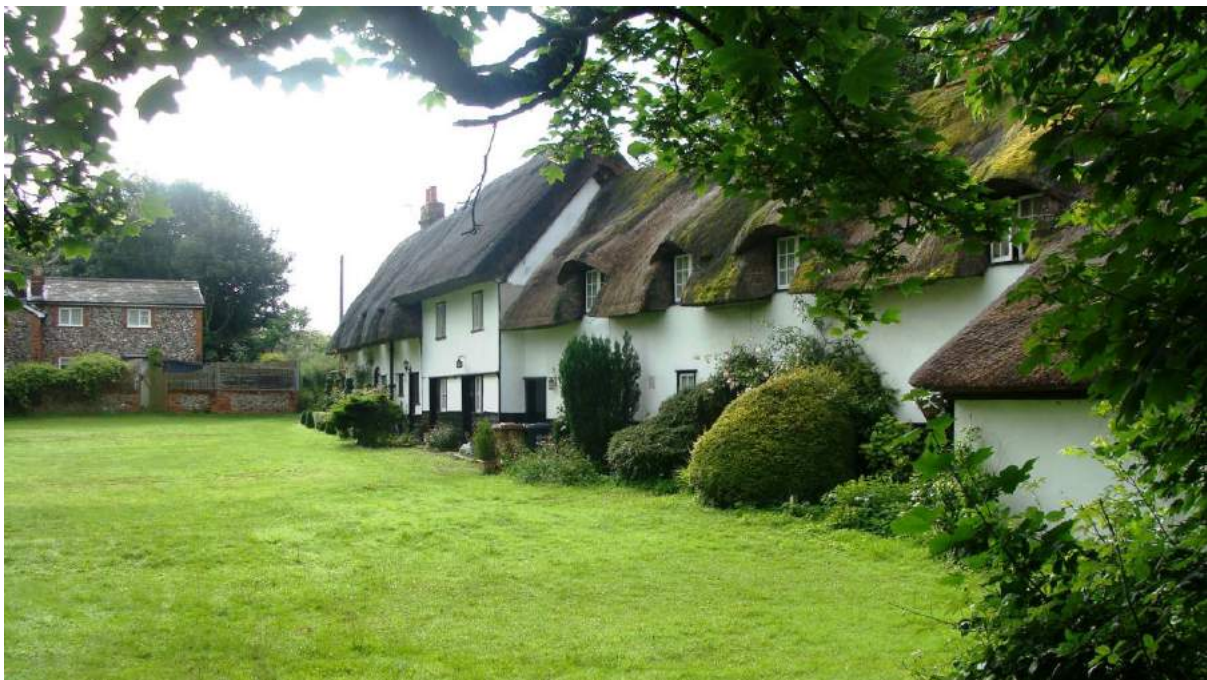
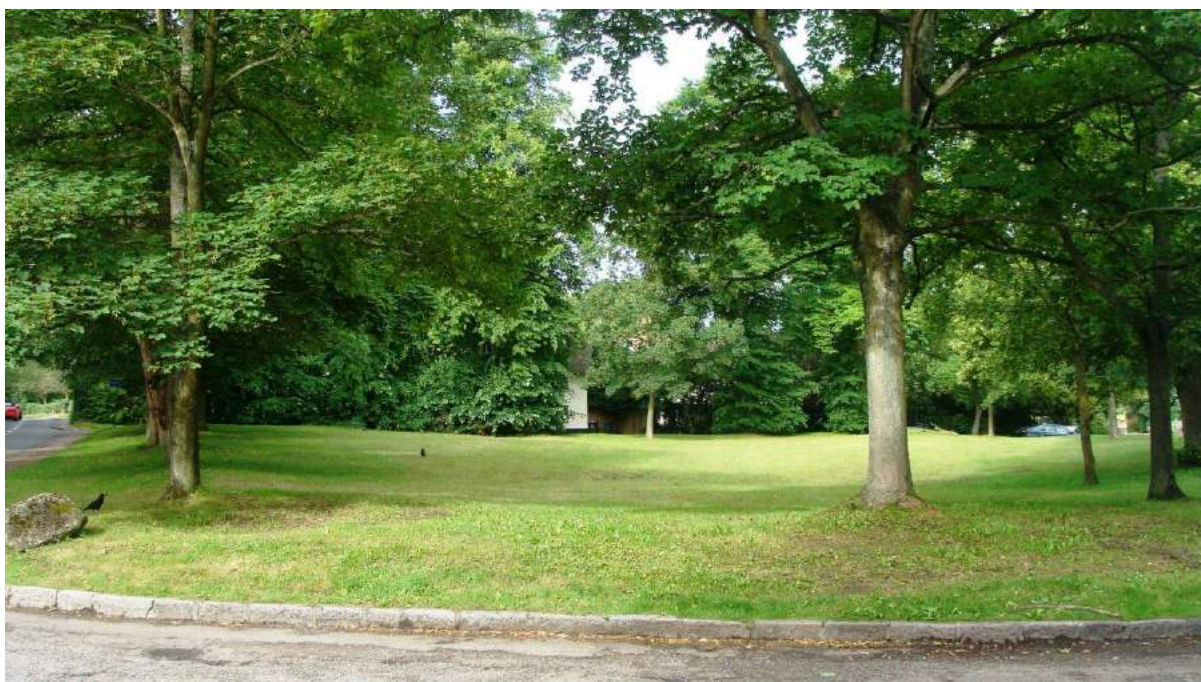
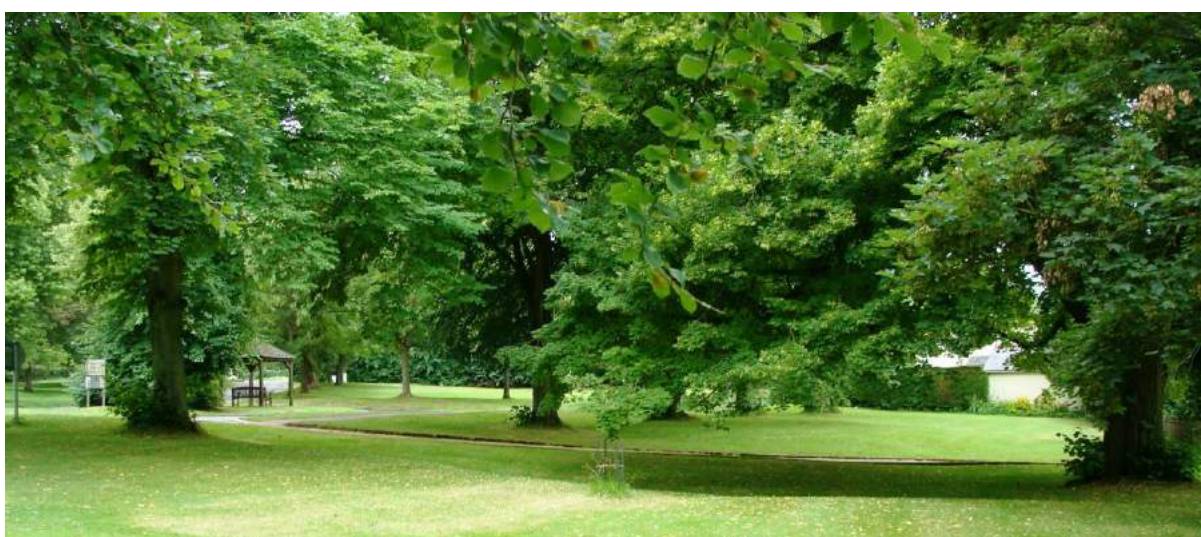
5.47. Central Greens Baldock Road. Greens, some with significant and visually important tree planting, both side of Baldock Road, are open spaces of the highest quality that add significantly to the appearance and diversity of the conservation area. Their disposition is little changed over the last 100 or so years. They are well maintained and a credit to the community. They act as settings to important listed buildings or as larger open greens with mature trees. They are generally uncluttered by street furniture, a principle that is important and which should remain a guiding principle. There is a simple and well designed shelter at Bowling Green with seat providing rest and a view over the open space.

Pictures 29-31. The various visual functions of some of the central greens on Baldock Road. Top picture - here the linear green provides a setting for an important group of listed buildings. Lower pictures - a wider open space at Bowling Green and another near the Bull PH; both planted with mature perimeter trees and open in character. Maintaining their open and uncluttered nature should be a guiding principle for the future.

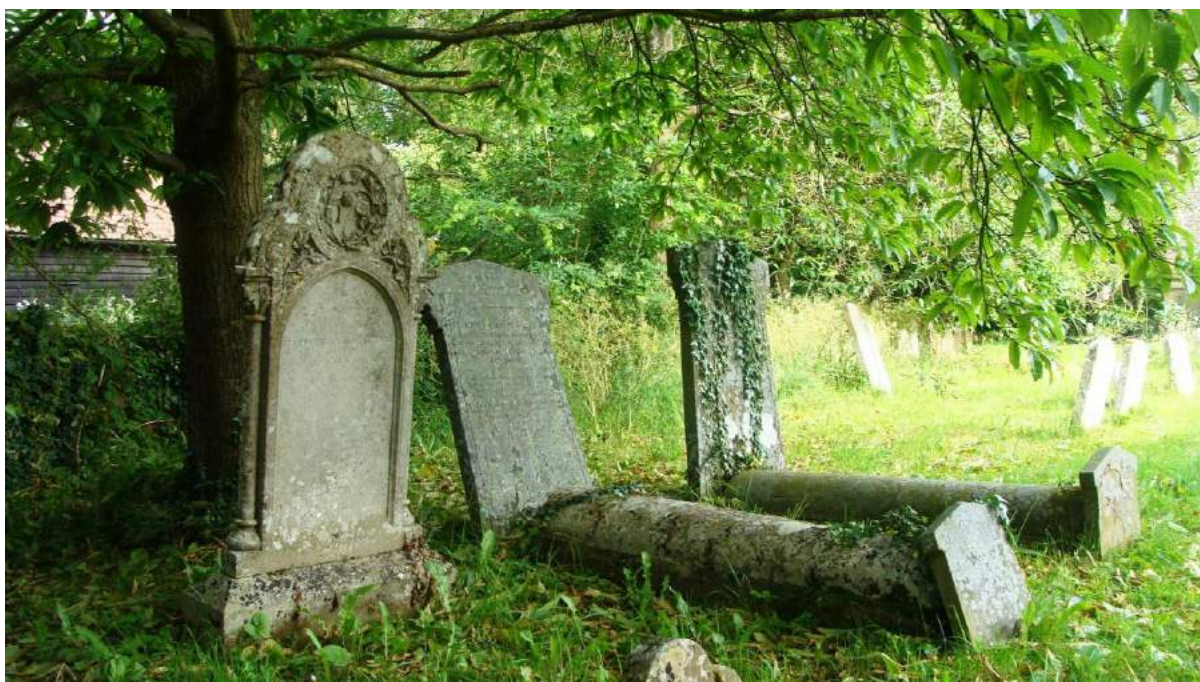
5.48. Parish churchyard. The churchyard is an important open space in the centre of the village with a variety of tombstones principally dating from 19th century to modern times. The main approach to the church from the south consists of an undistinguished open path. The latter could be significantly improved with an avenue of traditional churchyard trees such as clipped Irish Yews (the approach to Westmill church provides a local example worthy of consideration).

Picture 32. Traditional tombstones in the churchyard.

Picture 50-49 Recutting edging and formalising the approach to the church would secure significant visual improvements. Planting the realigned path with traditional churchyard trees such as a short avenue of clipped Irish Yew would be highly beneficial.

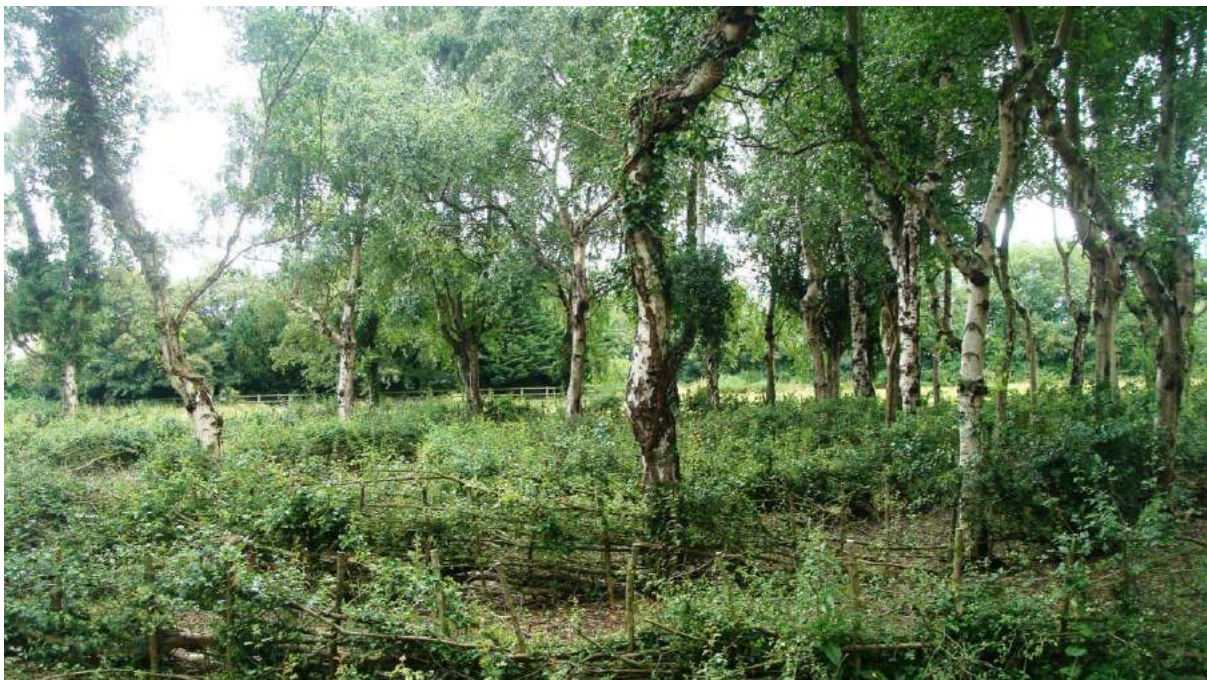
Picture 34. The Maze of early 20th century date currently being restored by the present owner. It consists of thorn hedging with mature birch trees.
