COTTERED CONSERVATION AREA APPRAISAL AND MANAGEMENT PLAN

DRAFT FOR CONSULTATION 2017

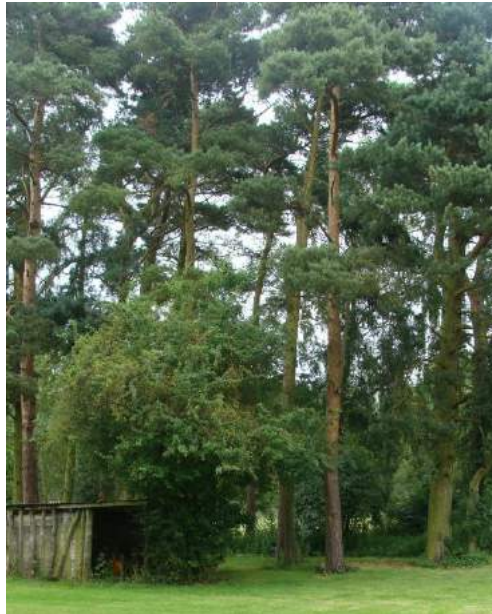
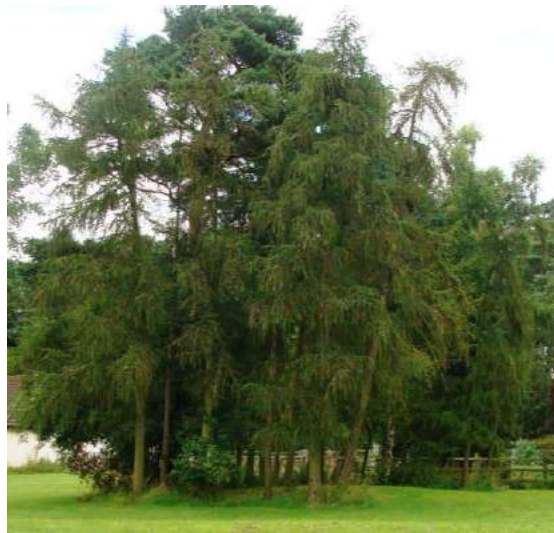
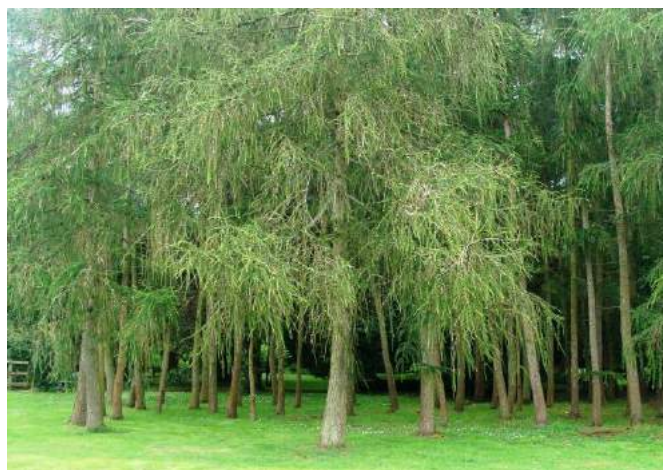
Pictures 35-37. A selection of different species of circular conifer groupings in the historic Registered Park to the west of Cheynes House.

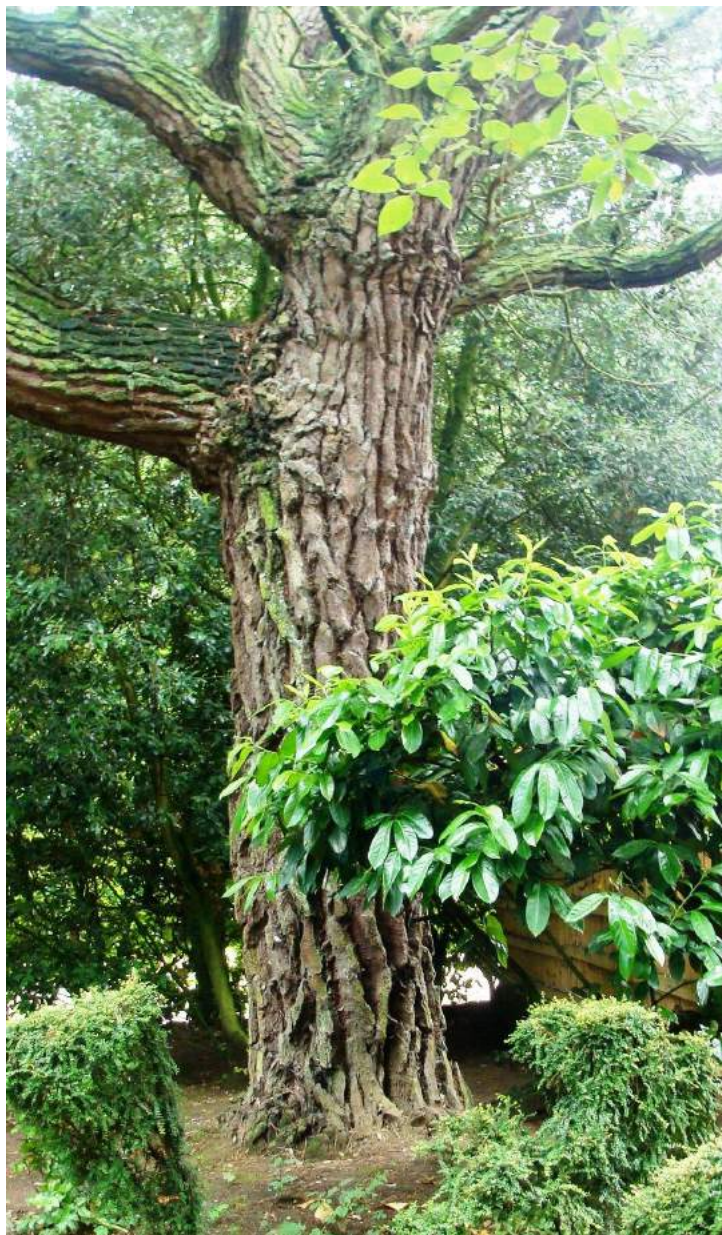
Picture 38. A magnificent tree within the grounds of Cheynes House, species uncertain but may be Japanese Black Pine. Can any reader assist?

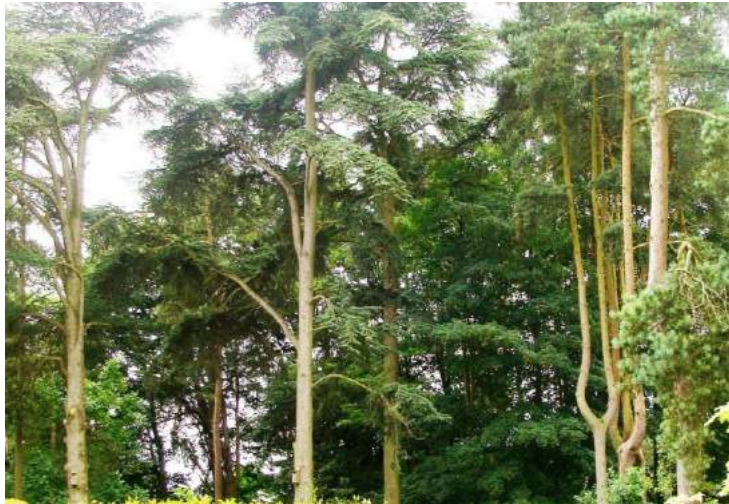
Picture 39. Fine Pine trees within The Garden House seen from the public domain, assumed to be Japanese species.

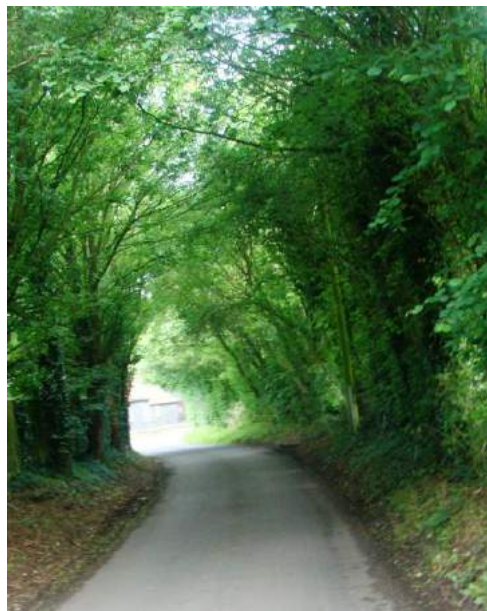
Picture 40. The village approach looking along Warren Lane. It is important to retain such landscape features.

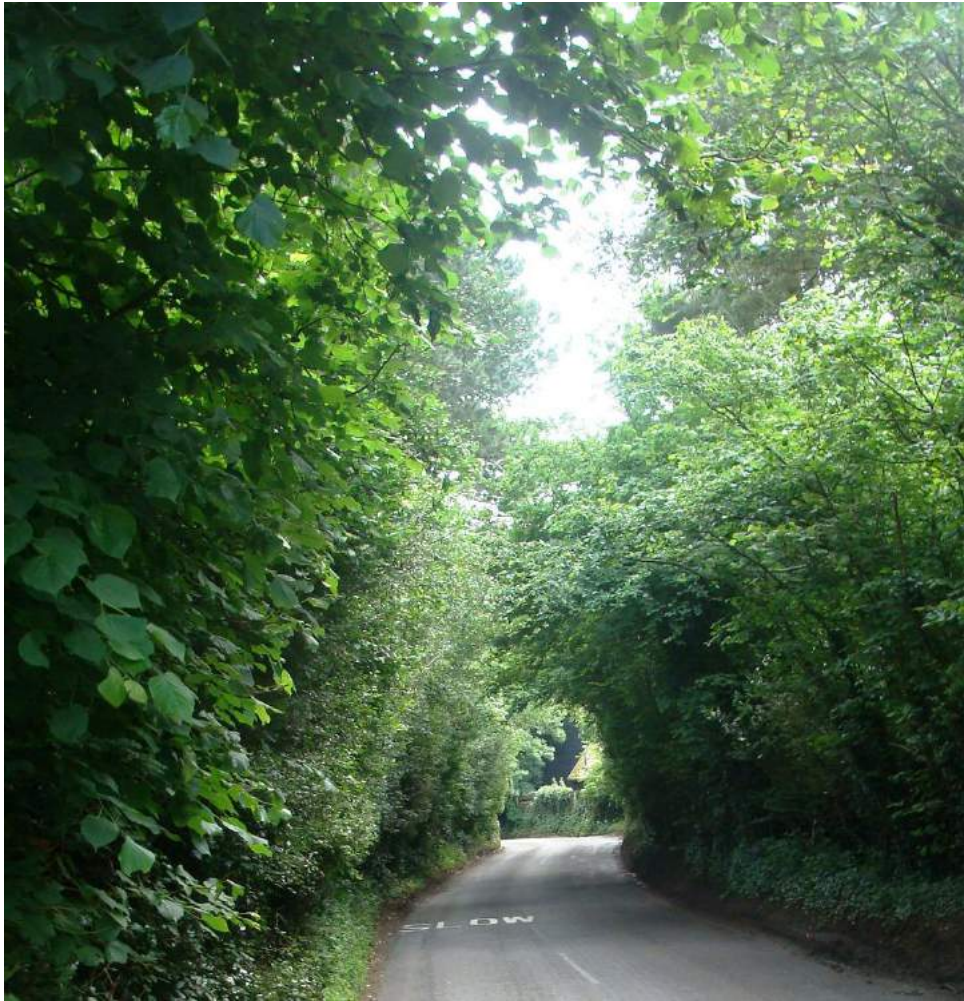
Picture 41. Similarly the enclosed nature north of Cheynes Lodge.

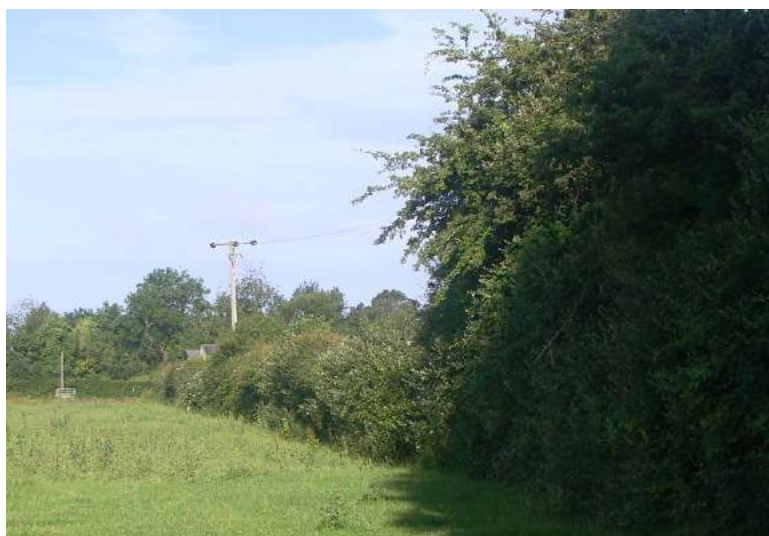
Picture 42. The importance of hedgerows. This one to the south of The Lordship is a strong boundary which separates the conservation area from adjoining open countryside.

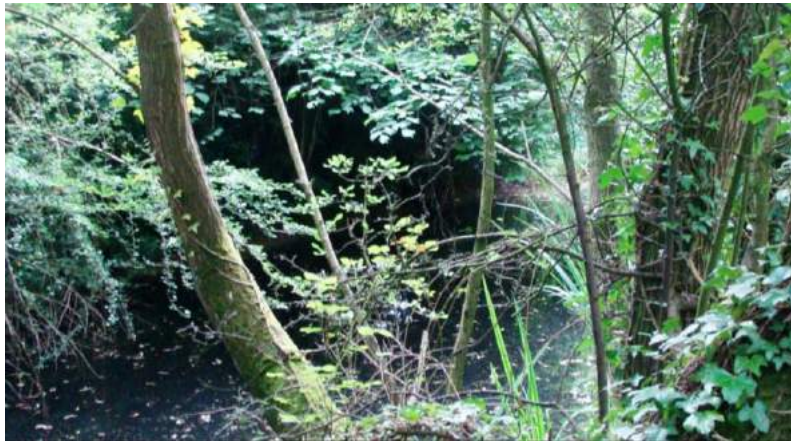
Picture 43. Overgrown water feature to the east of Childs Farm. Is there potential for making it visually more attractive?

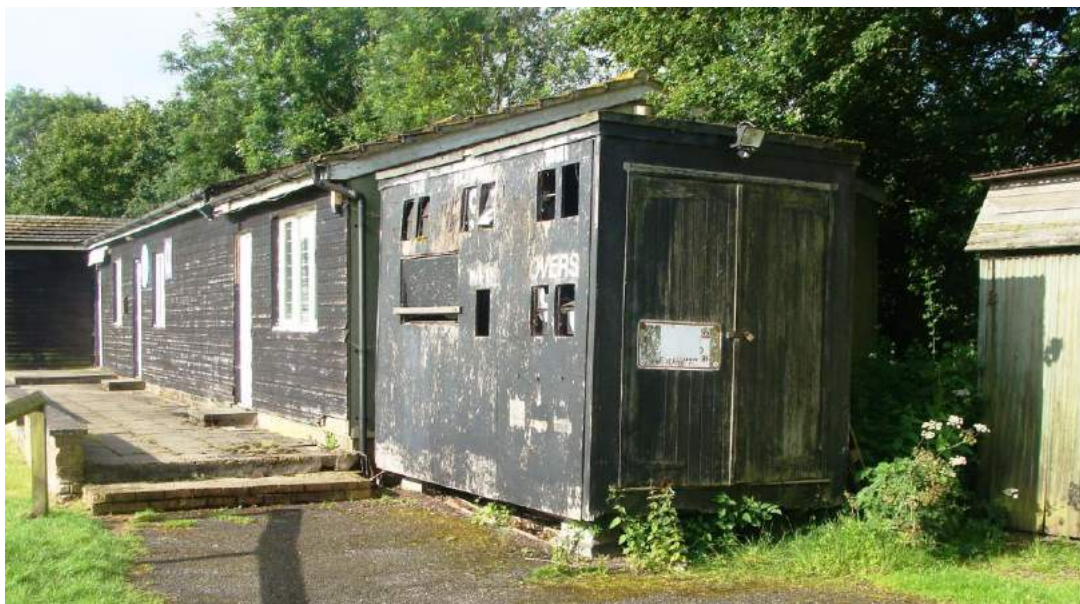
Picture 44. The cricket pavilion and associated facilities would benefit from improvements.

5.67. Opportunities to secure improvements. Seek further information relating to listed thatched building in Japanese Garden (illustrated previously) and discuss potential of improvements with owner. Secure improvements to cricket pavilion and associated facilities. Secure improvements to parish notice board. Re-erect No entry sign at north end of Warren Lane. **Seek removal of dumped material in field north of footpath 007.** Undertake selective repair works and removal of vegetation to church boundary wall. Consider improvements within the churchyard including a new avenue of trees of traditional churchyard species on the main approach path. Consider improving appearance of pond area to east of Childs Farm. Discuss with owner potential for improving thatched roof to ancillary building to Old Forge, Baldock Road. Consider improvements and rationalisation of signage on triangular green to east of The Old Off License.

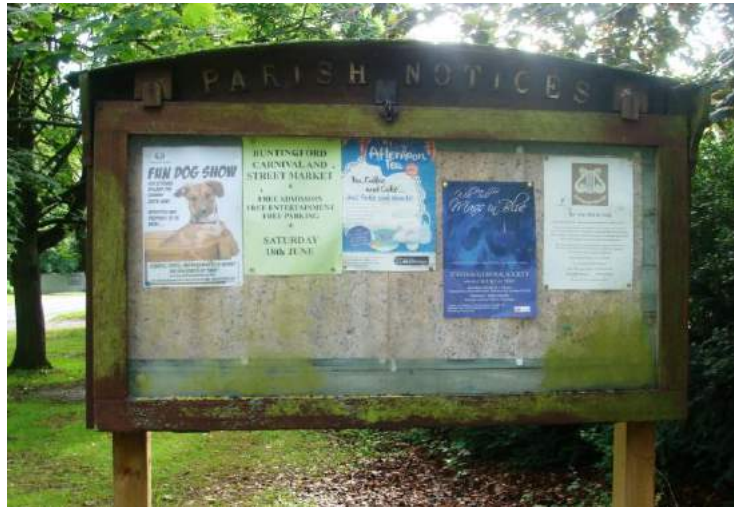
Picture 45. Improvements to the notice board would be beneficial.

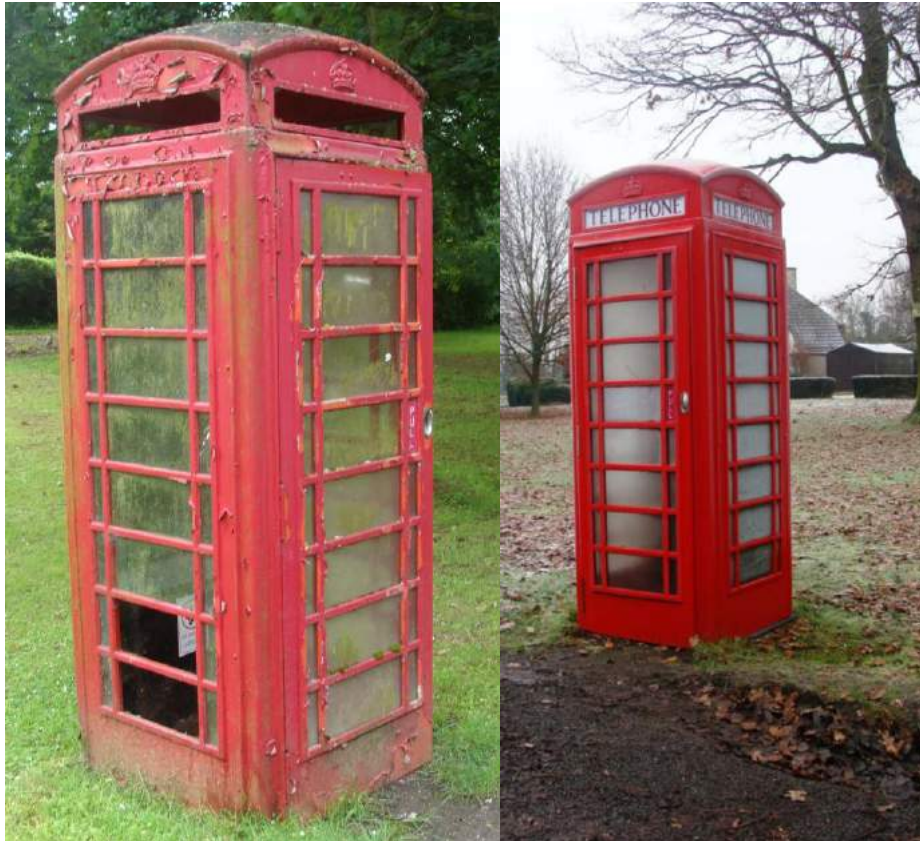
5.62. Disused Telephone kiosk. This telephone kiosk is known as a K6 type, originally designed by Sir Giles Gilbert Scott and made of cast iron by various contractors. Over 2000 of them in the country are listed although this one is not. ~~Until recently it is it was in very poor condition, and should be repaired. It is suggested the Parish Council discuss options with the owners (BT?). It is worthy of repair and with a little effort could take its place as a quintessentially English architectural icon in the street scene.~~ Elsewhere the fieldworker has seen such kiosks perform other community functions such as book exchange, seasonal floral tributes and on one occasion to house a defibrillator. UPDATE: ~~since this paragraph written~~ the telephone box has now been restored (see picture below). Congratulations for this initiative.

Picture 46. Telephone kiosk left no longer in operational use. An iconic British architectural feature most worthy of repair and retention. Right repaired and looking so much better. Even small improvements like this can make a considerable visual improvement.

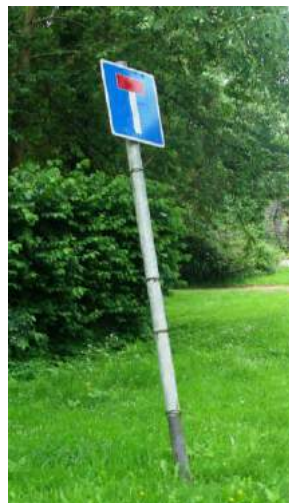
Picture 47. No entry sign Warren Lane needs re erecting.

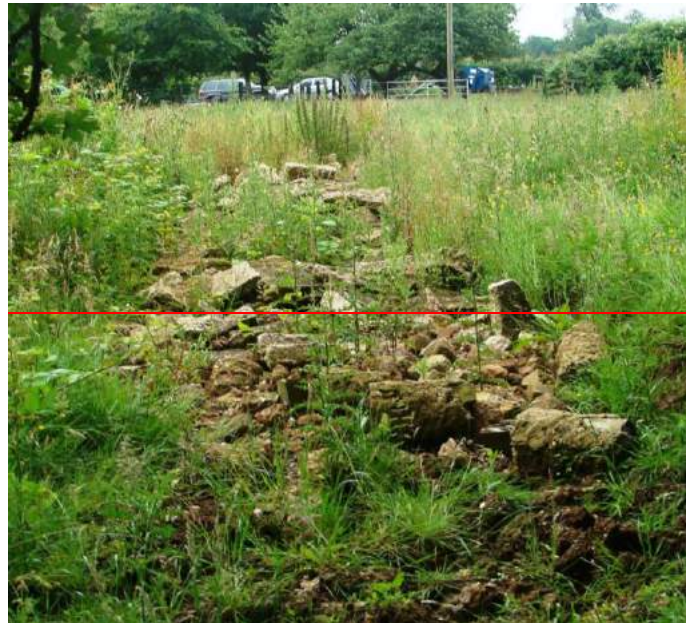
Picture 48. Dumped spoil/hardcore-modest effort could secure worthwhile visual improvements.

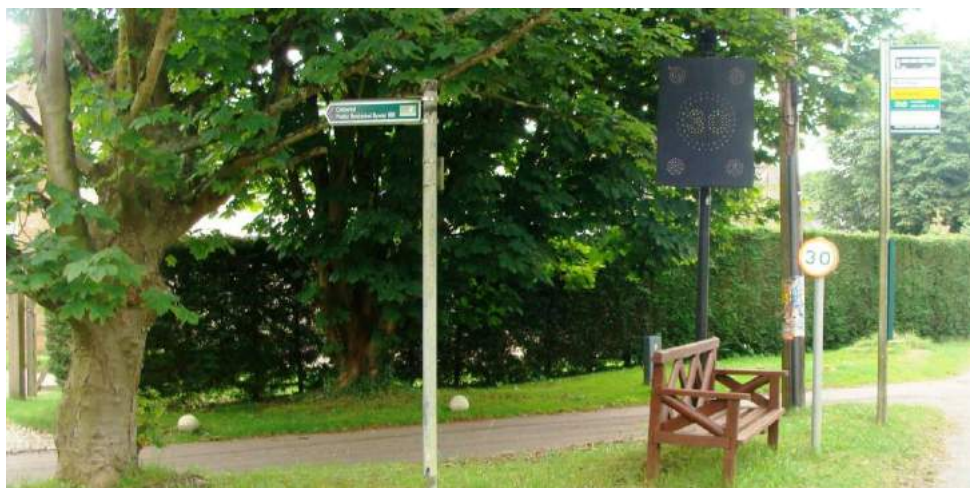
Picture 498. Could some rationalisation be achieved by combining some of the separately mounted signs on common poles?

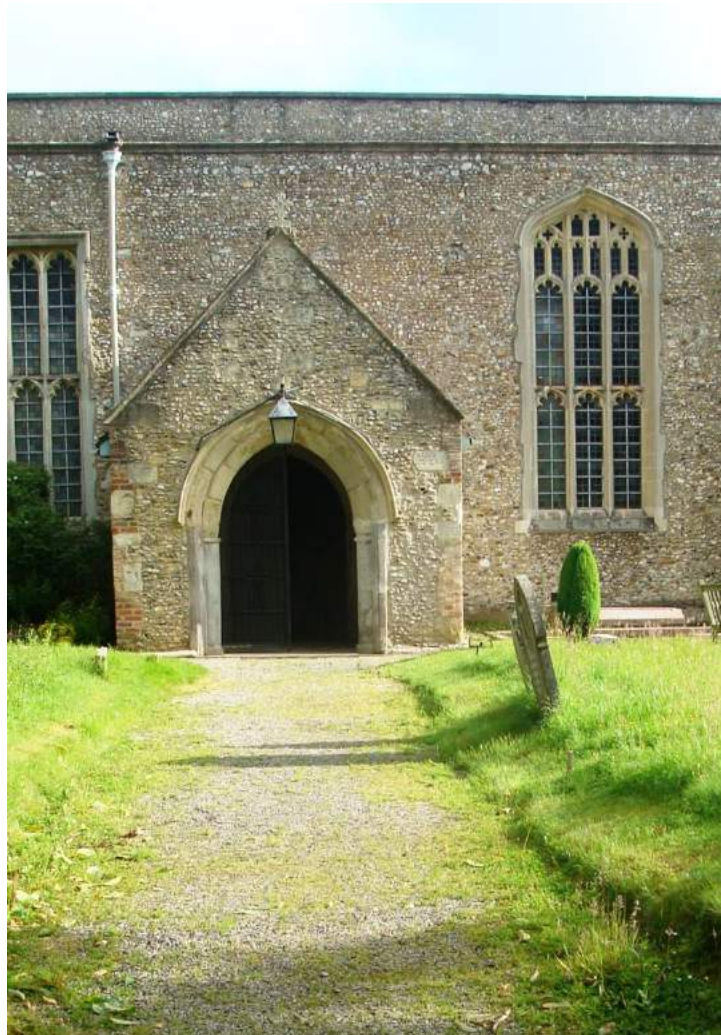
Picture 50-49 Recutting edging and formalising the approach to the church would secure significant visual improvements. Planting the realigned path with traditional churchyard trees such as a short avenue of clipped Irish Yew would be highly beneficial.

signage.	License.	achieving some rationalisation.
Other actions		
Friends burial ground, research history, explore opportunities for making site accessible and initiating improvements dependant on what is discovered there.		
Seek further information regarding condition of listed thatched building in Japanese Garden and if necessary include on Council's Heritage at Risk Register. Without prejudice grant assistance may be available.		
Contact owner of Cheynes Farm and investigate further the condition of the ancillary barn currently included on the Council's Heritage at Risk Register. Without prejudice grant assistance may be available.		
Discuss potential of undertaking repair works to church boundary wall and selective removal of vegetation. Without prejudice grant assistance may be available.		
Discuss potential of visually improving access to church, possibly by the provision of an avenue of traditional churchyard trees (such as Irish Yew).

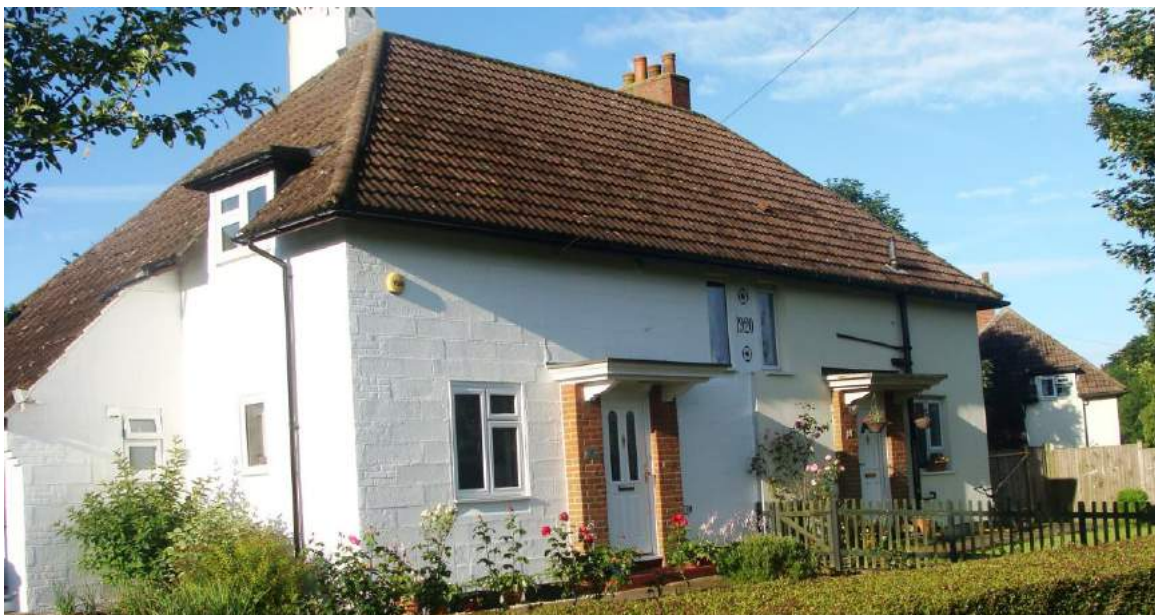
5.68. Suggested boundary changes. It is proposed to extend the conservation in an easterly direction to include Nos. 25-40 The Crescent. These are properties built as council houses in the early 20th century. They are of block construction with tiled roofs and chimneys principally of blockwork. In the main they retain many of the original features including canopy features and plaques dated 1920 to fronts. Modern window solutions detract from original character. Despite such changes the whole group is unified by visually attractive common design features that justify their inclusion in an extended conservation area. They are of local historic interest. An Article 4 Direction to provide protection for selected features may be appropriate subject to further consideration and notification.

Picture 540. Housing at The Crescent dating from the early 20th century, unusual and retaining many of the original features including canopies, date plaques, chimneys and roofing materials. The retention of these features is most important.

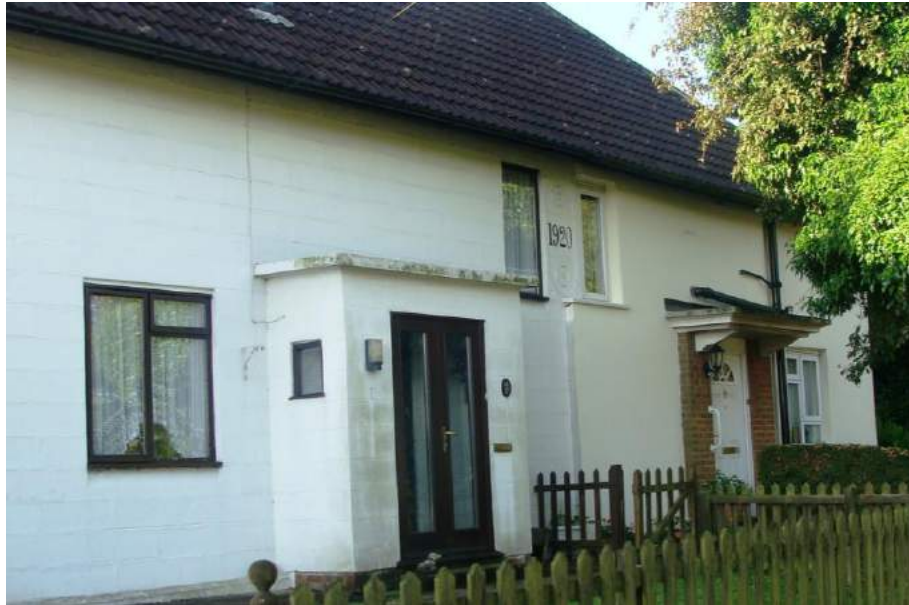
Picture 521. A property at The Crescent where regrettably the original canopy feature has been replaced. An Article 4 Direction as proposed would provide control in relation to the exercise of householder Permitted Development Rights. Some properties (right) have blockwork subsequently rendered.

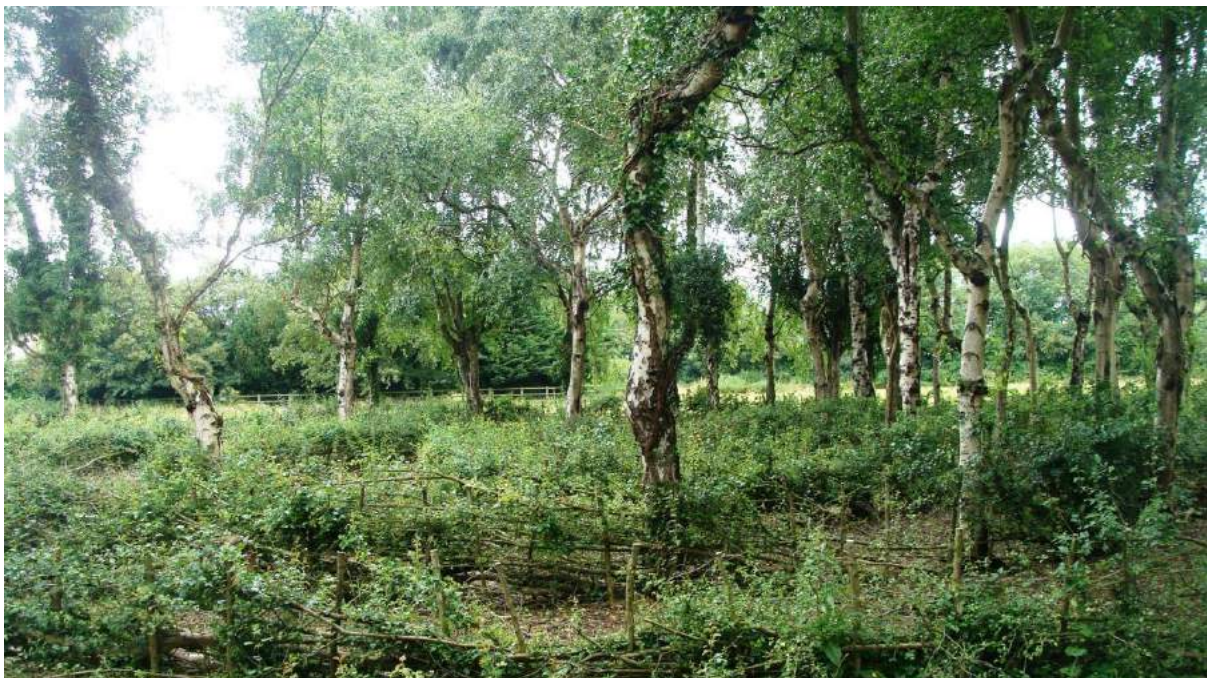
Picture 532. The Maze of early 20th century origin is currently being restored by the present owner. It consists of thorn hedging with mature birch trees. Some of the birch trees are past their prime.

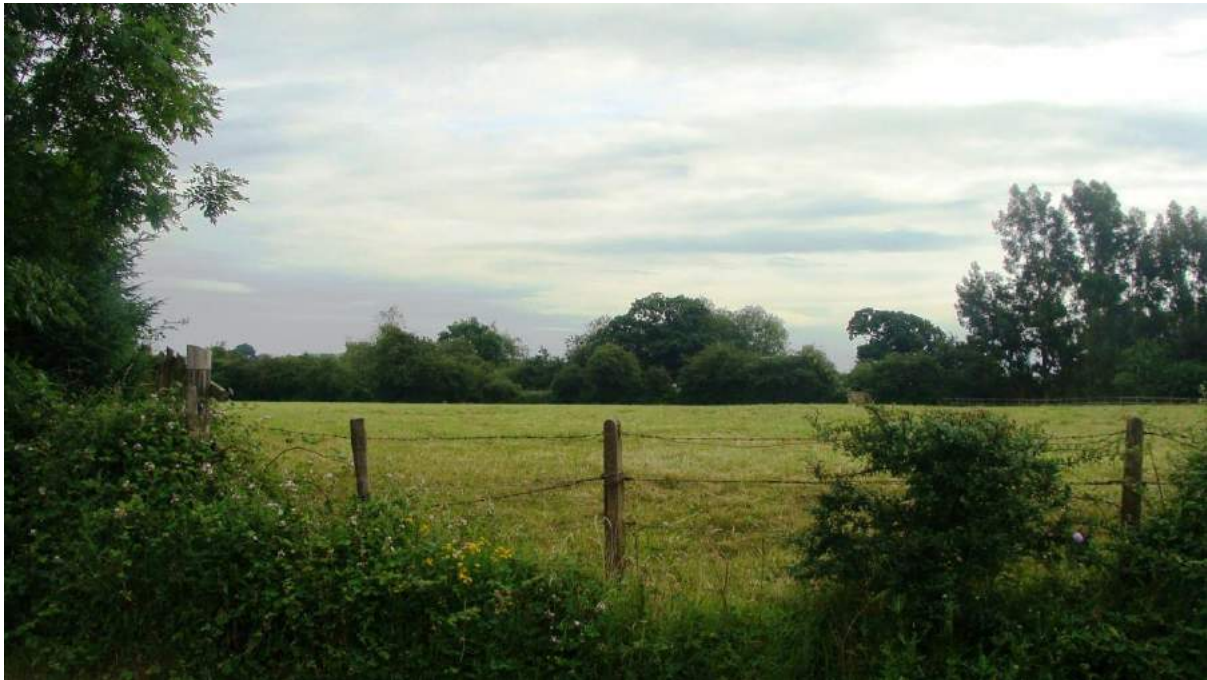
5.70. It is proposed to amend the conservation area boundary to exclude the open countryside to the north and west of Childs Farm at the western

extremity of the conservation area as this area is considered to be more closely associated with the open countryside. However it is suggested the boundary be redrawn to retain a small copse of trees adjacent to the road.

Picture 543. Open countryside to the north and west of Childs Farm which is proposed to be excluded from the conservation area.
