**THUNDRIDGE AND WADESMILL CONSERVATION AREA
APPRAISAL AND MANAGEMENT PLAN**

DRAFT FOR CONSULTATION

2015

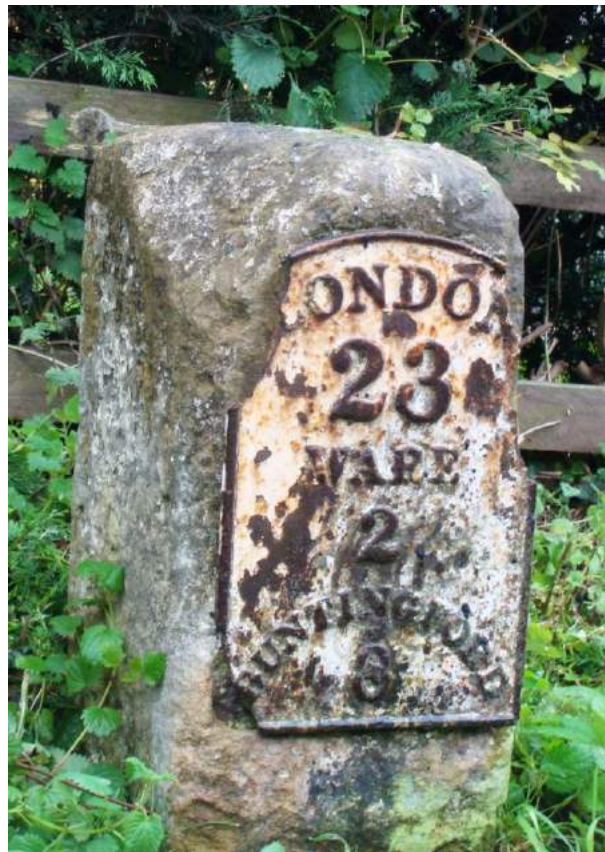
18th century milestone for Wadesmill Turnpike Trust in need of repair. Included on the Council's Buildings at Risk Register.

Picture 1. 18th century milestone for Wadesmill Turnpike Trust in need of repair. Included on the Council's Buildings at Risk Register.

5.45. Other actions. Contact HCC and seek repairs to 18th century milestone on the Cambridge Road. Amend EHDC mapping on District Plan documents relating to Youngsbury Park and Garden. Amend EHDC and Historic England mapping in respect of the Clarkson Memorial.

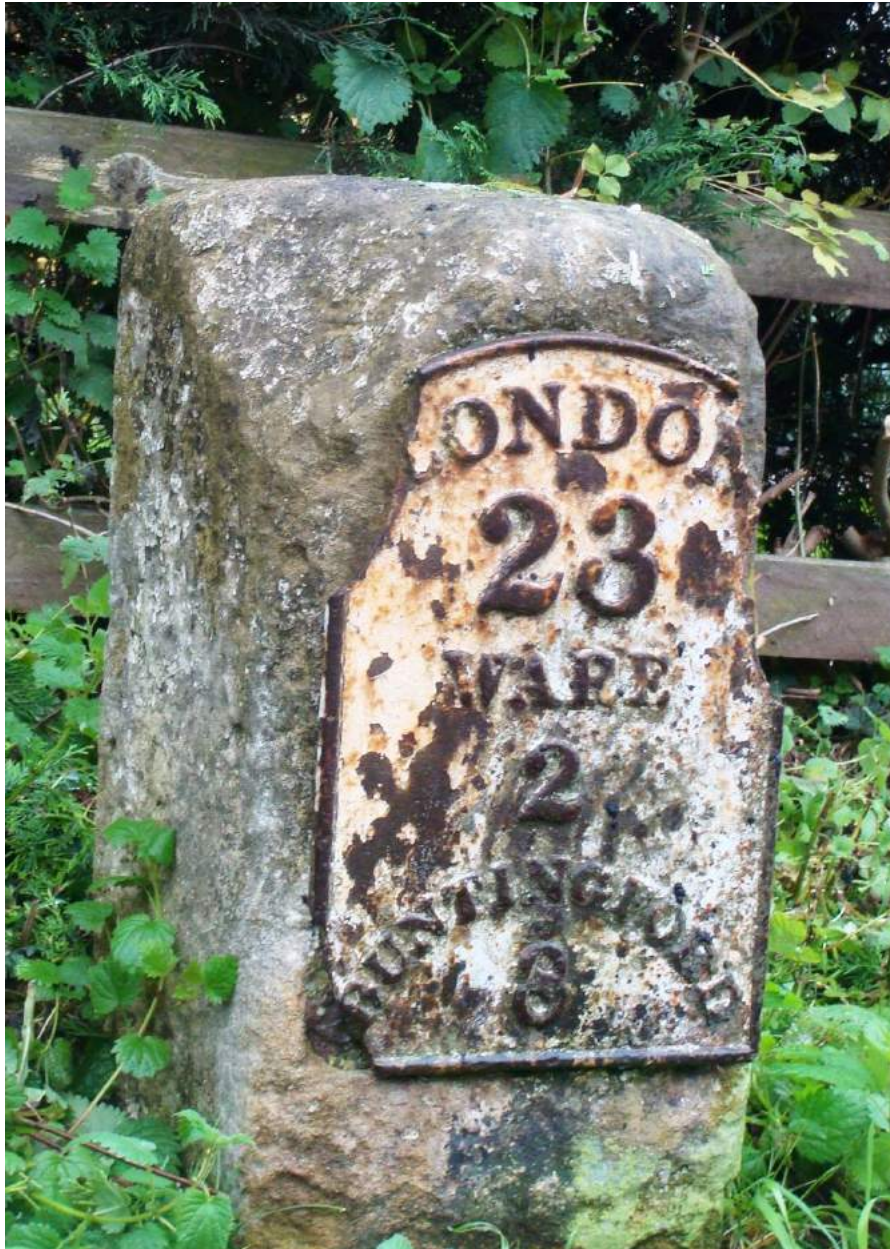
5.8. Milestone on south corner of track to Athena Cottage Grade II. Circa 1742 for Wadesmill Turnpike Trust, inscription covered by iron lettered plate circa 1804 possibly to design of McAdam. White freestone with cast iron front plate. A low square pillar of stone with large front plate of iron. Segmental curved top and raised bead all round plate. Inscription reads "LONDON/23/WARE/2/BUNTINGFORD/8". The first and last words are raised in segmental arcs. The milestone is on the Council's [BuildingsHeritage](#) at Risk Register.

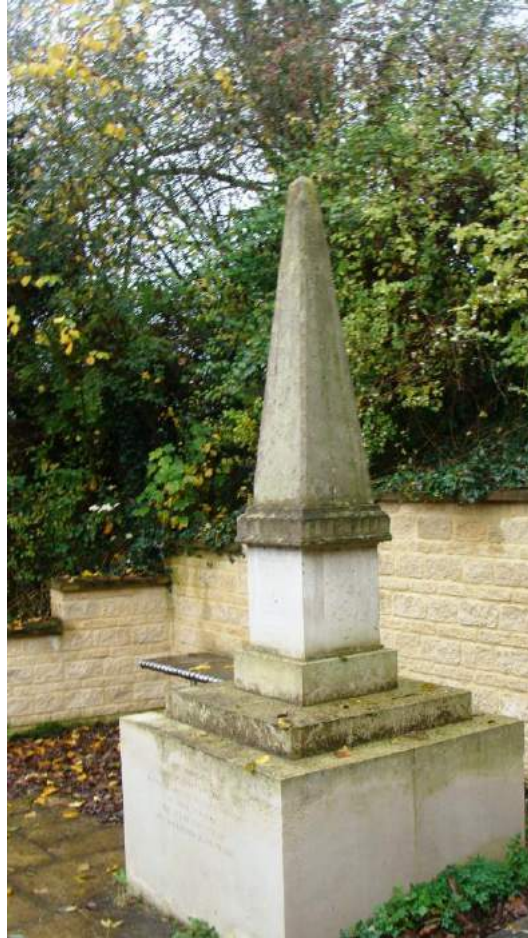
5.9. Clarkson Memorial High Cross Hill - Grade II . Commemorative monument, standing on the west side of Cambridge Road. Erected 9 October 1879 for Arthur Giles Puller of Youngsbury. A tall obelisk with chamfered arises raised on a square inscribed pedestal with chamfered plinth and capping. Overall, this original portion of the monument stands about 2 metres high. The front of the pedestal is inscribed with the words: 'On the spot / where stands this monument, / in the month of June, / 1785, / Thomas Clarkson / resolved / to devote his life / to bringing about the / abolition / of the slave / trade.' The monument was restored in the 1950s by members of US Air Force stationed nearby. In 1972 the monument was moved north-west in road widening. A further project of restoration was completed November 2007.

Picture 2. The Clarkson Memorial, erected 1879, commemorating Thomas Clarkson's contribution to the abolition of slavery.

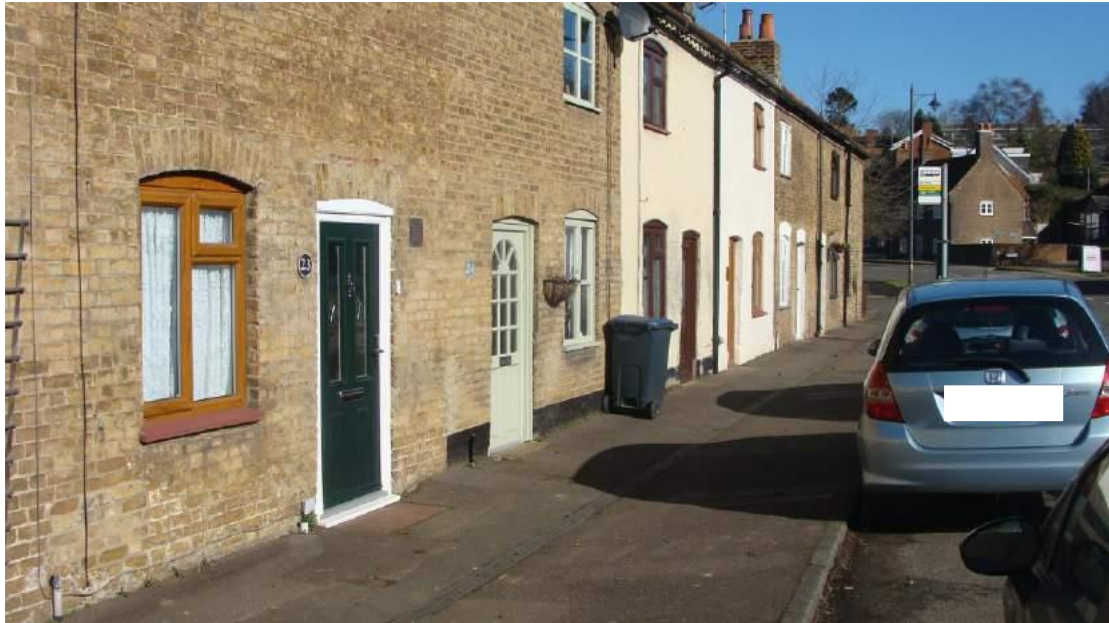
5.10. Nos. 20 to 29 Cambridge Road - Grade II. Terrace of houses. Late 18th century. Grey/yellow brick with old red tile roof, hipped at ends. 2-storeys. Each house has a door remote from the shared chimney and one front window to each floor. 2-light casement windows set flush. Doors and windows on each floor have segmental arches.

Picture 3. 20-29 Cambridge Road. Terrace of Listed Buildings dating from late 18th century. Whilst doors and windows are in original openings, a more pleasing result would have been achieved had common designs been applied (see picture below).

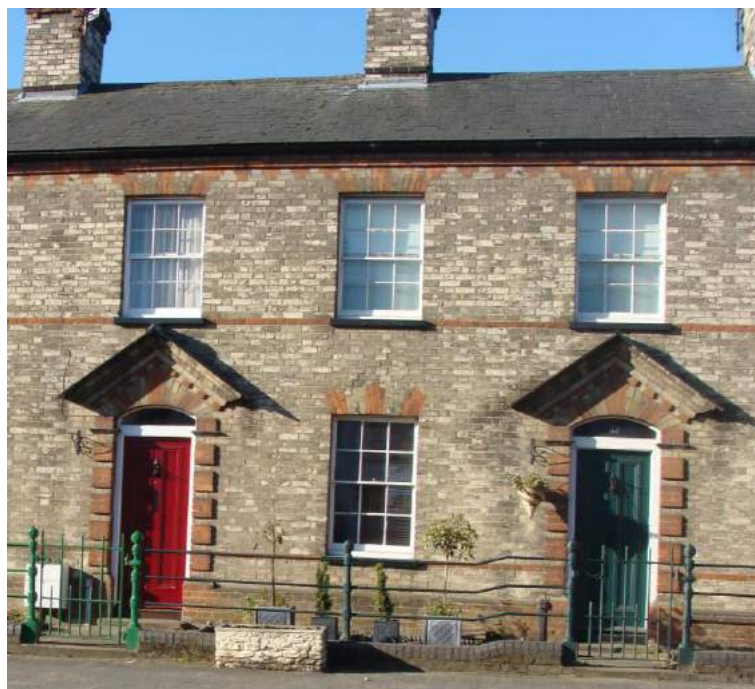
Picture 4. A terrace not local to Thundridge and Wadesmill: the purpose of this photo is to illustrate the importance of design detail. The retention of detail of an historic listed terrace depends on simple repetitive detailing, including original windows and doors. Expression of ownership can be provided by painting doors different colours. Compare with previous picture.

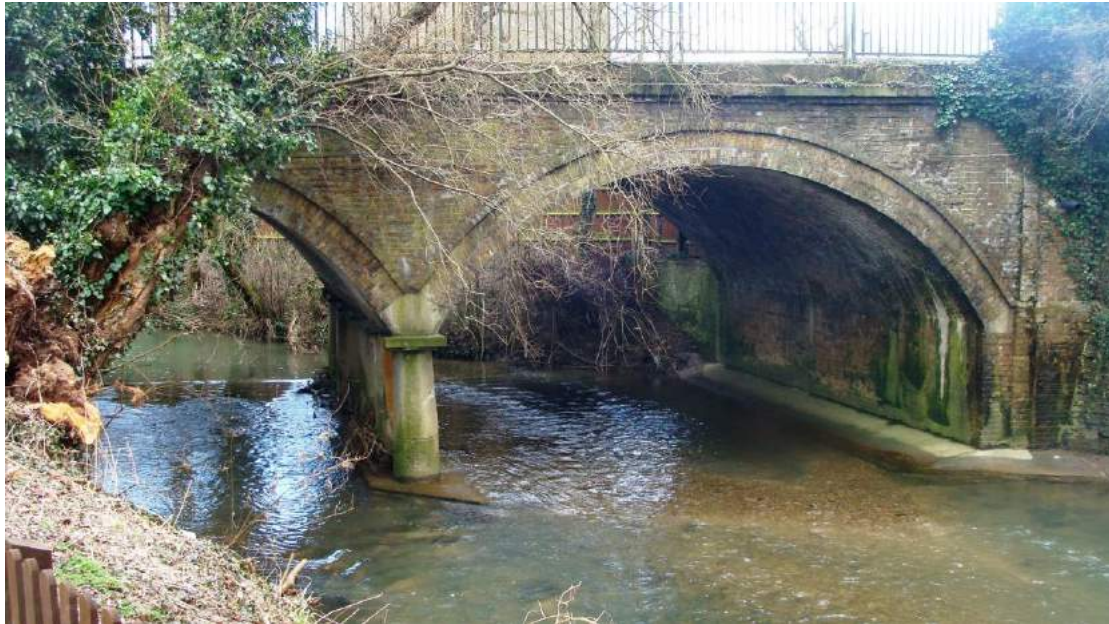
5.11. Wadesmill Bridge over River Rib in middle of village - Grade II. Road bridge over River Rib. 1824-5 by Mr Robson for Cheshunt Turnpike Trustees: contractors Brough & Smith of London. Grey/yellow brick with grey granite columns, string course, and haunched beams and reused

limestone copings. 2 semi-circular arches of 25 foot span, resting centrally on a row of 6 unfluted Greek Doric columns, each of 2 drums of grey granite, with an angled haunching of granite at the springing of each arch. The chamfered stone coping and pier cappings were probably reused from the 1767 repairs to the previous bridge. The original iron latticed side rails to the central spans were replaced to a simpler pattern after being damaged in 1966. An unusual Neo-Classical design. Branch Johnson notes that it is one of the best bridges in the county.

Picture 5. Listed road bridge over River Rib. Considered to be very fine in some of its detailing.

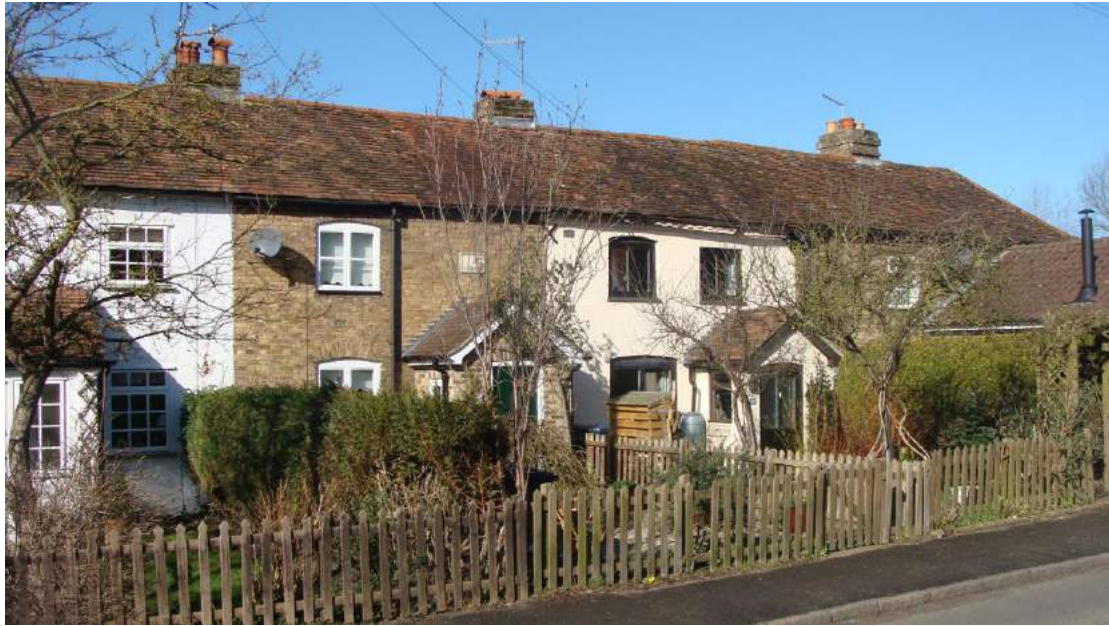
5.12. No. 31 Cambridge Road. Grade II. 'D G 1797' on wall plaque over door. Grey/yellow brick with old red tile roof. A 2-storeys small house set in a contemporary row of similar houses now altered. Dentilled brick eaves courses and segmental brick arches to door, on right, and the 2-windows, one to each floor. 2-light flush wooden casements. Small rectangular date plaque with raised surround.

Picture 6. 31 Cambridge Road. The centrally located house with the plaque is listed. Others in the terrace described as having been 'altered' demonstrate the conflicting problems of resolving a good environmental solution to small historic properties versus providing additional accommodation.

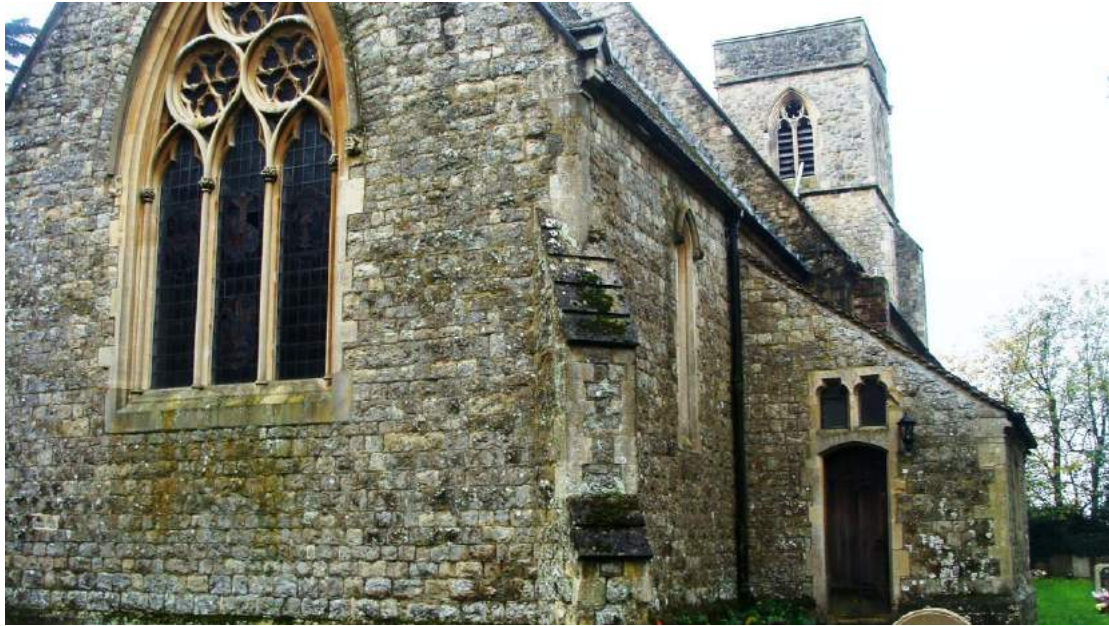
5.13. Parish Church of St Mary Grade II. -1853 by Benjamin Ferrey for Robert Hanbury. Squared coursed Kentish ragstone with freestone dressings and red tiled roof with ridge cresting of pierced trefoiled tiles. Early English style, consisting of a chancel, nave, south timber porch and tall, buttressed western tower with octagonal south west projecting stair turret carried higher than the unbattlemented parapet. Late 18th century mural monuments. 19th century mural monuments by Bedford and Theed (Caroline Hanbury died 1883: R C Hanbury 1867). Victorian stained glass. Commanding position high on a hillside overlooking the valley and village.

Picture 7. Church of St Mary's built in 1853 to replace the old medieval church in the valley that had fallen into disrepair by the mid 19th century. Certain monuments, the Royal Arms and the bells were taken from the old church and installed here in the new one.

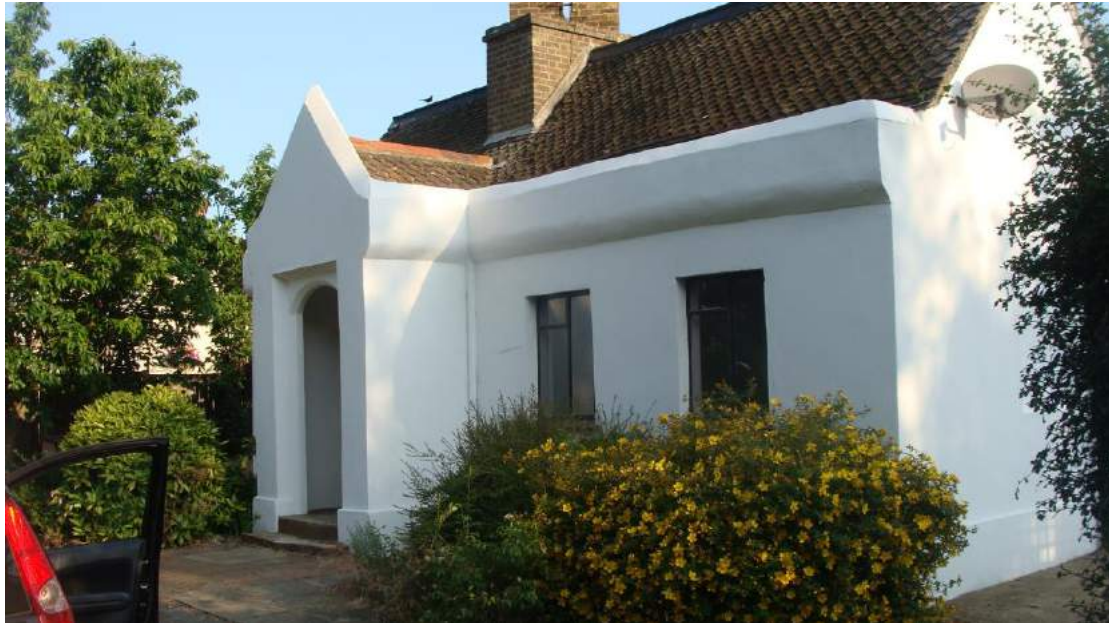
5.15. South Lodge. Despite its distance from the main building, perhaps a kilometre from Youngsbury, this building is located at the entrance to the Grade II* Park and Garden identified on Historic England's national list. South Lodge is identified on late 19th century mapping and is described in the park and garden listing description under 'west drive entrance and approaches' thus: *The west drive, designed by Brown, approaches the park off the A10 in the centre of the village of Wadesmill, entering at a single-storey, stuccoed lodge in Tudor style standing 1km south-west of the house. A pair of stone piers supporting iron gates flank the entrance to the drive, close to which on the north side stands the lodge, with the River Rib close by to the south.*

Picture 8. South Lodge - single storey rendered Lodge, tiled roof slate ridge and later metal windows. [Whatever its status in law \(i.e. curtilage listed or not\) it is a building that is worthy of retention.](#)

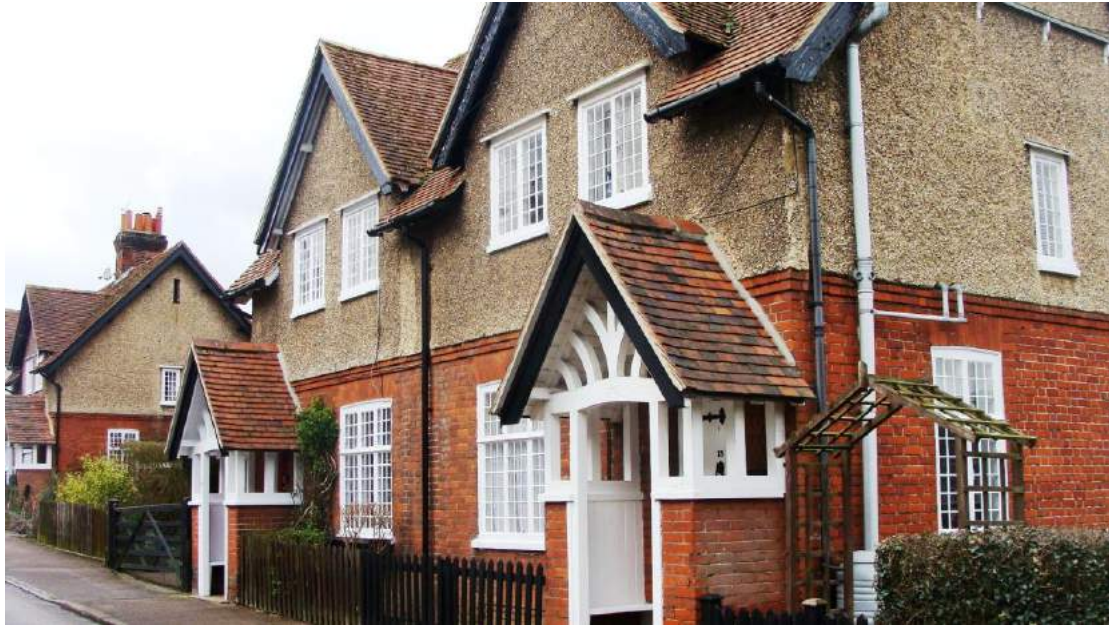
5.17. 11-13 Ermine Street. Pair of cottages, two storey. Brick to ground floor, pebble dash to upper floor. Tiled roof. Prominent central chimney stack with pots. Two number porches each with tiled roofs and decorative wooden detailing. Late 19th/early 20th century. Fine small pane window detailing with rubbed brick lintel detailing. An Article 4 Direction to provide protection for selected features may be appropriate subject to further consideration and notification.

Picture 9. 11-13 Ermine Street - fine late 19th/early 20th century cottages with much original detailing.

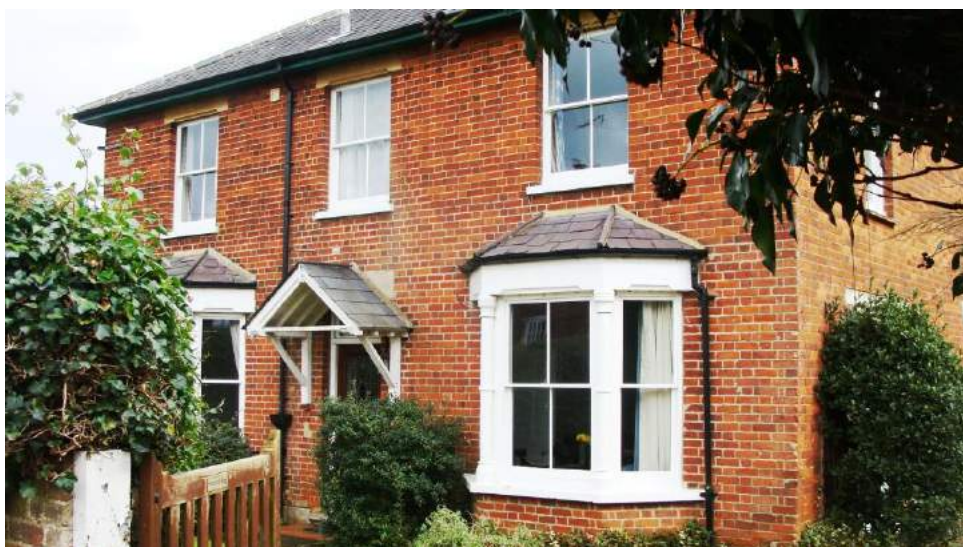
5.19. The Limes, Ermine Street - a late 19th century large detached residence of brick construction with pyramidal slate roof and two prominent chimney stacks with pots. Three range windows with vertical sliding sashes to first floor. 2 no. bay windows with slate roofs above to ground floor. An Article 4 Direction to provide protection for selected features may be appropriate subject to further consideration and notification.

Picture 10. The Limes Ermine Street - a late 19th century detached residence worthy of retention.

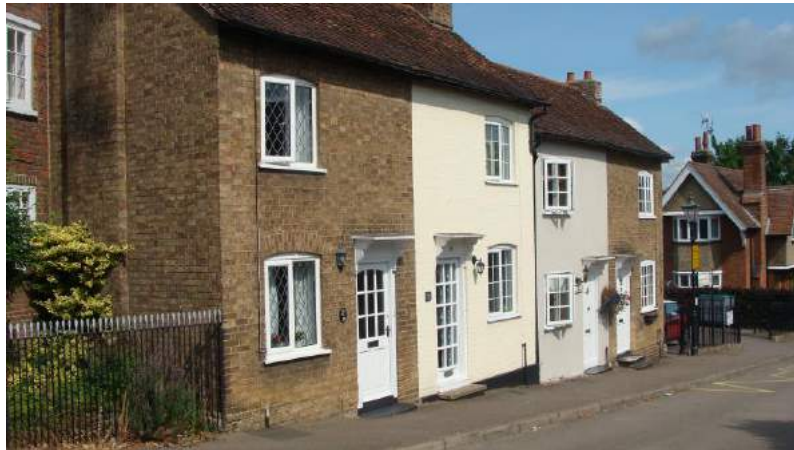
5.20. Nos.17-23 Ermine Street. Group of late 19th/ early 20th century cottages of brick construction with tiled roofs and chimneys, some of which are tall, with pots. Properties have been individually modified where a variety of modern doors and windows have created an overall uncoordinated design solution. No. 23 retains original windows.

Picture 11. Nos.17-23 Ermine Street - had the various treatments of surfaces, windows and doors been coordinated the result would have been more pleasing.

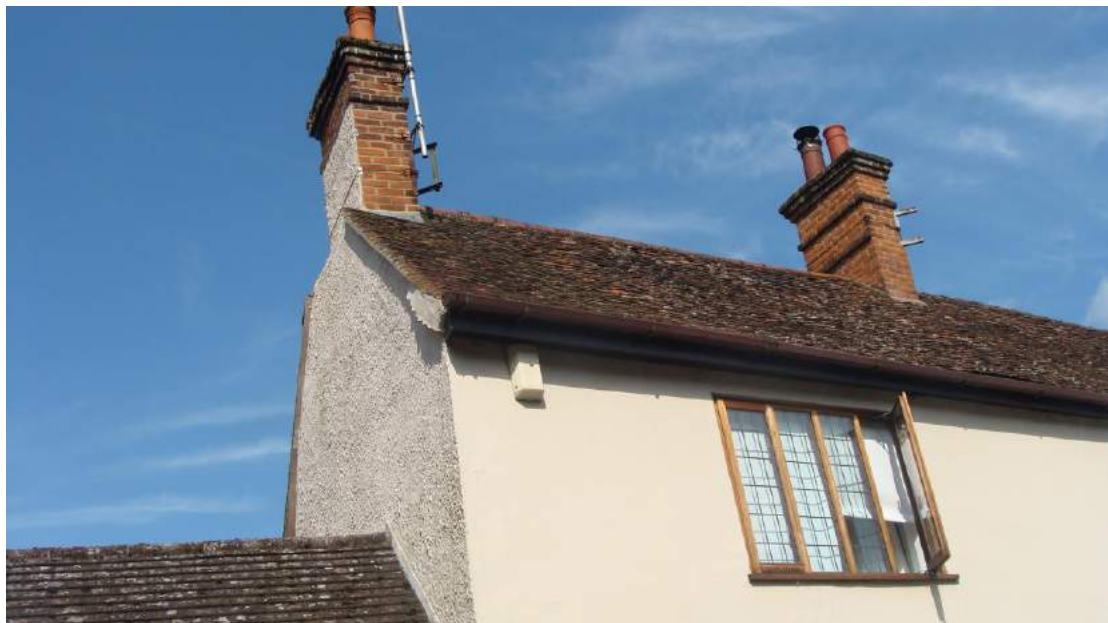
5.21. Nos. 35-37 Ermine Street/ corner of Old Church Lane. Two storey render with old tiled roof and 2 no. chimneys with pots. Modern windows. The roofscape of this group adds to the quality of this strategic corner location. An Article 4 Direction to provide protection for selected features may be appropriate subject to further consideration and notification.

Picture 12. Good quality roofscape on strategic corner location of Ermine Street and Old Church Lane that should be retained.

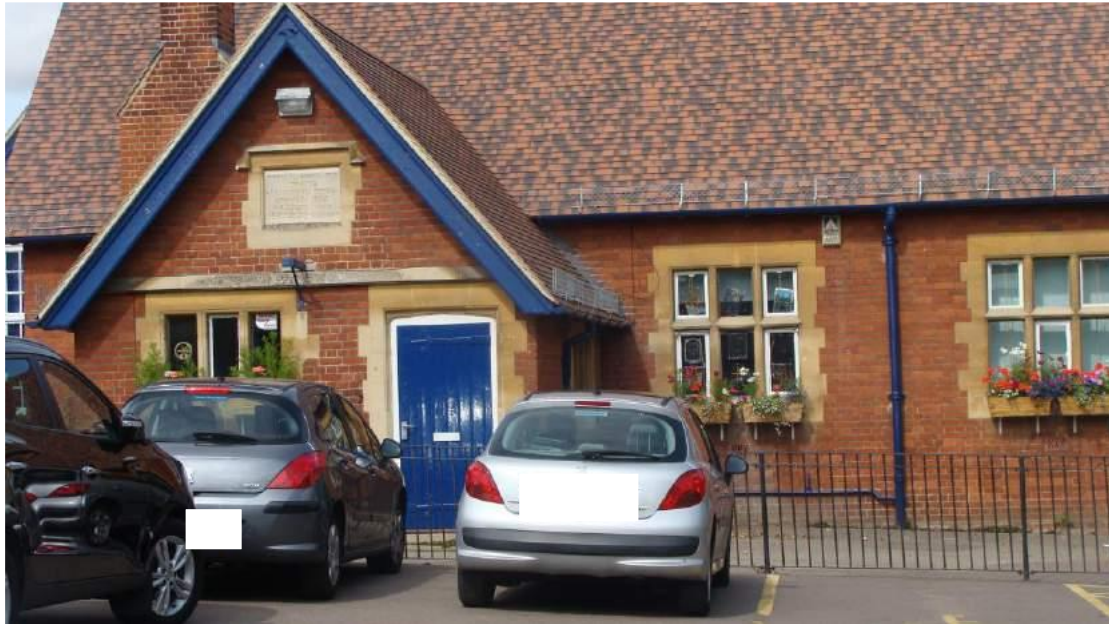
5.22. Thundridge school - Ermine Street. Single storey red brick building with tiled roof. Original stone window and door detailing. Entrance door and wooden barge board detail assumed to be original. Plaque to front reads *National School for Infants Thundridge Parish Erected 1894. H A Mason Vicar E G Hanbury Treasurer*. As it is important to retain selected features in their original form on this school building an Article 4 Direction may be appropriate subject to further consideration and notification.

Picture 13. School building Ermine Street. An important component of the Conservation Area both in terms of visual and historic importance. Some fine original features that should be retained.

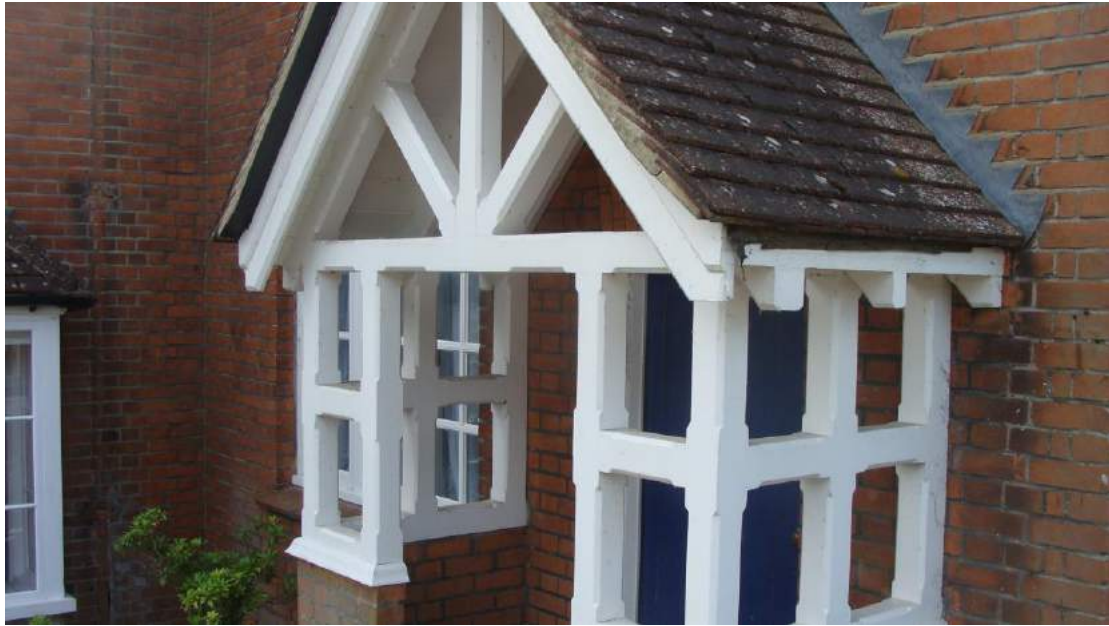
5.23. Thundridge Village Store/ no. 39. Early 20th century two storey of red brick construction. Good quality rubbed brick lintols, bay window detailing and decorative wooden porch. Fine tall chimney stacks, one with 3 no. diagonal stacks. Also pantiled outbuildings to rear. Plaque reads *E S H A H 1909*. Important features worthy of retention, planning legislation protects virtue of commercial use.

Picture 14. Attractive decorative wooden detailing to Thundridge Village store/no. 39.

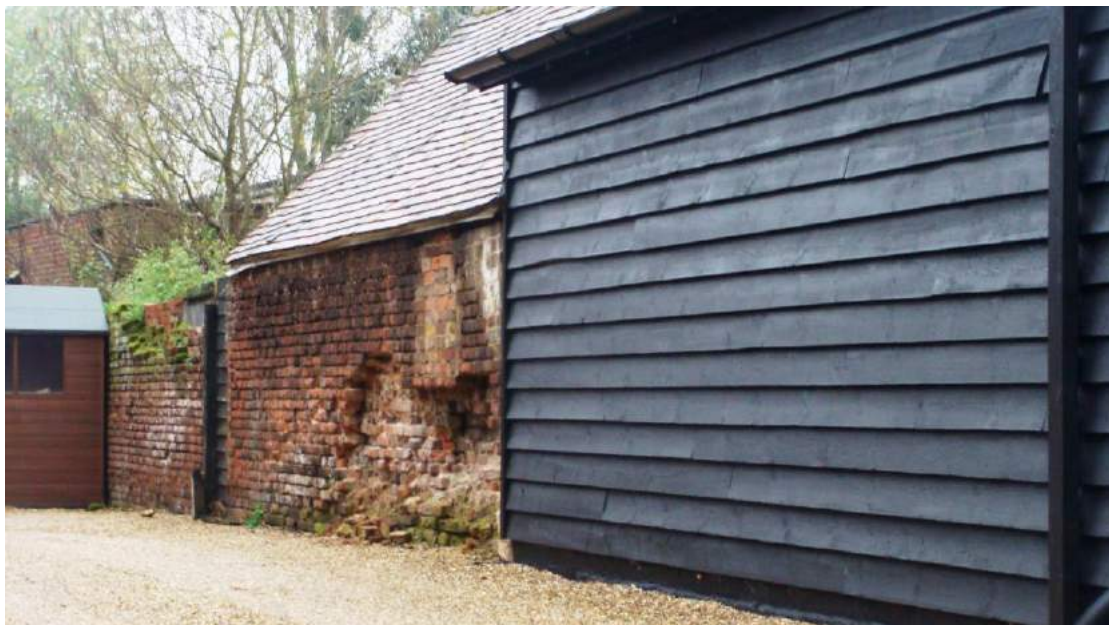
5.24. Trinity Barn and associated outbuildings. The main building is two storey weather boarded with slate roof. Associated buildings are single storey with tiled and slate roofs. Assumed to have previously been part of Rennesley Farm complex (although not processed as being curtilage listed). A well detailed and sympathetic conversion. The brickwork to one ancillary building believed to form part of the complex needs repair.

Picture 15. Ancillary building assumed to form part of Trinity Barn complex whose brickwork is in need of repair.

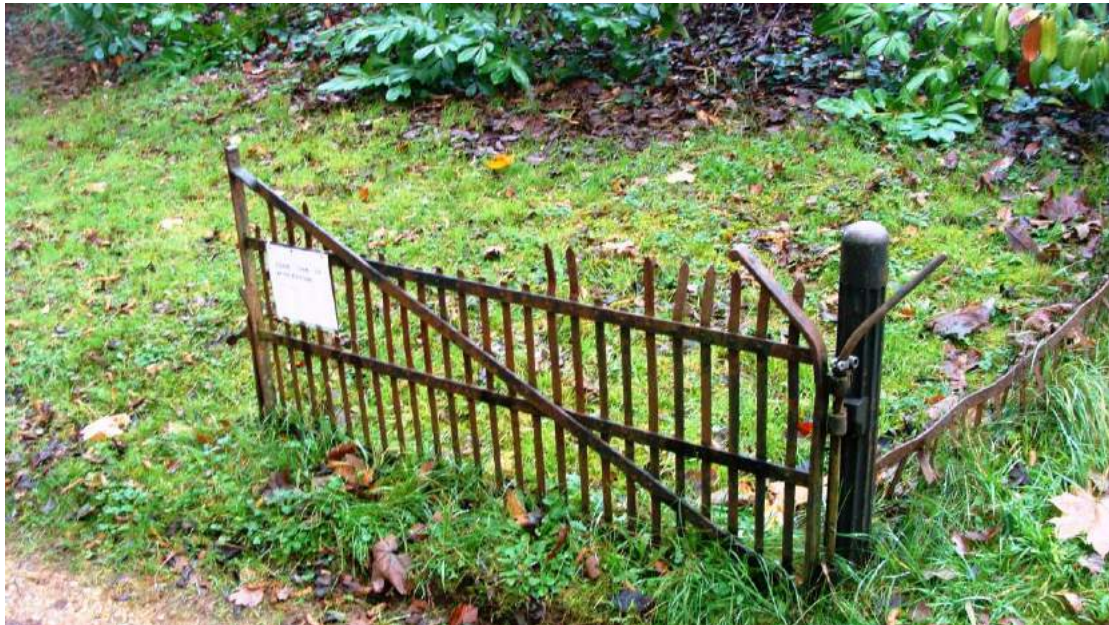
5.26. Wall surrounding churchyard constructed of brick with slate triangular section capping detail. Also curious iron gates and associated low metal railings in need of repair.

Picture 16. Curious iron gates probably contemporary with the church in need of repair - a challenge but nevertheless possible.

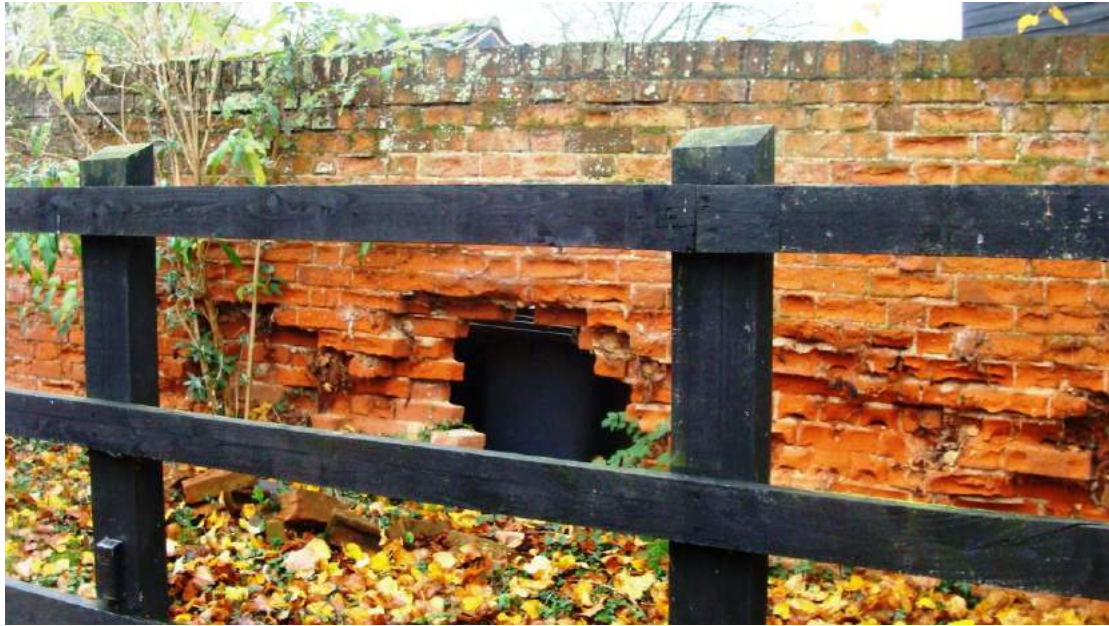
5.28. Walls at Rennesley Farmhouse. One brick wall in deteriorating condition and included on the Council's [Heritage Buildings at Risk Register](#). It may be possible for the Council to assist and it is recommended the owner approach the Conservation Team in this respect and seek further advice.

Picture 17. 19th century wall at Rennesley Farmhouse in urgent need of repair. The potential of grant assistance from EHDC exists.

5.43. Opportunities to secure improvements. Discuss potential of improving area of open land to east of commercial premises north of Rennesley Farm. Repair curtilage wall at Rennesley Farm. Discuss potential of improving frontage to no. 8 Ermine Street. The Parish Council may wish to approach the utility company and explore the potential of reducing the visual impact of selected utility poles at Ermine Street.

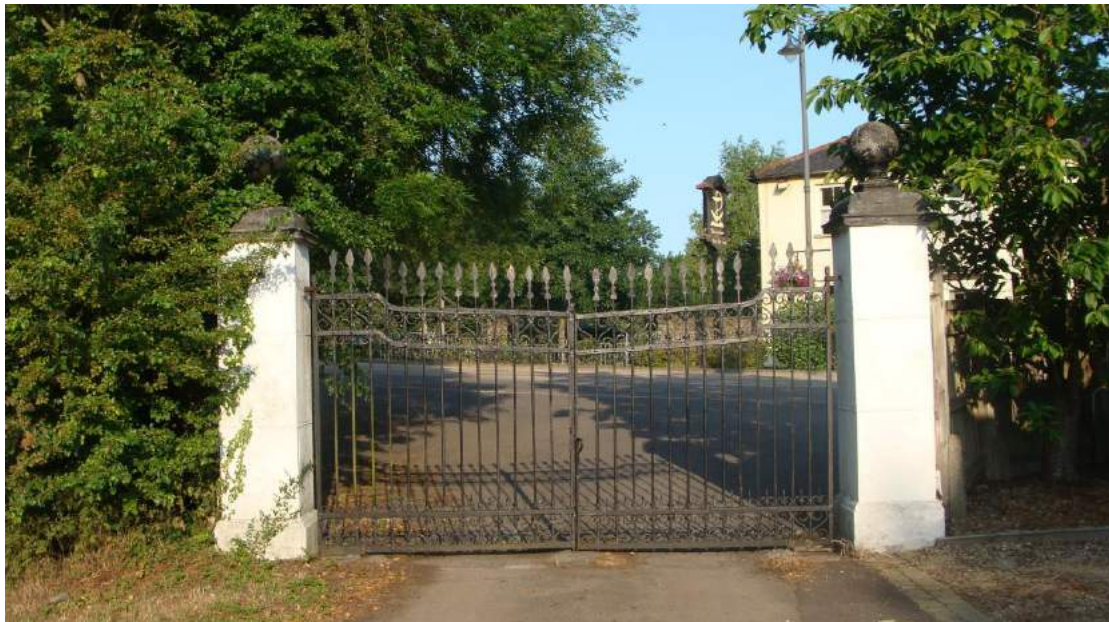
5.29. Iron Gates near South Lodge. Large pair of decorative metal gates supported by substantial piers each surmounted by ball finials. Provides interesting historic feature on drive entrance accessing Youngsbury Grade II* historic Park and Garden.

Picture 18. Decorative iron gates and piers on entrance drive to Youngsbury - a grade II* historic Park and Garden.

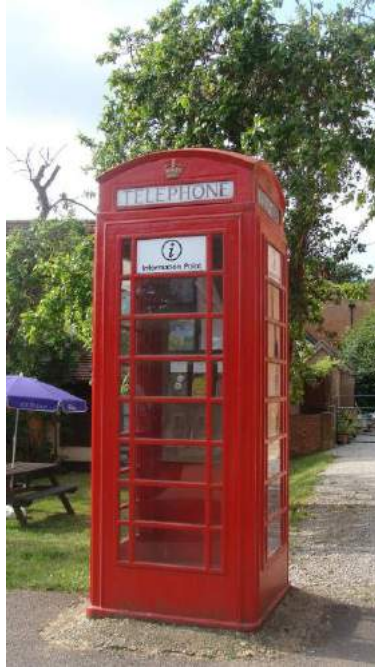
5.30. K6 Telephone Kiosk. Many are listed although this one is not. Looking at mid 20th century mapping, it would appear to be in original position. Designed 1935 by Sir Giles Gilbert Scott. Made by various contractors. Cast iron.

Picture 19. K6 Telephone kiosk, well maintained and in good condition, now an information point.

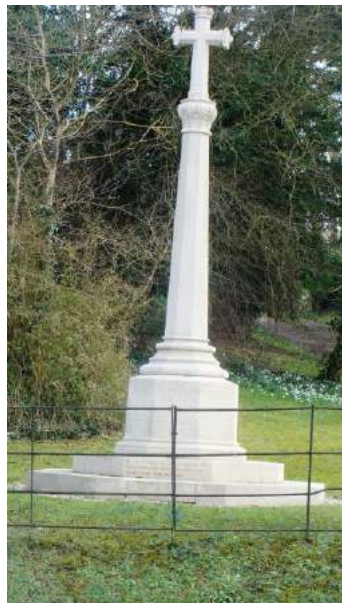
5.31. War Memorial. Stone tapered octagonal shaft surmounted by cross on stepped octagonal base commemorating those from Thundridge who gave their lives in both World wars.

Picture 20. War Memorial well maintained and in good condition.

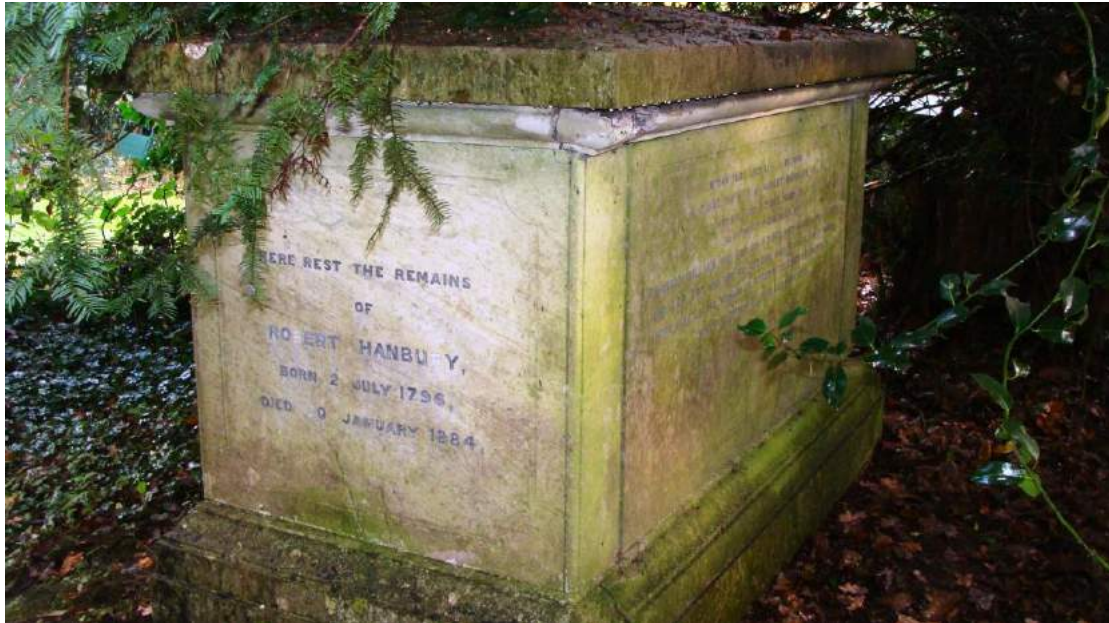
5.32. Miscellaneous gravestones in churchyard including vault to Robert Hanbury and family who built and endowed the church.

Picture 21. Vault of Robert Hanbury and family who built and endowed the church.

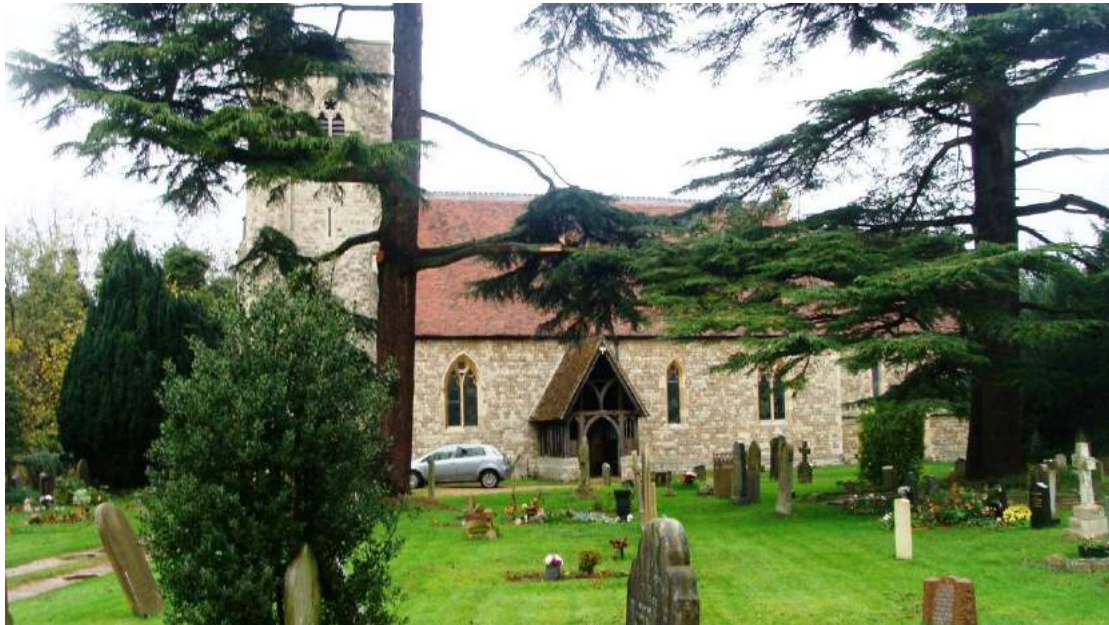
5.34. St Mary's churchyard and the entrance to it is an important open space surrounded by a wall with several mature trees of typical churchyard species including Irish Yew and Cedar of Lebanon. It is well cared for with a variety of gravestones dating from the 19th century when the church was built.

Picture 23. St Mary's churchyard - a traditional churchyard dating from the 19th century.

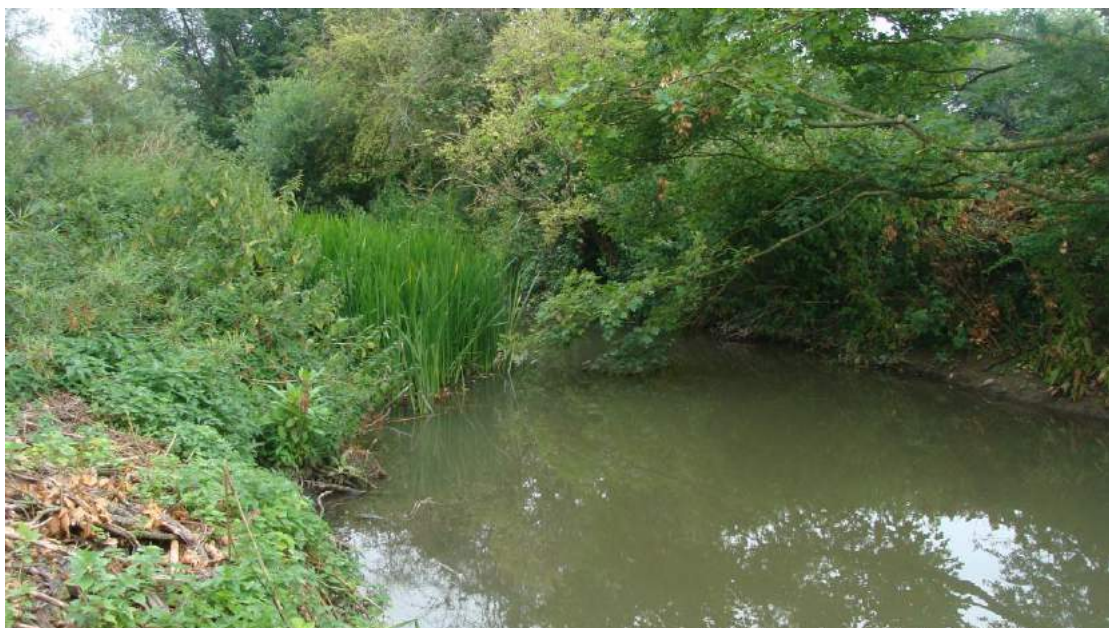
5.35. Important Water features. The River Rib in the valley bottom is an important environmental feature.

Picture 24. The River Rib is an important environmental feature adding significantly to the quality of the Conservation Area. Its character varies. This photograph was taken at a location near to Old Church Lane in the east.

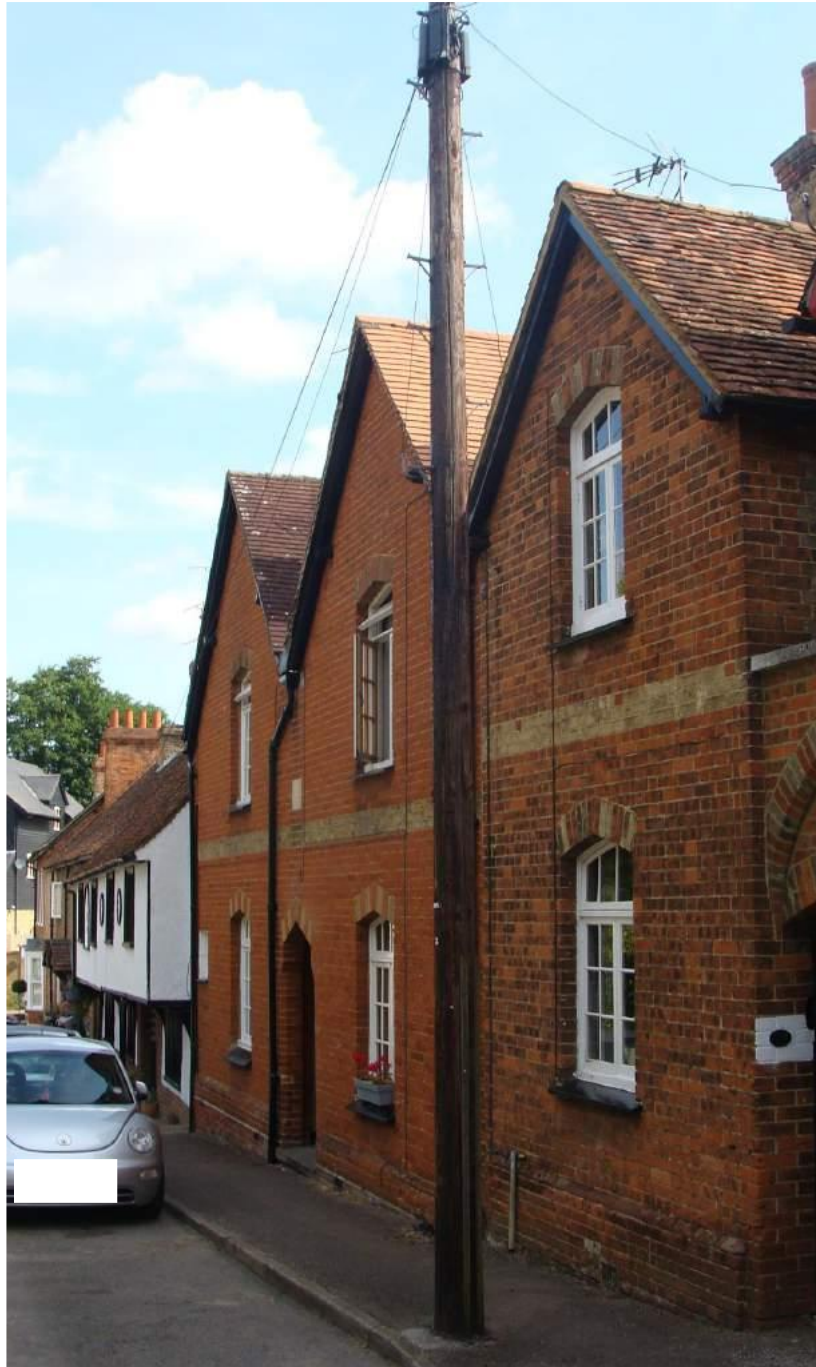
5.42. Utility poles. There are a number throughout the Conservation Area whose presence is perhaps most intrusive on Ermine Street detrimentally affecting the appearance of some important buildings. In the first instance it is suggested the appropriate utility company be approached with a view to seeking their long term co-operation in reducing the visual impact of some of this overhead infrastructure.

Picture 25. Utility poles detract from the high quality of the Conservation Area in this location on Ermine Street. The potential of resolving the situation could be explored with the utility company.
