HERTINGFORDBURY CONSERVATION AREA APPRAISAL AND MANAGEMENT PLAN

DRAFT FOR CONSULTATION 2013

REVISED AND UPDATED 2016

East Herts District Council
Pegs Lane, Hertford, SG13 8EQ

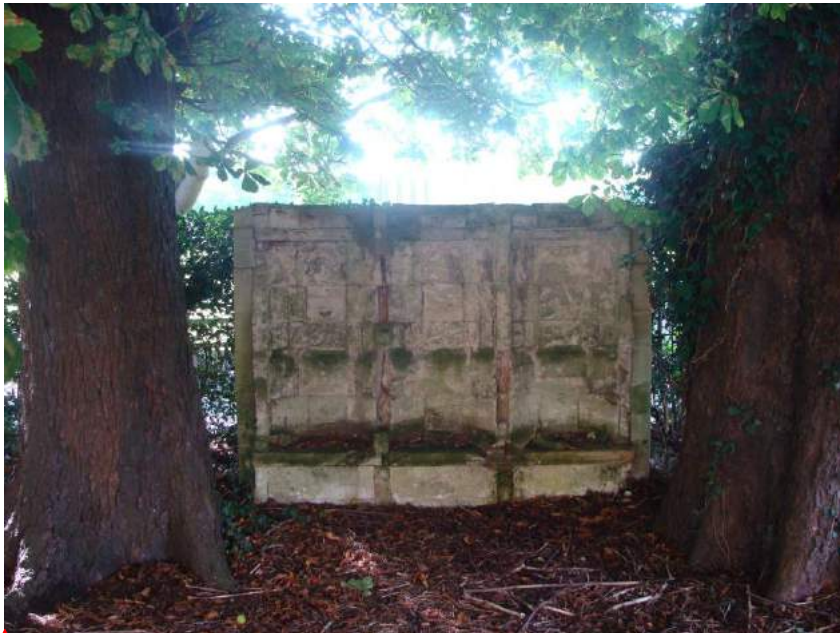
6.8. Sedilia, St Mary's churchyard- Grade II. This sedilia, dating from the 14th century was removed from the church during its restoration and rebuilding in 1891. In a decorated Gothic style with stone seats and recessed bays, it is now badly eroded. The structure is identified as being 'At Risk' on East Herts **BuildingsHeritage** at Risk Register. Careful restoration and consolidation is required and its long term protection from further erosion might involve returning it to the church interior or providing a proper shelter in its external location. Ongoing deterioration continues, which if remaining unresolved, will lead to its eventual destruction.

Picture 43 – 14th century grade II Sedilia removed from church during 19th century 'restoration', now in need of urgent repairs. Included on the Council's **BuildingsHeritage** at Risk Register.

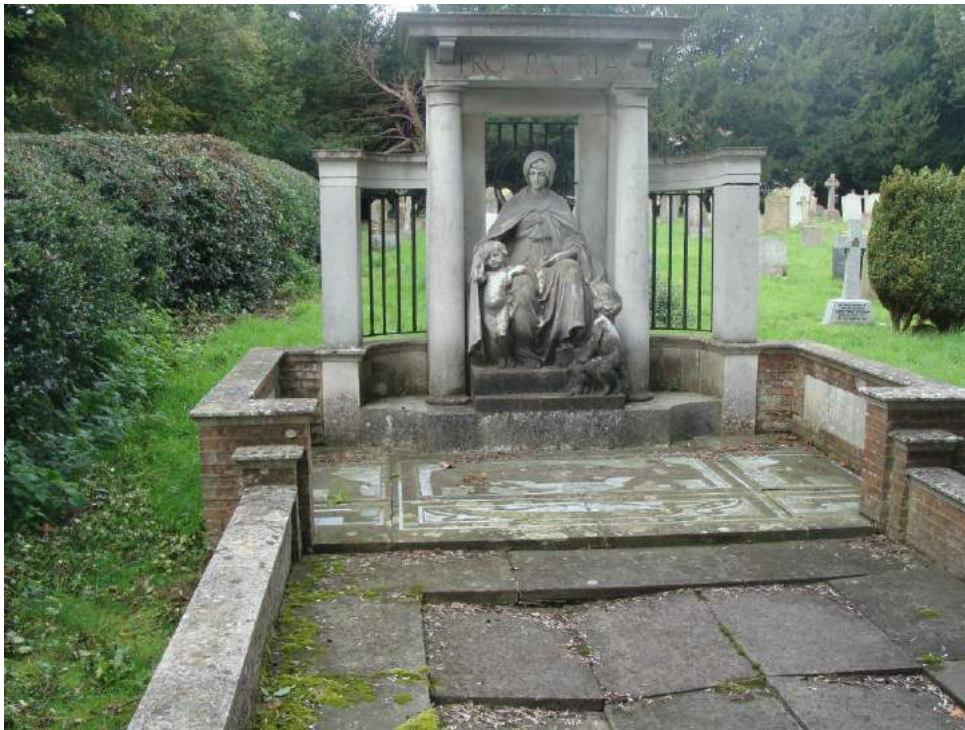
William Collins Whitney sometime secretary of the US Navy, 1874-1916'. Inset into the limestone slab in front of the sculpture are lead figures of soldiers and sailors from the First World War. The artist of this important memorial has not been traced. Selected repairs need to be undertaken, including the resetting and re-laying of ~~9 no. its~~ forecourt slabs.

Picture 54 – A fine early 20th century memorial to Pauline Payne Whitney Paget, in need of repair, listed grade II.

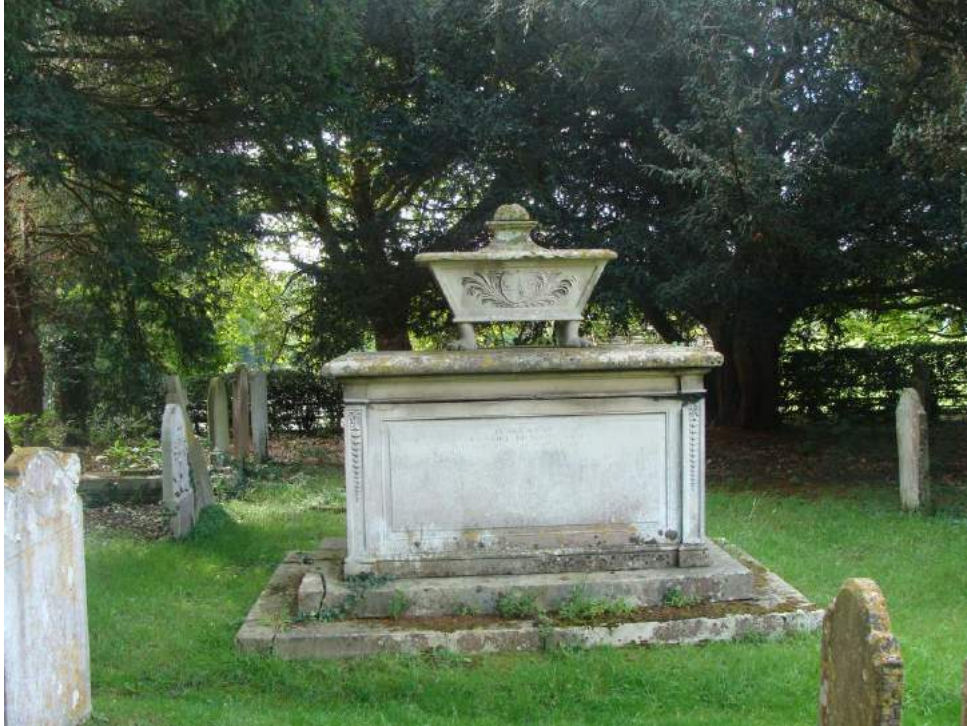
6.10. Nathaniel Brassey Tomb in St Mary's Churchyard- Grade II. A chest tomb with sarcophagus, 1798 to Nathaniel Brassey. Of Portland stone being a chest tomb on stepped base, with corner pilasters and long panels inscribed, with tapered sarcophagus on claw feet and armorial bearings. Metal railing surround removed. Remove vegetation and undertake repairs as necessary.

Picture 65 - Nathaniel Brassey tomb from 18th century, listed grade II.

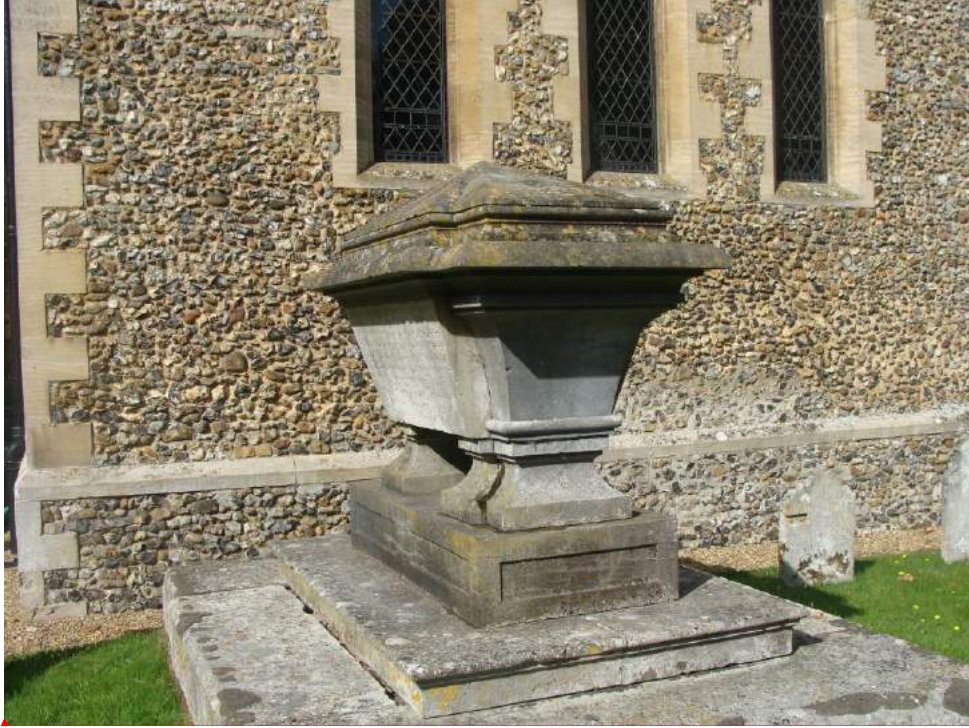
6.11. Sarah Lady Cowper Tomb in St Mary's Churchyard – Grade II. Sarcophagus, 1719, to Lady Sarah Cowper. Grey marble on Portland stone stepped base sarcophagus with pedestal feet on paneled base, coved sides with inscribed tablets; low pyramidal cap. Lady Sarah Cowper, widow of William Cowper of Hertford Castle, was mother of William, first Earl Cowper, Lord Chancellor to George I. Remove vegetation, devise schedule of minor repairs and undertake works as necessary.

Picture 76 - Sarah Lady Cowper tomb, listed grade II.

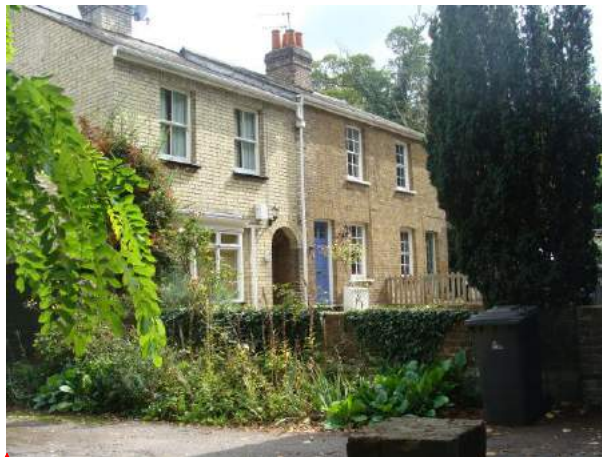
6.22. 11-15 St. Mary's Lane; Group of 19th century cottages constructed in 2 phases of yellow stock brick with slate roofs and 2 no. prominent chimneys; some vertical sliding sash windows. Despite modern additions, these cottages are important and in the street scene. Selected features are worthy of protection by Article 4 Direction subject to further consideration and notification.

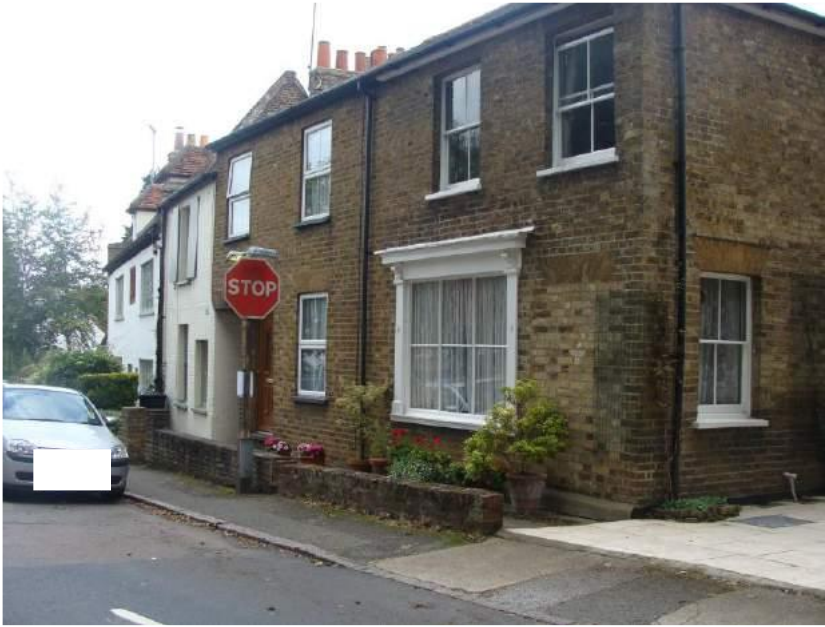
6.23. No. 267 Hertingfordbury Road and nos. 1- 3 St. Mary's Lane. Group of 19th century, 2 storey cottages constructed of brick with slate roofs. Brickwork to no. 267 is painted. 2 no. chimneys, one prominent with decorative pots. Particularly important former shop window and vertical sliding sash windows to upper storey of no.3. Some modern windows detract. Selected features are worthy of protection by Article 4 Direction subject to further consideration and notification.

Picture 98 - No. 267 Hertingfordbury Road and nos. 1- 3 St. Mary's Lane. Unlisted buildings whose mass and selected architectural details contribute to the quality of the street scene.

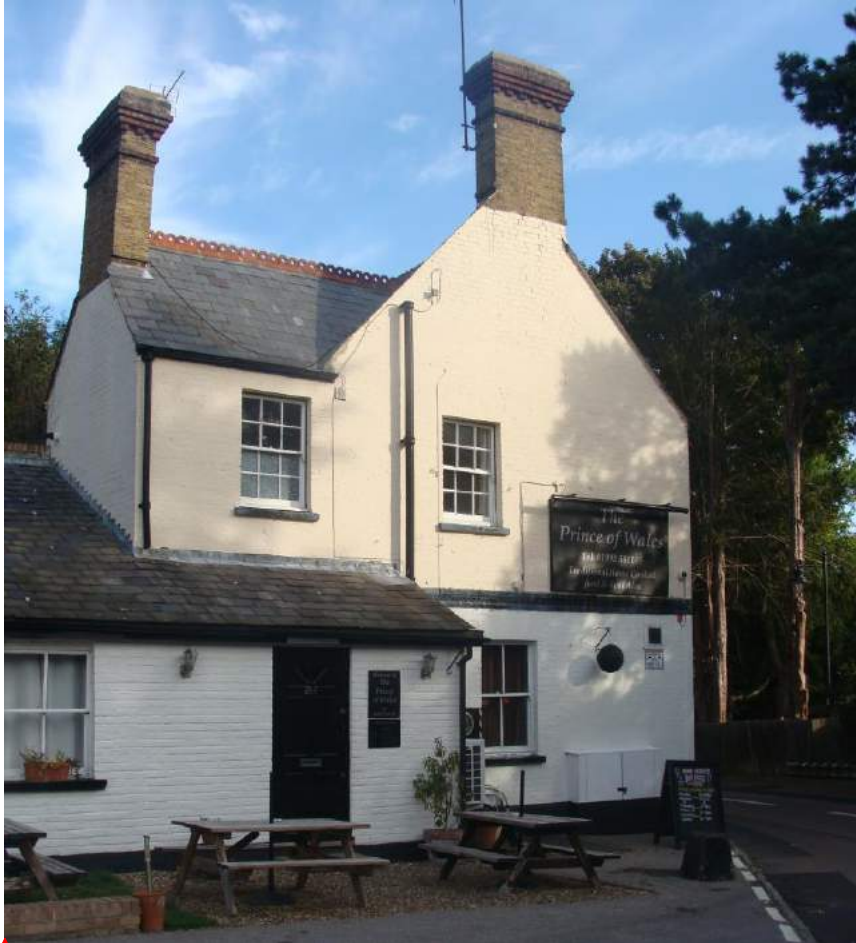
Picture 409 – The Prince of Wales PH, a prominent unlisted property in a central location whose historic mass and scale and architectural details contribute to the street’s environmental qualities, **a view supported through the appeal process.**

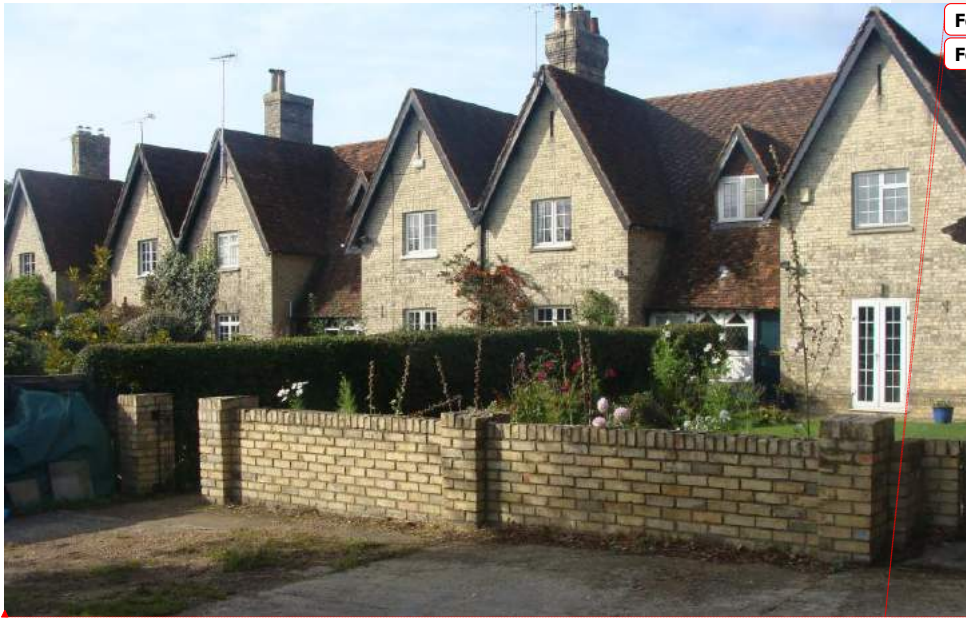
roofs in slate. The historic and architectural quality of the main terrace has been eroded by replacement windows but its mass and chimney detailing remains important. The single storey outbuildings are also important, particularly from a historical perspective, and should be retained. Selected features are worthy of protection by Article 4 Direction subject to further consideration and notification.

Picture 140 - Nos. 260 – 274 Hertingfordbury Road, an unlisted 19th century terrace whose imposing mass contributes to the Conservation Area in this location.

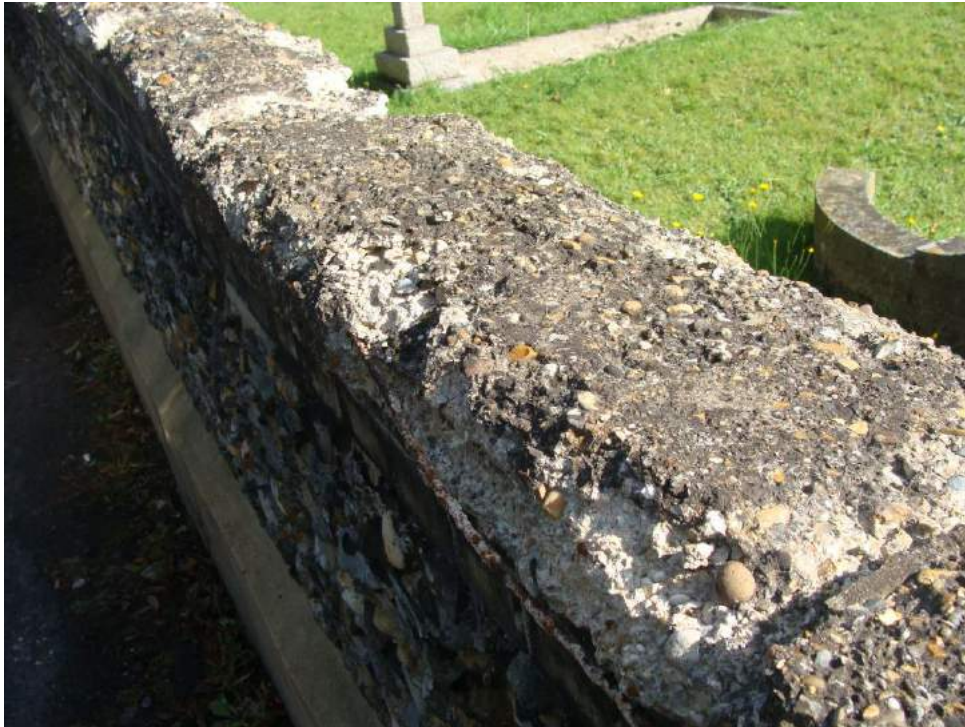
6.28. Other distinctive features that make an important architectural or historic contribution. Wall forming boundary to churchyard and Hertingfordbury Road. 1.2 m flint and brick wall with entrance gates, probably of late 19th/early 20th century date. Concrete capping slabs, some **recently replaced in need of replacement.**

Picture 132 – Concrete capping slabs to church boundary wall. Picture retained as an historic record. These degraded capping slabs have now been replaced. in need of replacement.

Church boundary wall.	Fronting Hertingfordbury Road.	Discuss replacement of selected capping slabs with church authority; possibly in association with external grant aid assistance should this course be pursued.
Metal boundary fence and steps.	Churchyard and access to churchyard extension.	Undertake necessary repairs; possibly in association with external grant aid assistance should this course be pursued.
Boundary fencing.	Thames Water site,	Discuss with Thames Water, seeking to initiate necessary

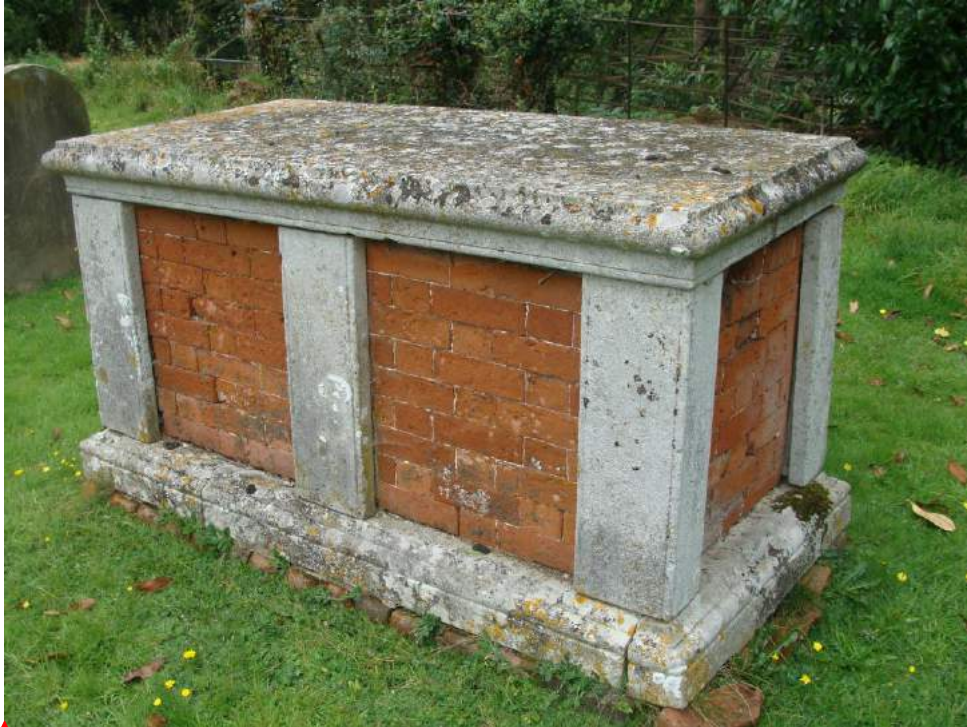
Picture 143 – One of many fine chest tombs in the churchyard, this one being of stone and rubbed brick.

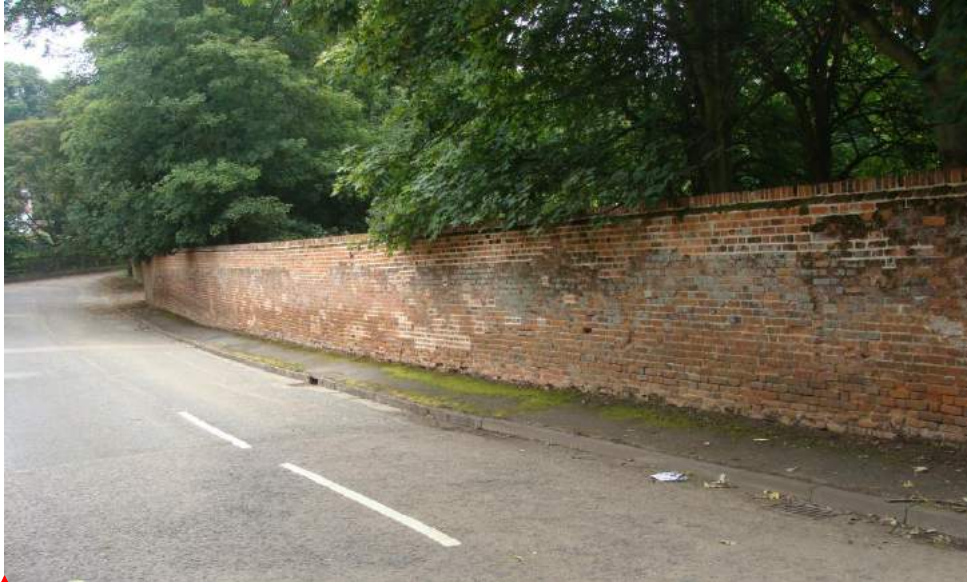
Picture 154 – Western boundary wall to ‘Epcombs’, a prominent and important feature, protected virtue of being within the curtilage of a Listed Building.

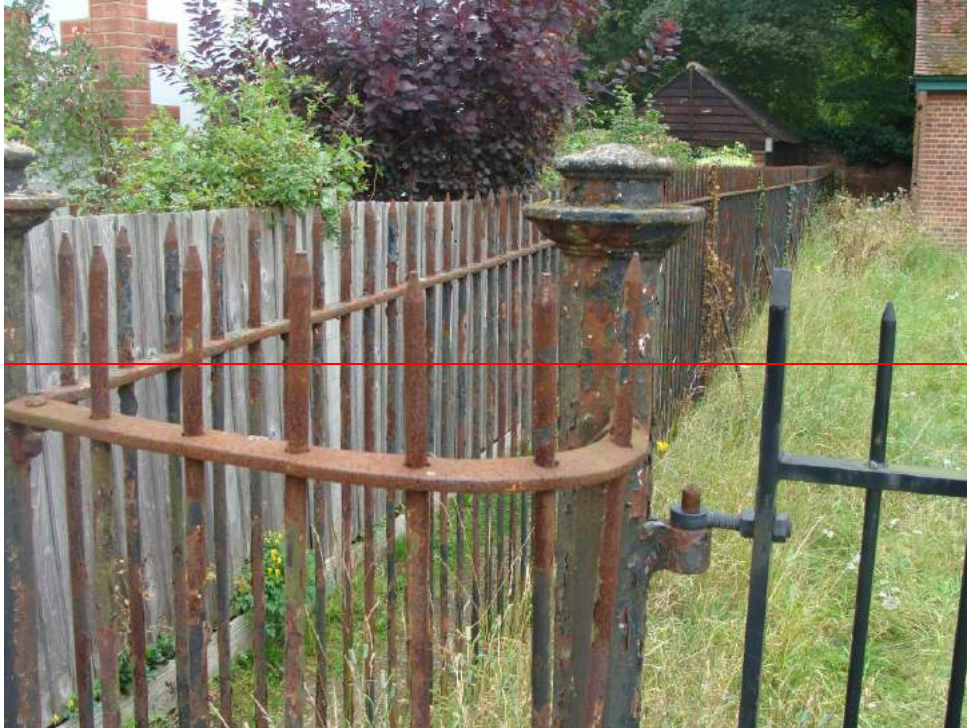
6.33. Metal fence frontingsurrounding Thames Water facility. ~~Stout metal fence approximately 1.6m in height that adds to the quality of the Conservation Area in this location. Generally in good condition but in need of repainting. Northern side boundary fence is unprotected from removal without prior consent and should be retained. An Article 4 Direction may be appropriate subject to further consideration and notification. Northern side, metal fence, formerly of traditional design, has recently been replaced with a less satisfactory solution from an historical perspective..~~

Picture 16 — Metal fence to side of Thames Water facility, worthy of retention and in need of repainting.

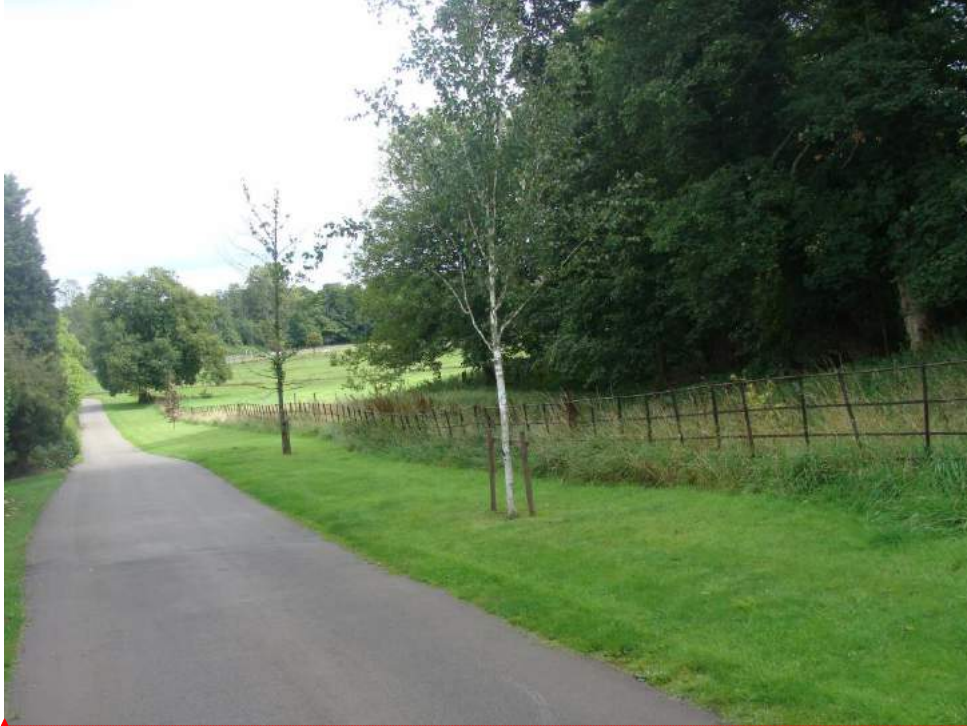
6.35. Metal estate fencing approximately 1m in height on access route to The Old Rectory. This long run of metal estate fencing dating from late 19th/early 20th century is prominent and important in its rural parkland setting and is worthy of retention. Its status in law needs assessing before considering whether or not an Article 4 Direction may be appropriate.

Picture 175 – 19th/20th century metal estate fencing of quality that adds to the rural qualities of the Conservation Area in this location and which should be retained.

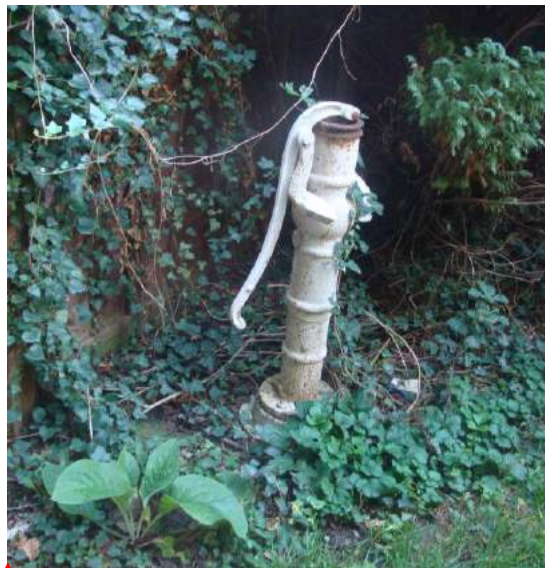
6.38. Pump to rear of Prince of Wales PH. 19th century pump broken and in need of repair.

Hertingfordbury Road.	repainting.
Boundary fencing.	Approach road to St Joseph's in the Park school.	Discuss potential of repair/ replacement with owners.
19 th century pump.	Rear of Prince of Wales PH.	Establish ownership and potential for repair and potential for subsequent listing if adequate repairs can be executed.
Orchard area.	To front of Mimrams House.	Discuss possibility of additional orchard planting with owner.
Other actions.		
Establish location/fate of separately listed gates at Epcombs and if appropriate seek their replacement in original location.		
Advise English Heritage that maps accompanying several listed building descriptions have locations wrongly plotted; e.g. St Josephs Lodge and The Hill.		
Amend EHDC mapping in relation to location of Brassey memorial on its information base.		
The symbol for the Wildlife Site on EHDC's Local Plan mapping needs amending to properly reflect its proper location, i.e. St Mary's churchyard.

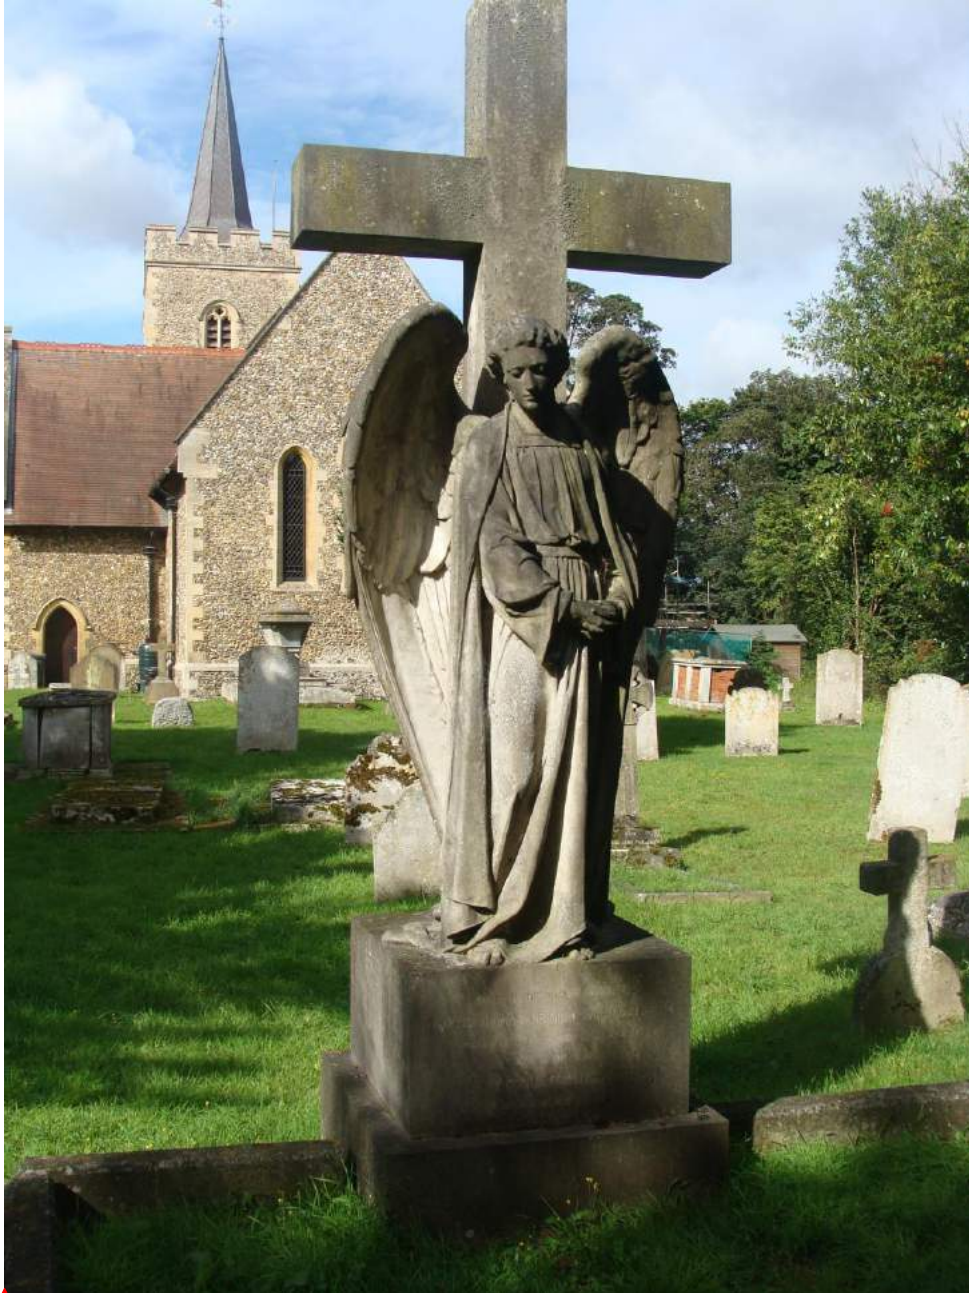
Picture 249 – St Mary’s churchyard. This open space is of the highest quality in terms of its open space, ecology and quality tombs. This Appraisal recommends repairs be carried out to selected tombs, possibly in association with external funding.

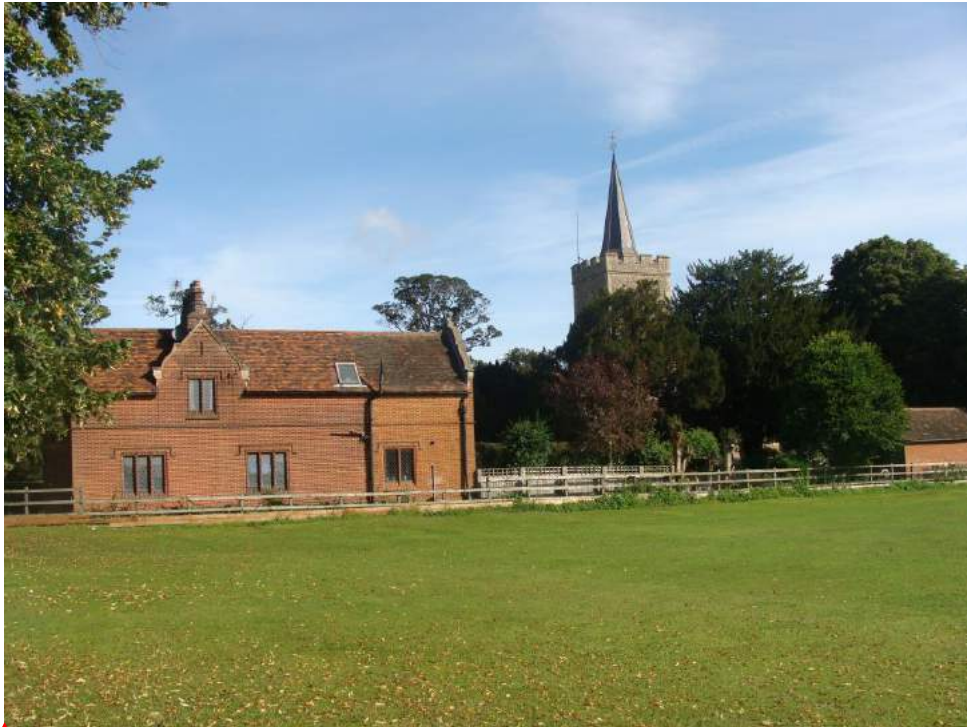
6.42. The Sports ground. This area to the south of the churchyard contains a cricket pitch and tennis courts whose tree lined boundaries enclose the open space. A combination of the cricket pitch, surrounded by trees with views of the church beyond, creates a traditional quintessentially English scene when viewed from the seating provided on the western boundary.

Picture 220 – The sports ground, church spire and 20th century listed lodge.

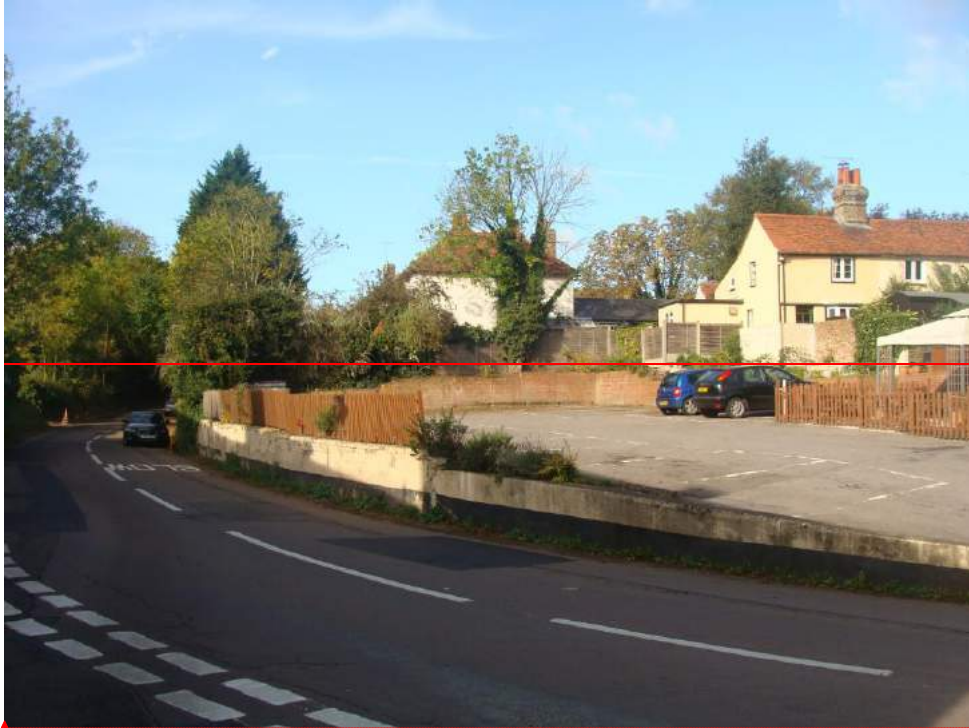
Picture 23 – The car park to the Prince of Wales PH – its appearance could be improved by comprehensive landscaping.

Detracting element	Location	Proposed Action.
Car park	Prince of Wales PH.	Contact owner with view of discussing landscape improvements to this important central location. Seek to achieve improvements and an appropriate planning solution.
Selective length of boundary fence and west elevation of property.	'Amores' and surrounding 'Amores'.	Contact owner with view of discussing improvements.
Highway directional sign	To front of Garth House.	Seek replacement.
Modern telephone kiosk.	Northern approach, Hertingfordbury Road.	Contact BT and ParishTown Council to establish usage. If kiosk to be retained, repair it. Otherwise consider its removal.
Eroded Sedilia – a listed structure 'at risk'.	Churchyard.	Establish church's considerations. Consider restoration and consolidation in situ or returning structure to church interior. Highest priority.
Other unlisted monuments/tombs in the churchyard in need of repair.	St Mary's Churchyard.	Discuss issue with church authority/owners. Identify monuments in need of repair, develop a schedule of restoration. Explore the potential for external grant aid including Heritage Lottery Funding for both listed and unlisted monuments.

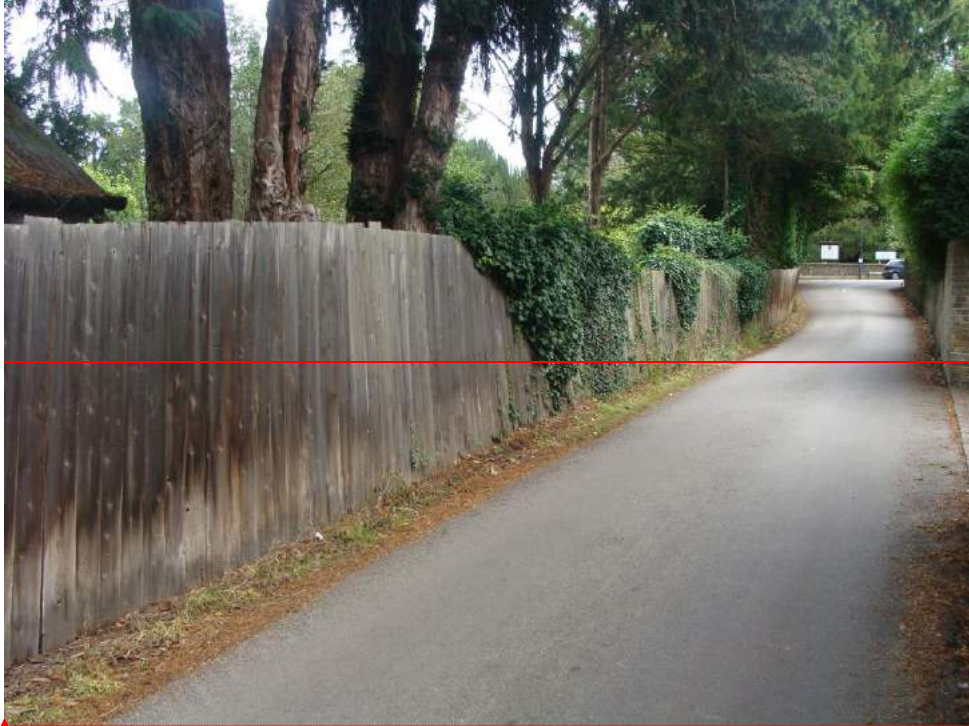
6.52. Fence around Amores. Amores is an important grade II* listed building and the many trees in its extensive grounds greatly contribute to the quality of the centre of the Conservation Area. Parts of the boundary fencing have recently been replaced, however other lengths remain in a deteriorating and unattractive condition. The west elevation to ‘Amores’ detracts in part and is in need of repainting.

Picture 24 — Boundary fencing to 'Amores' that detracts from this important central location.

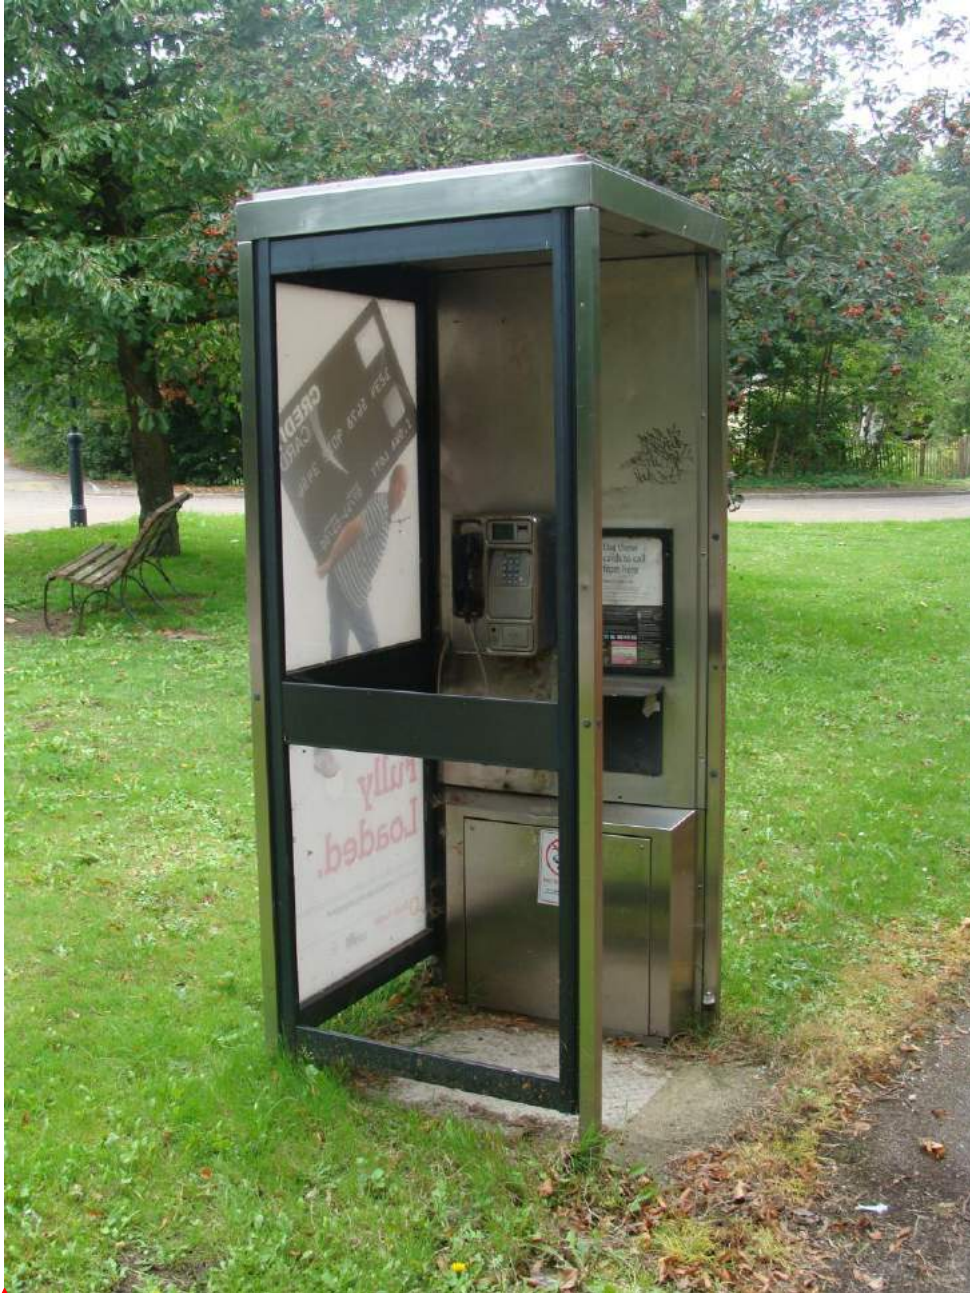
6.532. Telephone kiosk on northern approach. This modern telephone call box is in poor condition with some elements missing including door and one elevation. Some graffiti is evident. It is suggested that BT contacted to ascertain its current use. If the view is taken that it should be retained then the necessary repair works need undertaking. If on the other hand it is considered redundant, the call box should be removed.

Picture 251 – Modern telephone box that should either be repaired or removed.

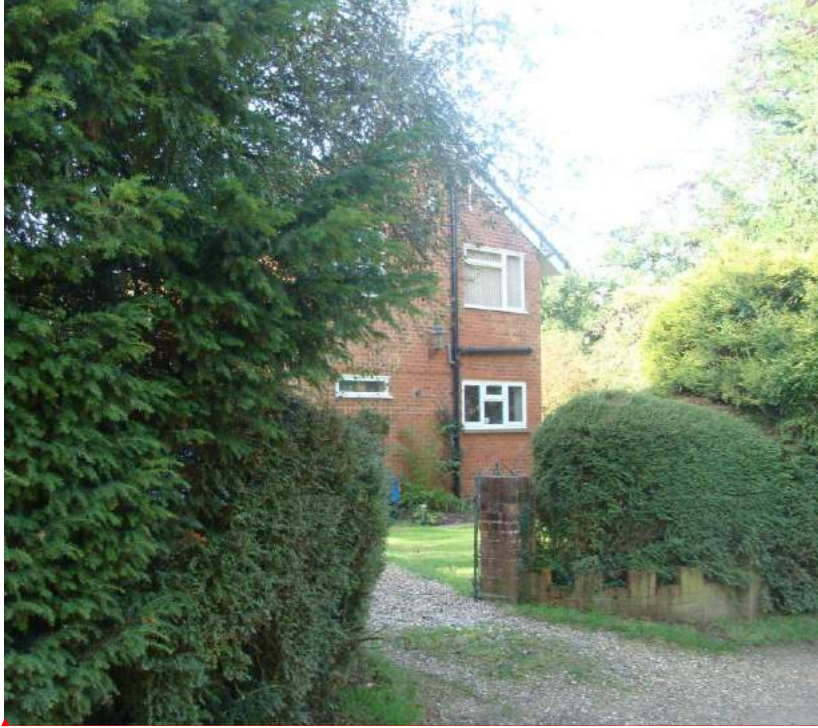
Picture 273 – An example of a pleasing modern 20th century housing but one of insufficient architectural or historic importance south of Cole Green Way. The whole area is proposed to be excluded from the Conservation Area.
