# ANSTEY CONSERVATION AREA APPRAISAL AND MANAGEMENT PLAN

DRAFT FOR CONSULTATION 2018

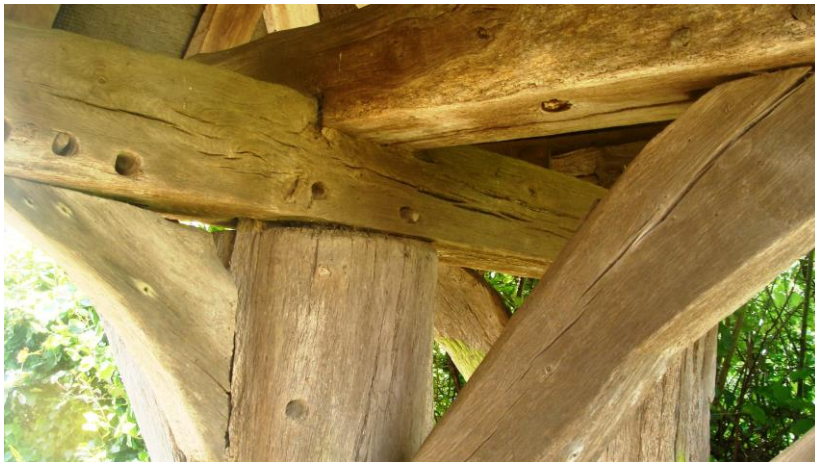
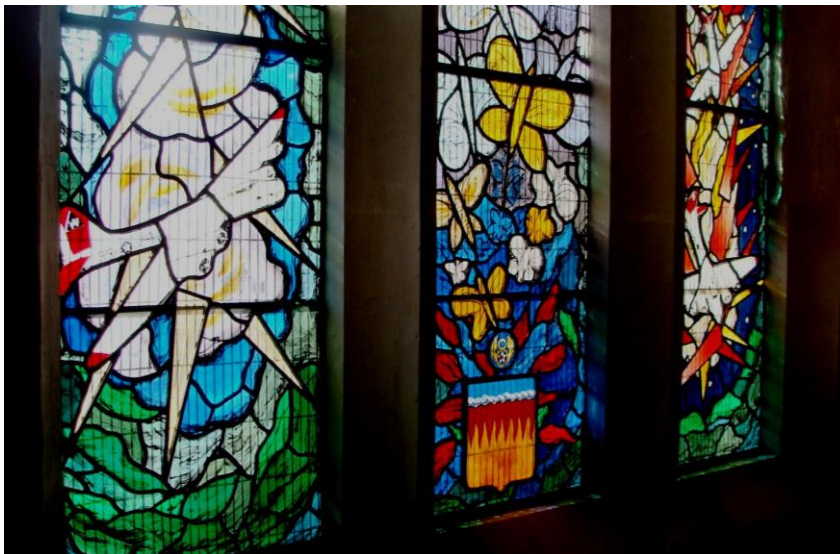
Top: heavy wooden arched knee brace construction detail of Lych-gate to church probably dating from the 15th century, perhaps earlier; below part of 20th century stained glass in church. The latter commemorates the 292 USAAF airmen who were killed in action flying B17 Flying Fortresses in WW11 from nearby Nuthamstead air base. Ten airmen were lost in one take off incident when a fully laden plane crashed near the church. The names of all those who died are etched in the wings of the butterflies.

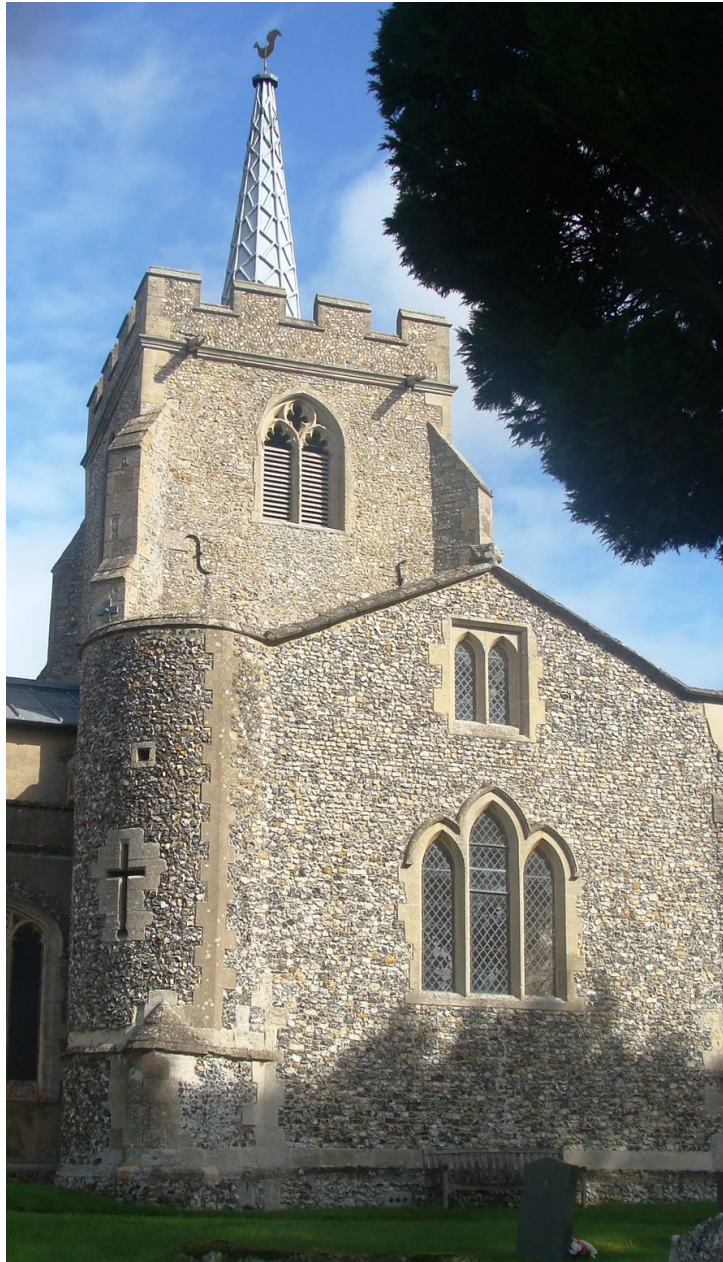
Picture 3. Church of St George which dates from the 12th century.

5.8. Church of St George - Grade I. Late 12th century central tower chancel and transepts rebuilt in late 13th century, 14th century nave and aisles, late 15th century south porch. Roofs lowered in 1831. Carefully restored 1871-2 by William Butterfield (1814-1900). Repairs by Sir Arthur Blomfield 1907. Flint rubble with stone dressings. Metal roofs of low pitch behind parapets. A fine cruciform church with chancel, 4-bays clerestoreyed nave, north and south aisles, transepts, south porch and central tower with battlements and spike. Unusual semi-circular lower stages to 13th century diagonal buttresses. Central tower of 3 stages with embattled parapet and Herts spike. Transept largely occupied by organ but also large iron bound medieval chest. *Unusual 20th century stained glass windows commemorating nearly 300 young Americans who were killed whilst serving in the 398th Bomb Group of the USAAF. Their names appear in the wings of butterflies etched on the stained glass.*

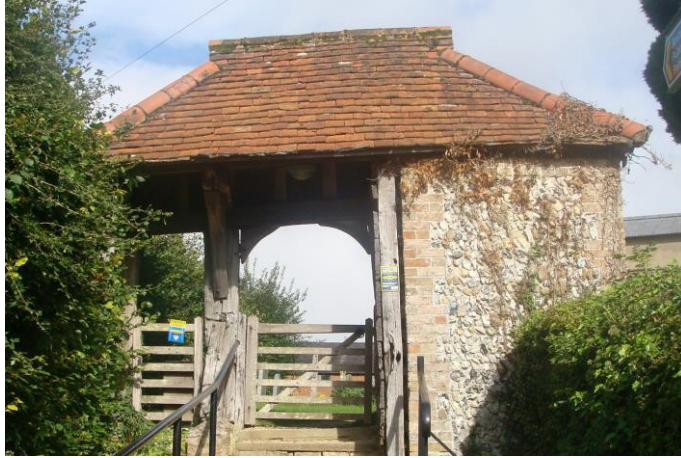
**5.9. Lych-gate Grade II. Lych-gate incorporating a lockup. 15th century or earlier, lockup enclosed in flint and brick walls in 1831. Timber frame on red brick sill walls uncoursed flint with grey brick quoins to lockup, and hipped old red tile roof with gablets. A small, single-storey rectangular structure... the square lockup occupies the east 2/5ths. 3 heavy chamfered square posts in line on the central long axis support the rest of the structure. Arched knee-braces in the head of the central opening. In use as the parish cage up to the early 20th century.**

Picture 4. Lych-gate and lockup, the latter being in use until the early 20th century.

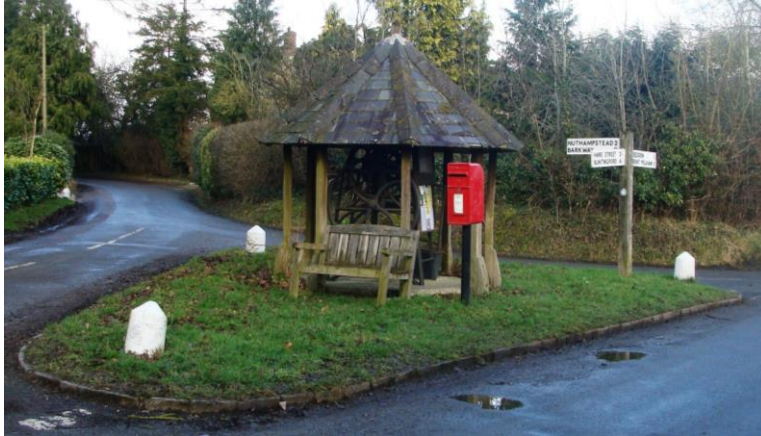
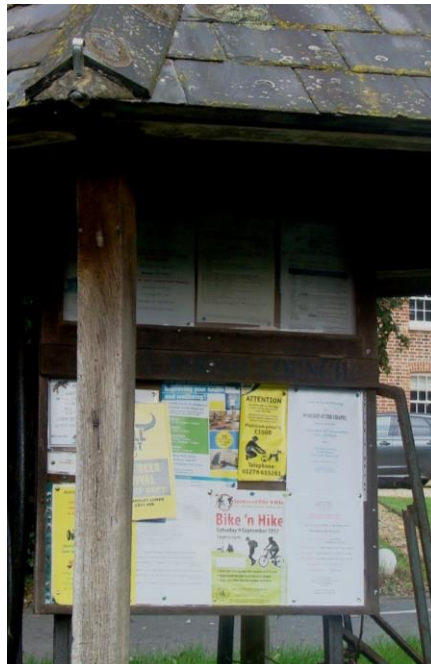
**5.11. Wellhead and Shelter - Grade II. Well head and shelter. Early 19th century. Cast iron wellhead, timber shelter and octagonal pointed slate roof with finial. A large openwork cast iron wellhead on an island at crossroads with an octagonal shelter on oak posts thickened by spurs at the base. Large flywheel on south side with mounting for handle on one of its four serpentine spokes. Trestle of 3 stages constructed of 2 parallel castings spaced apart. Small gear on spindle from flywheel drives large gear mounted on top spindle with a flanged winding wheel at its centre. A picturesque village feature of special social and technological interest. *Some may consider the presence of local information notices on hoarding within the structure detracts.***

Pictures 5-6. As the listed building says this is *A picturesque village feature of special social and technological interest*. However there is an opportunity to consider inexpensive improvements that would much improve the quality of this most unusual feature. In the authors opinion the notice board hoarding detracts.

5.546. Opportunities to secure improvements. Consider if improvements could be made to the listed well head at cross roads in centre of village by removing or reducing impact of local information hoarding and notices. Consider minor repairs cleansing and general refurbishment of listed telephone kiosk. Explore condition of eastern wall to churchyard covered in ivy and initiate any necessary repair works. ~~Discuss potential of securing improvements at the Blue Fiddler PH. Promised improvements to fence adjacent PH in centre of village have been carried out.~~ The PC may wish to approach the relevant utility company to discuss the potential of securing selected improvements.

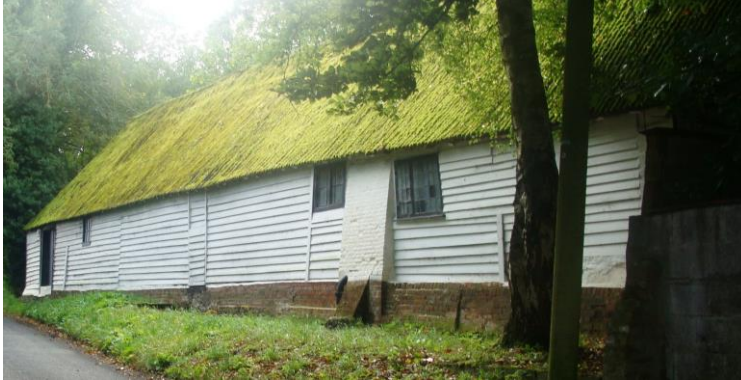
**5.12. Barn at Anstey House - Grade II.** Late 16th century west part, late 17th century east part. Timber frame on red brick sill, white weatherboarded on south, rear (north) side roughcast on road side. Steep, hipped thatch roof. A long barn with low side-walls and tall roof. 18th century leaded casement windows to convert it to a coachman's house. *Original thatched roof no longer exists - replaced.*

Picture 7. Barn at Anstey House. A prominent historic feature in the street scene.

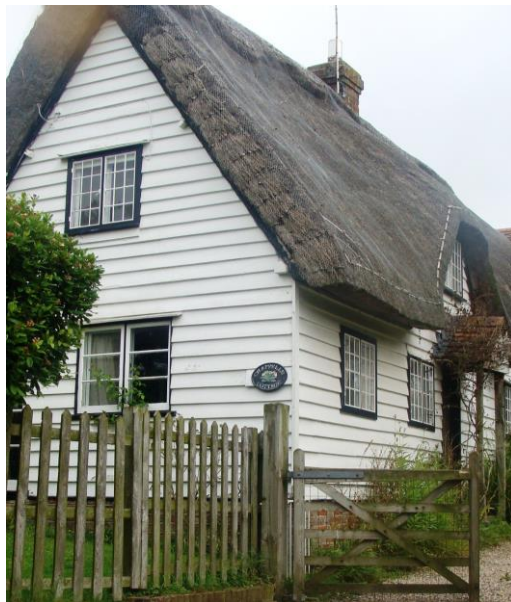
5.13. Chappells Cottage, Cheapside - Grade II. Later 17th century, north bay later. Timber frame on red brick plinth, white weatherboarded with a steep thatched roof. 2 eyebrow dormers on east with cast iron casements, **and** plank door under gabled tiled hood. Interior has axial beams and wide fireplace.

Picture 8. Chappells Cottage, Thatched roofs are an important feature in Anstey.

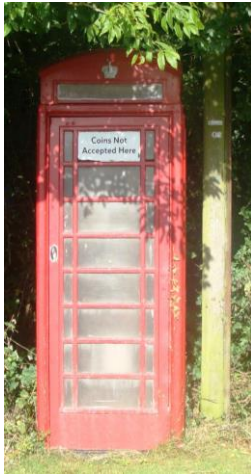
5.14. Telephone kiosk, 30 m. north-east of Wellhead and Shelter - Grade II. Type K6. Designed by Sir Giles Gilbert Scott. Made by Lion Foundry Co Ltd. Cast iron. Square kiosk with domed roof. Unperforated Elizabeth II crowns to top panels and margin glazing to windows and doors. *Appears to be in working order but in need of a good 'clean-up.'*

Picture 9. 20th century listed telephone kiosk. Would benefit by undertaking minor repairs and cleansing and if necessary repainting.

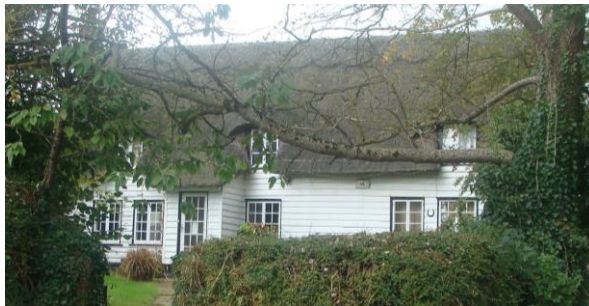
**5.15. Well Cottage - Grade II. 17th century, matching north part 1865. Timber frame, white weatherboarded with steep thatched roof. A 1½ storeys, 3 cells, end chimneys plan house facing east. 3 dormer windows of 2-light casements cut into thatch at eaves. Lean-to weatherboarded and thatched porch central to older south part.**

Picture 10. Well Cottage one of a number of important thatched properties in the local street scene.

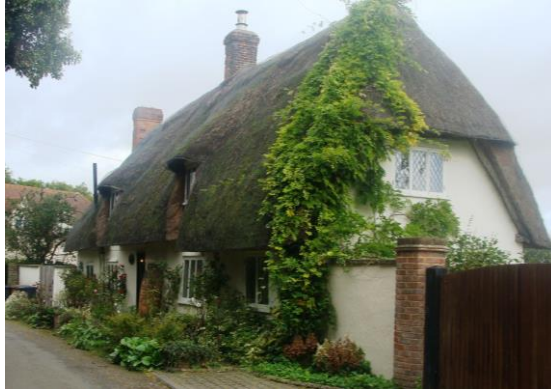
Picture 11. Snow End and Essex Cottage in foreground, part of a group of important listed properties principally dating from the 16th century.

**5.17. Essex Cottage - Snow End - Grade II. 16th century or earlier. Hall floored and chimney inserted in 17th century. Restored in 20th century. Timber frame roughcast with steep half-hipped thatch roof.**

Interior has evidence of former open hall, with slots for braces in bay posts in south bay flanking inglenook.

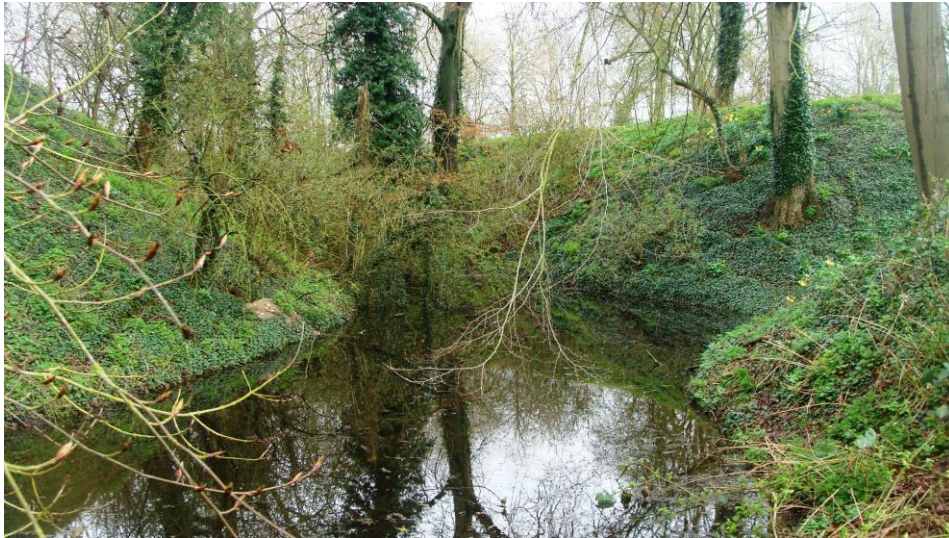
**5.20. Anstey motte and bailey castle to north of Anstey Hall. The monument includes a motte and bailey castle situated at the south end of a broad spur, adjacent to the Norman church of St George's. It survives as a large flat-topped motte. Surrounding the motte is a water filled ditch with a causeway to the south-east. To the north and east of the motte is the L-shaped bailey which is still surrounded on its north-western and north-eastern sides by a dry ditch. Within the projected**

area of the bailey, just east of the motte, is a square-shaped landscaped mound surrounded by a dry ditch. Its position and shape are incongruous with the bailey and it is considered to be a later ornamental addition. In 1902 excavations carried out by R. T. Andrews on the eastern edge of the motte summit revealed a trapezoidal foundation of flint dug circa 46 cm deep into the boulder clay. Fragments of tile and 13th century pottery were also found. The castle is attributed to Eustace, Count of Cologne, who held the manor at Domesday. In 1218 Nicholas de Anstey was ordered to reduce his castle which was in the king's hands in 1225.

Picture 12. Part of the Anstey Motte and Bailey site, an important Scheduled Ancient Monument attributed to Eustace Count of Cologne.

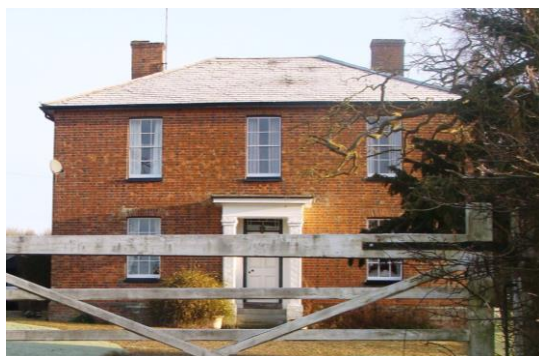
**5.27. High Hall, Mill Lane. Of mid/late 19th century date. Brick construction with hipped slate roof; 2 No. chimney stacks. 3 range vertical sliding sash windows to first floor. Central decorative portico (not examined or dated) and entrance door with flight of steps. An Article 4 Direction to provide protection for selected features may be appropriate subject to further consideration and notification.**

Picture 13. High Hall a prominent 19th century building of good proportions worthy of retention.

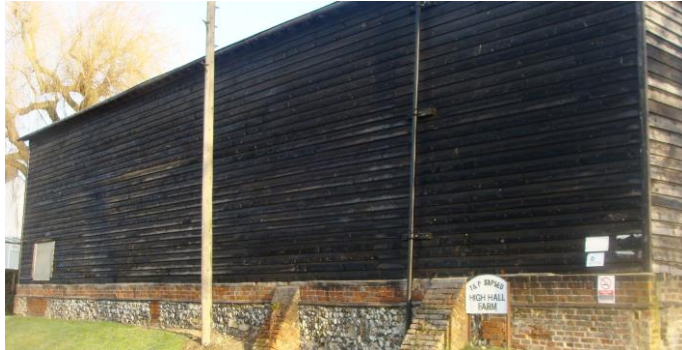
**5.28. Barn at High Hall Farm. Of 19th century date. Weatherboarded farm building on brick and flint base with slate roof adjacent to the public road and prominent in the street scene. An Article 4 Direction to provide protection for selected features may be appropriate subject to further consideration and notification.**

Picture 14. Prominent barn in the local street scene - High Hall Farm worthy of retention.

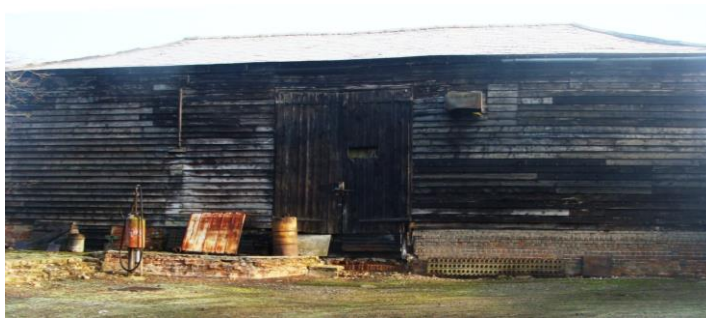
**5.29. Agricultural barn at High Hall Farm. Probably of mid/late 19th century date. Principally weatherboarded with slate roof. Largely unaltered with large central entrance to front elevation. An Article 4 Direction to provide protection for selected features may be appropriate subject to further consideration and notification.**

Picture 15. 19th century agricultural barn of historic and architectural interest associated with High Hall Farm probably from mid/late 19th century.

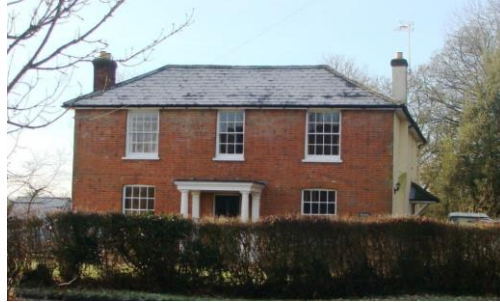
**5.30. The Hale, Mill Lane. At furthest eastern extremity of the conservation area and to the east of Anstey House. Probably of mid 19th century date. Of brick construction with three range vertical sliding sash windows to first floor. Slate roof with 2 No. chimneys. Later central canopy detail. An Article 4 Direction to provide protection for selected features may be appropriate subject to further consideration and notification.**

Picture 16. The Hale - makes a worthwhile architectural and historic contribution to the conservation area in this location.

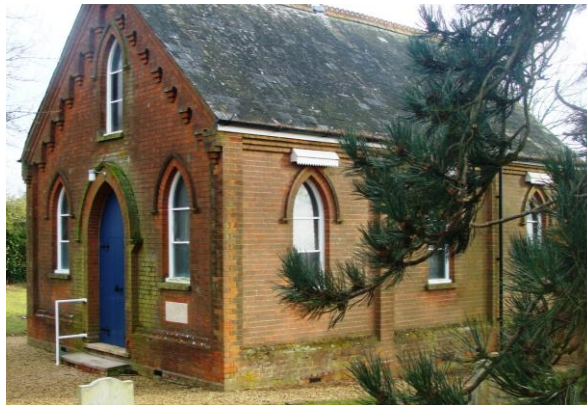
**5.31. The Union Chapel. Dating from the early 20th century. Of brick construction with slate roof and decorative ridge tiles. Central entrance door to front and three range window to side. This building seems to have replaced an earlier original Primitive Methodist chapel to the north, now demolished. Commemorative stone reads *This stone was laid to the glory of God by J. C. Wilkerson Esq. October 27 1902*. This building and window openings with central entrance and brick hood moulding and label stops is/are most worthy of retention.**

Picture 17. The Union Chapel, of early 20th century date apparently replaced a Primitive Methodist Chapel at Cheapside to the north.

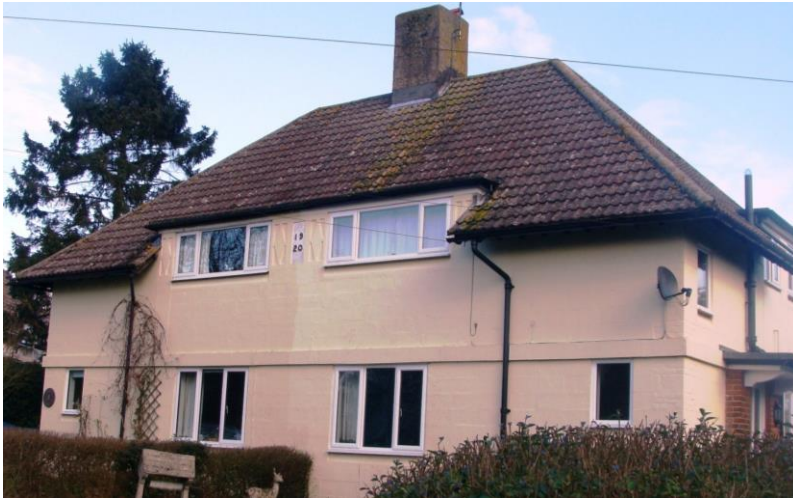
**5.32. Nos.1-6 Castle Cottages. Of block construction painted/rendered. All with original roof chimney and date plaque (1920) detailing. Mostly with original entrance canopies to side. Two have later extensions but executed in a sympathetic manner. Despite late window detailing, and on balance, these early 20th century properties have sufficient architectural and historic value to be protected and retained. An Article 4 Direction to provide protection for selected features may be appropriate subject to further consideration and notification.**

Picture 18. Nos. 1-6 Castle Cottages. Dating from 1920 these properties on balance are considered to be of sufficient quality to be protected and retained.

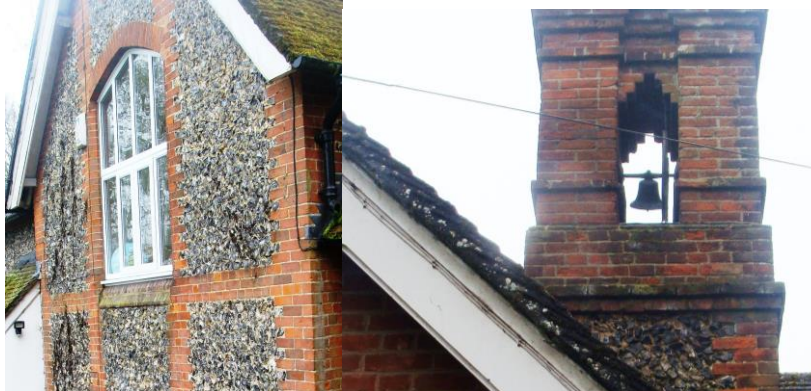
**5.33. School building in part. Parts of the old school remain and are visible from the main road. The brick and flint front elevation and bell tower are pleasing features and worthy of retention. However various extensions and additions elsewhere on the site are visually less satisfactory.**

Picture 19. Historic elements of original 19th century school building which make an historic and architectural contribution to the street scene.

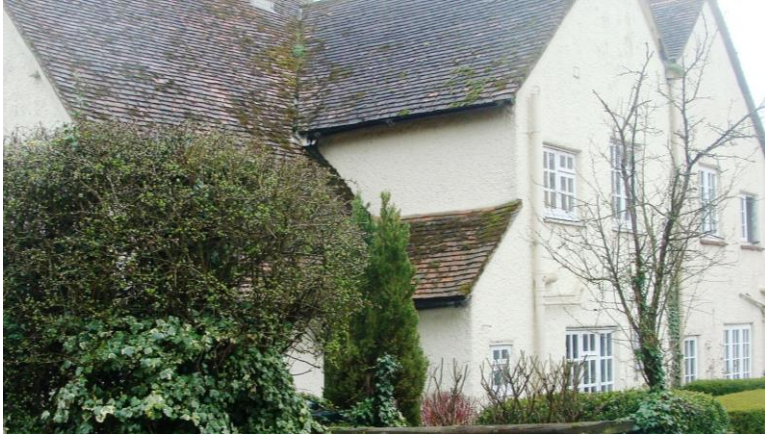
Picture 20. Church Gate Cottage and Anstey Hall Cottage, St Georges End.

**5.34. Church Gate Cottage and Anstey Hall Cottage, St Georges End. A large two storey rendered building probably of 19th century date with tiled roof and chimneys with pots. Inappropriate but subservient extension to Church Gate Cottage. On balance the whole is worthy of retention. An Article 4 Direction to provide protection for selected features may be appropriate subject to further consideration and notification.**

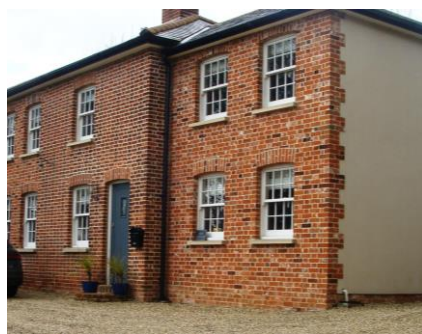
**5.35. Elm Cottage.** From preliminary consideration (albeit no detailed site inspection or discussion with owners, see reference at para. 1.7) and historic map inspection, the southern element of Elm Cottage is interpreted as being late 19th century of brick construction with hipped roof and centrally located chimney. The northern extension, although quite prominent is well designed and in keeping with the original in terms of design and materials. Therefore the building as a whole makes an important architectural and historical contribution and on balance the whole is considered worthy of retention. An Article 4 Direction to provide protection for selected features may be appropriate subject to further consideration and notification.

Picture 21. Elm Cottage A sensitive design and use of materials of new extension is successful and in keeping with the original.

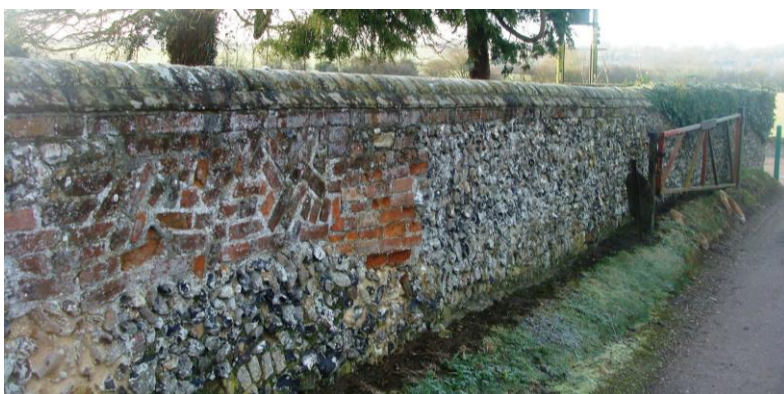
5.37. Flint wall at High Hall Farm. Prominent feature in the farm complex. Of flint construction capped with typical 19th century rounded brick detailing. Not adjacent to the highway and less than 2m in height and thus unprotected by conservation area legislation. An Article 4 Direction to provide protection for selected features may be appropriate subject to further consideration and notification.

Picture 22. Good quality 19th century wall at High Hall Farm worthy of retention and protection.

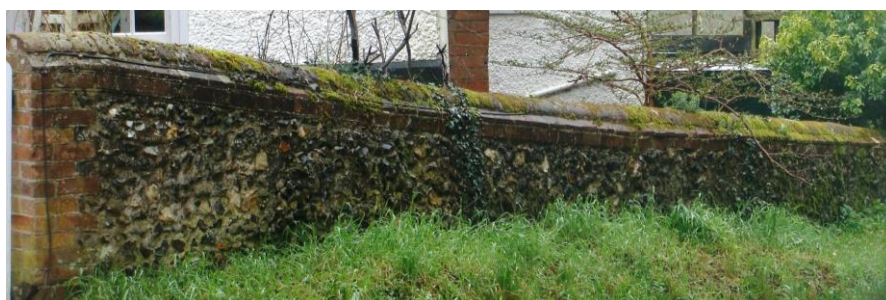
5.38. Wall to frontage of ~~Clare Cottage~~ Snow End House. Approx. 1m in height of brick and flint construction with rounded brick capping detailing.

Picture 23. Wall of brick and flint construction to front of ~~Clare Cottage~~ Snow End House.

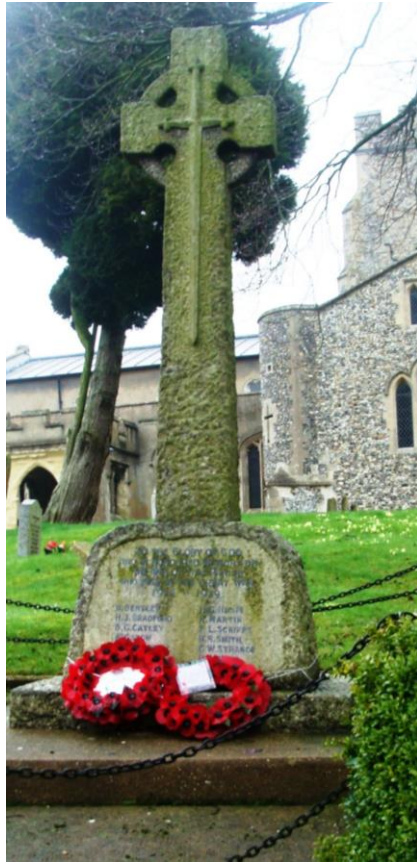
5.39. War Memorial. Advised designed and built by G. Maile and Son London and dedicated in 1921 (see Picture 1). Celtic Cross with sword commemorating the local war dead of the Great War 1914-1919.

Picture 24. Fine stone War Memorial believed dedicated in 1921, see also Picture 1.

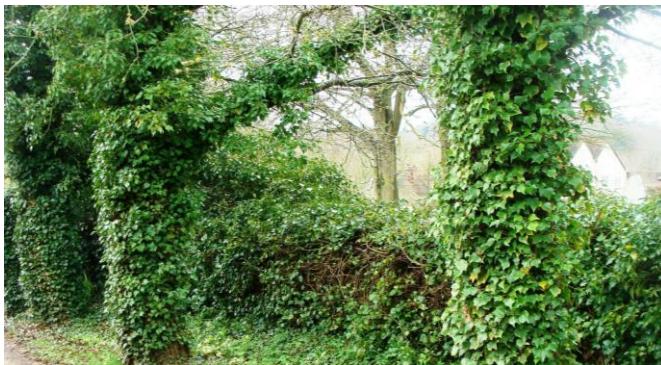
**5.40. Eastern boundary of church presumed brick/flint wall. Partly repaired but partly heavily covered in ivy. Condition of wall beneath ivy unknown. Suggest careful removal of ivy and if necessary initiate repairs.**

Picture 25. The condition of the eastern boundary of the church boundary wall? is unknown. Suggest explore further and consider implementing any necessary repairs.

Detracting element.	Location.	Proposed Action.
<del>Open storage area and broken</del> boundary fence.	<del>Adjacent to The Blue</del> Fiddler PH.	Contact owner to consider if improvements can be secured <del>to this sensitive central site.</del> <u>Owner contacted. Repair of fence now executed.</u>
Selected Utility poles and overhead services.	Various.	PC may wish to discuss potential of improvements at selected locations with utility company.
Consider the potential of improving the appearance of Well head gear and small green at crossroads in centre of village by removing or reducing impact of local information hoarding and notices.		
Consider minor repairs cleansing and general refurbishment of listed telephone kiosk.		
Explore condition of eastern wall to churchyard and initiate any necessary repairs.

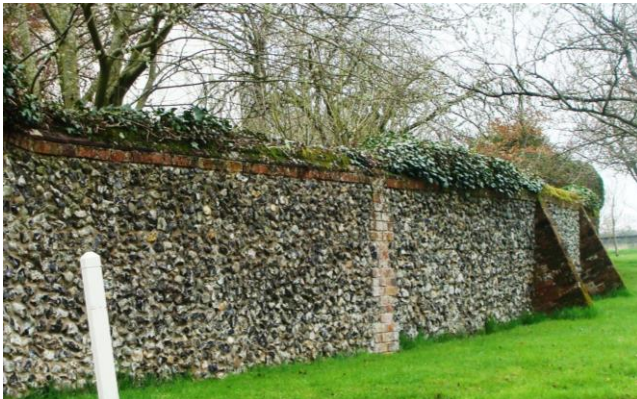
**5.41. Boundary wall to Anstey Hall. Wall of high quality of flint construction with rounded brick capping. Height varies.**

Picture 26. High quality boundary wall to Anstey Hall - a prominent and visually important feature in the street scene.

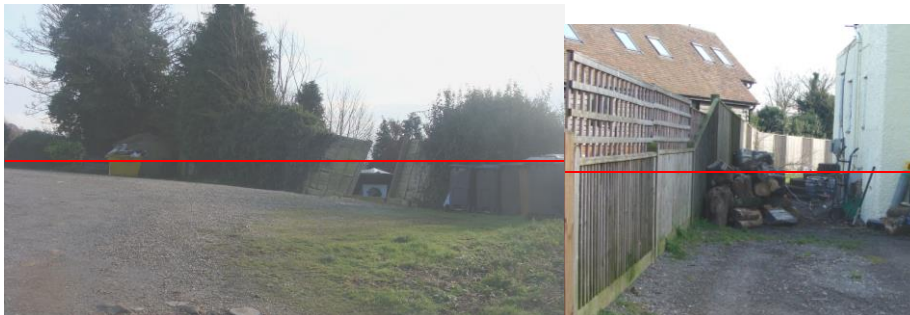
**5.52. Elements out of character with the conservation area. The site offence adjacent to The Blue Fiddler PH is in the centre of the village and a visual focal point. The site is untidy in some respects and would benefit from modest improvements including repair and replacement. Discussions have now taken place with the owner who has promised positive action. of part broken fence. This has now been implemented.**

**Pictures 29-30. The Blue Fiddler PH – broken boundary fence and open storage area detract.**

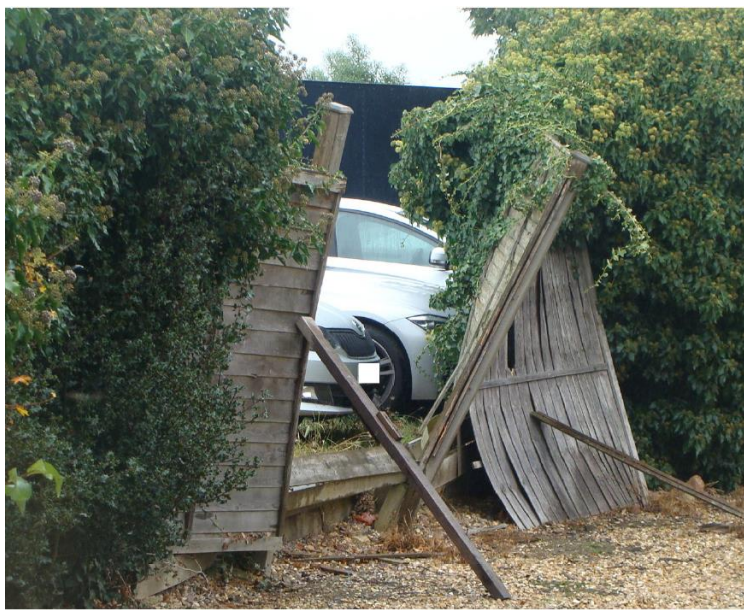
**Picture 29. Broken boundary fence between No. 1 Buryfield and adjacent PH detracts. The owner has promised a positive outcome which has now been implemented.**

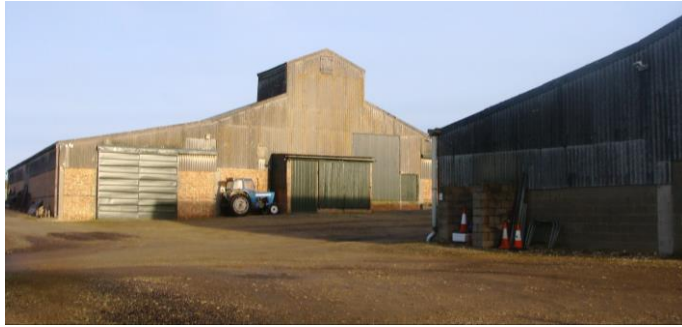
Picture 340. Modern agricultural barns to north of High Hall Farm to be removed from the conservation area because they are of no historic or architectural value.

(b) Exclude two large modern agricultural barns at High Hall Farm of no architectural or historic interest.

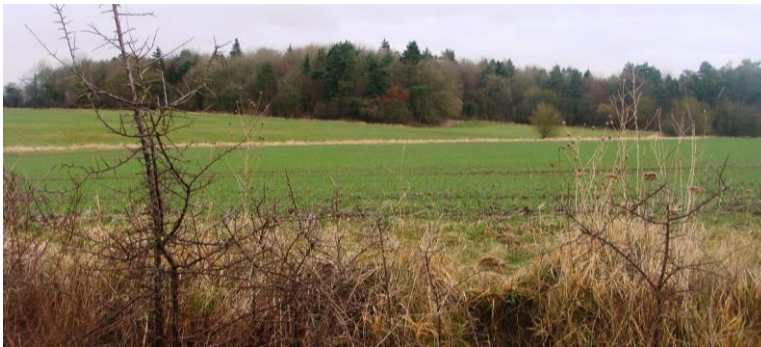
Picture 321. One of two linear strips of agricultural land with undefined northern boundaries clearly forms part of the wider agricultural landscape and as such their exclusion is consistent with Historic England advice.

(c) Exclude two narrow linear areas of open countryside to north of Mill Lane and north of Anstey House. These pockets form part of the wider landscape and farmland.

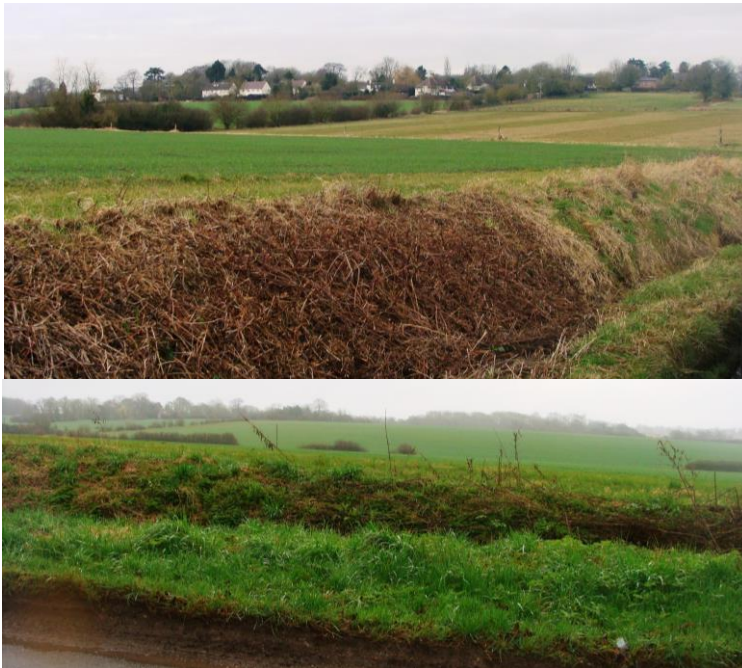
Picture 332-343. Extensive tract of open countryside/ farmland between Mill Lane and Castle Cottages extending south to land beyond Silver Street now excluded from the conservation area being contrary to National advice and local practice.

(d) Exclude a very large area principally of open countryside and agricultural land to the south of Mill Lane and east of Castle Cottages and extending further south to include land beyond Silver Street at Dawe's End. This very extensive area also includes a scatter of properties and smaller scale paddocks. Overall it forms part of the wider landscape, the inclusion of which is not consistent with National advice and local practice. Within this area are a number of properties mainly modern but also ~~three~~ a listed buildings (LB) protected by ~~their~~ its own legislation. These properties include: a collection of farm buildings to south of Essex Cottage; Yew Tree Cottage, Nos. 1-2 Dawe's End Cottages; The Old Bell (LB); The Mayflower; Bell Cottage; Goldings; building south of Goldings on north west corner of Silver Street; ~~Dove Cottage (LB); Welspen Thatch (LB)~~. On reflection and following

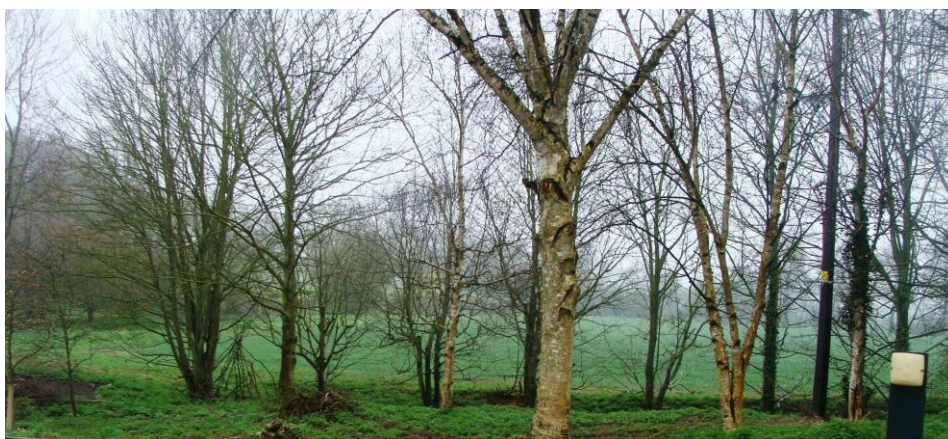
Picture 354. The field beyond the trees on the approach to the Village Hall clearly forms part of the open countryside.

(e) Exclude field to west of Village Hall. This farmland is open and forms part of the wider agricultural landscape. Its exclusion is clearly in accord with Historic England advice.

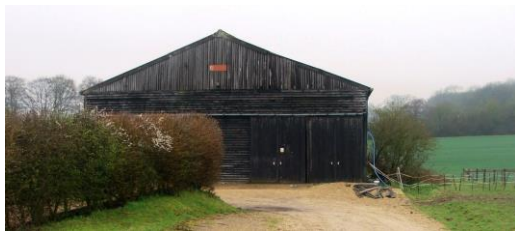
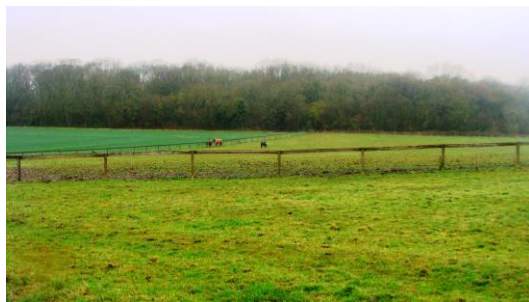
Pictures 365-376. Agricultural barn and area of open countryside north of St Georges End. Current national advice and local practice generally advise against the inclusion of such areas within a conservation area.

(f) Exclude large area of open agricultural/grazing land and modern agricultural barn north of St Georges End and west of Two Acre Farm stretching north to include Northey Lodge. Within this area there is a loose scatter of several residential properties at Pain's End. The latter are mainly modern and include Northey Lodge, Woodside Cottage, Brokers Retreat and property under construction on site of High Tree. Woodside Cottage is listed and there is a moated site at Northey Lodge; both protected by their own legislation. This area is interpreted as being part of the open countryside and beyond the obvious physical edge of the village at Two Acre Farm.
